# YOUR INSPECTION REPORT

Inspection prepared for: [REDACTED]  
Date of Inspection: [REDACTED]  
Age of Home: 2006 Size: 1151  
Weather: Cloudy 90  
[REDACTED]

Inspector: Eddy Lai  
License #7799  
Riverview, FL 33569  
Phone: 813-486-8551  
Email: [info@waypointinspection.com](mailto:info@waypointinspection.com)  
[www.waypointwest.com](http://www.waypointwest.com)

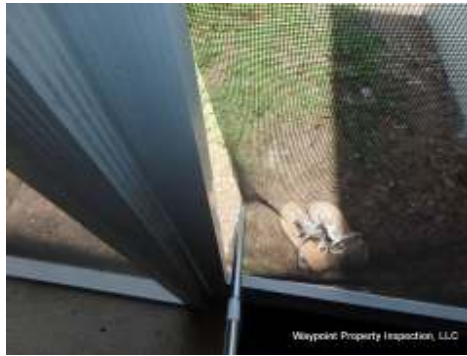
Screening had visible tears/holes.

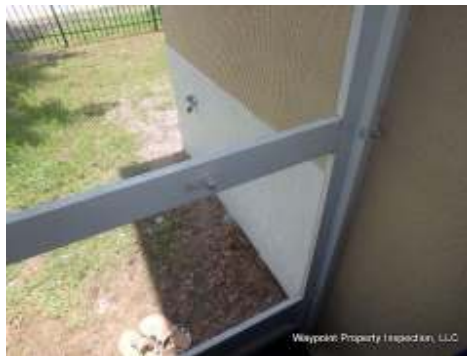
Screen door closing device was damaged/missing.

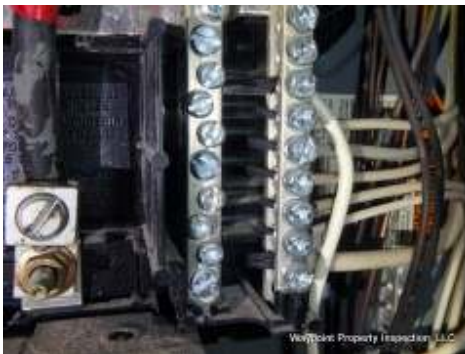
Panel wiring appeared to be corroded/discolored at sub-panel A. Evidence pf possible corrosive drywall.

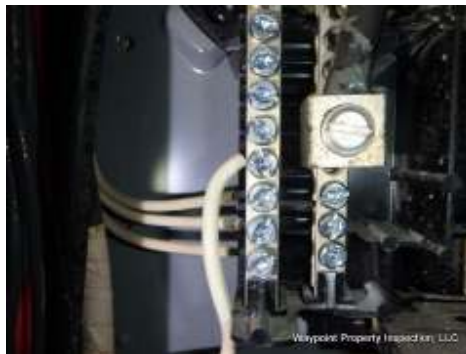
Panel wiring appeared to be corroded/discolored at sub-panel A. Evidence pf possible corrosive drywall.

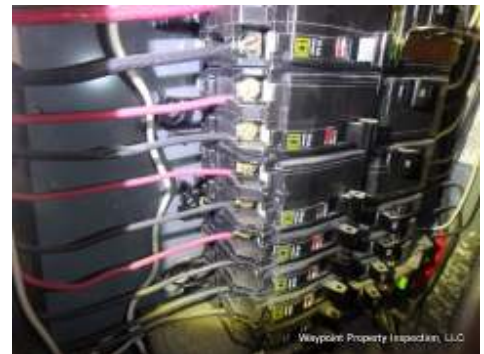
Panel wiring appeared to be corroded/discolored at sub-panel A. Evidence pf possible corrosive drywall.

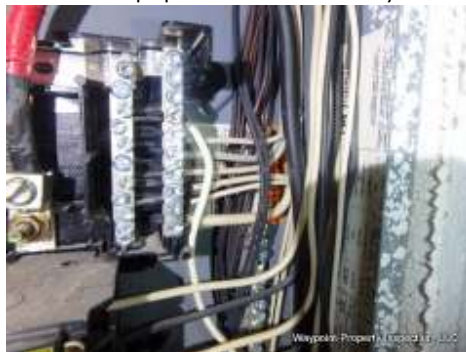
Panel wiring appeared to be corroded/discolored at sub-panel A. Evidence pf possible corrosive drywall.

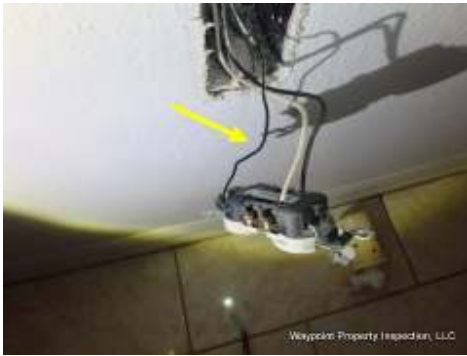
Evidence of possible corrosive drywall.  
Copper wires were black.

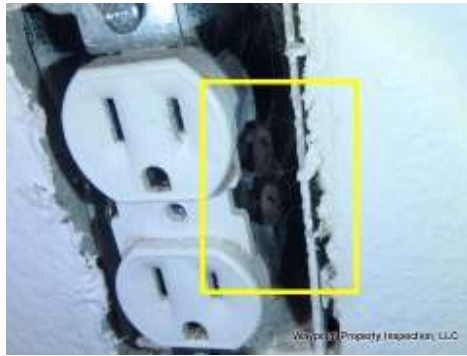
Evidence of possible corrosive drywall.  
Copper wires were black.

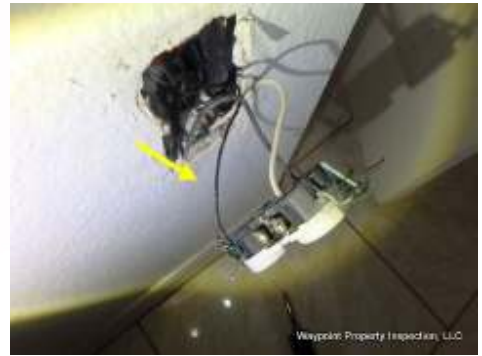
Evidence of possible corrosive drywall.  
Copper wires were black.

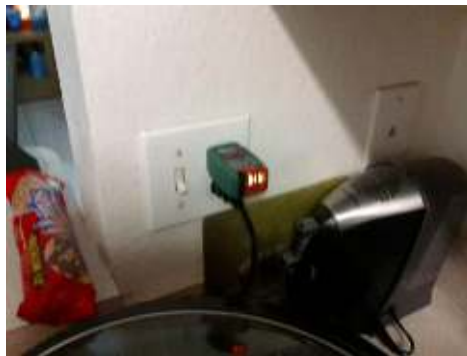
GFCI (Ground Fault Circuit Interrupter) outlet(s) should be installed at kitchen outlets.

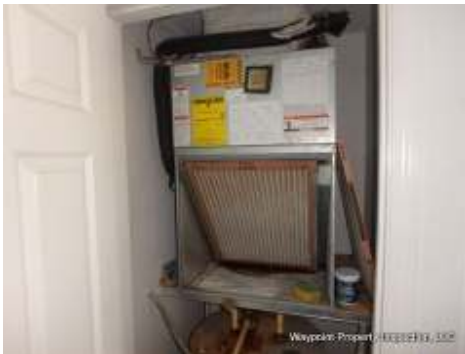
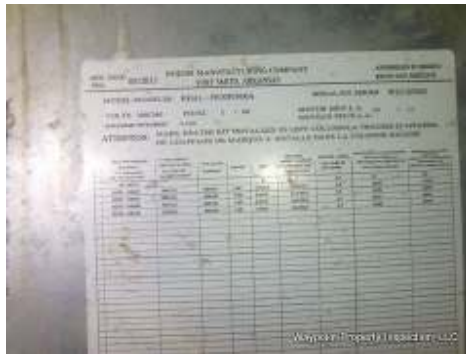
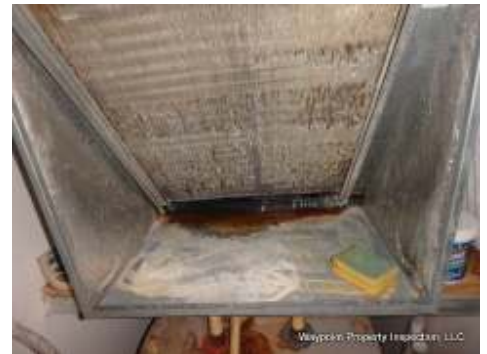
- Heating system did not appear to have been properly serviced per manufacturer's guidelines in the past year.
- Insulation should be installed on the condensate line.
- Heating coils should be serviced and cleaned on a regular basis.

Heating coils should be serviced and cleaned on a regular basis.

- Heating system should be evaluated, serviced and cleaned, including cleaning the condensate drain line to prevent clogging and backup. Additionally, the ducts should be serviced and cleaned as needed.

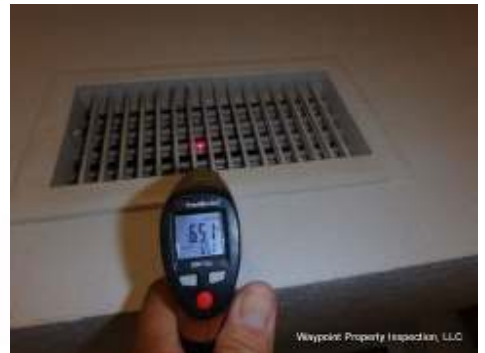
Cooling system did not operate properly.  
Air temperature differential was below  
manufacturer range of 14-22 degrees.

- Cooling system should be evaluated, serviced and cleaned, including cleaning the condensate drain line to prevent clogging and backup.
- Based on the condition of the cooling system(s), it should be evaluated by a licensed HVAC specialist.

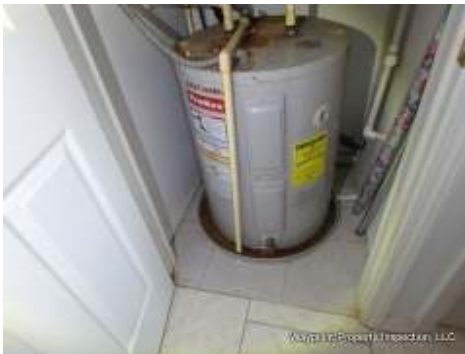
Significant corrosion was visible at top and base of the water heater. Water was full in the drain pan.

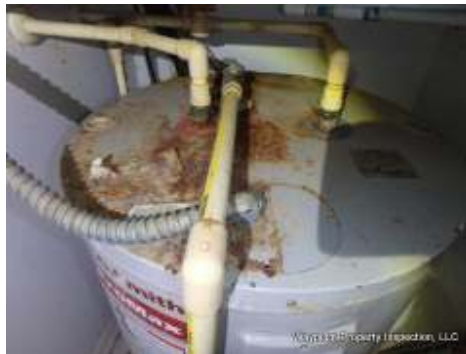
Significant corrosion was visible at top and base of the water heater. Water was full in the drain pan.

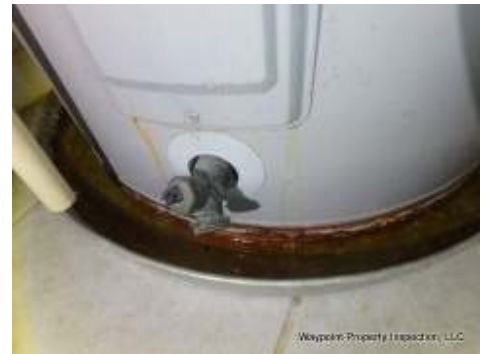
Significant corrosion was visible at top and base of the water heater. Water was full in the drain pan.

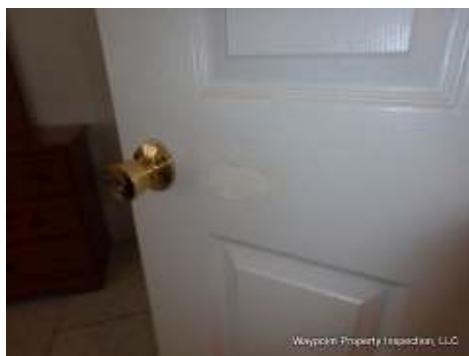
Door had visible repair.

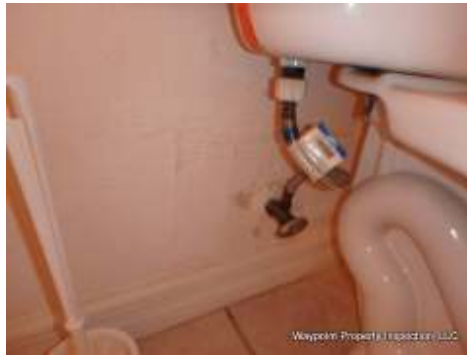
Prior repairs were visible at hallway bathroom.

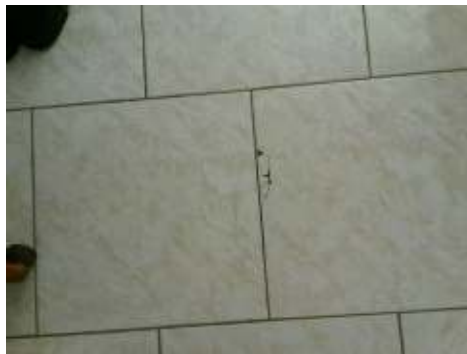
Flooring was damaged at master bedroom.

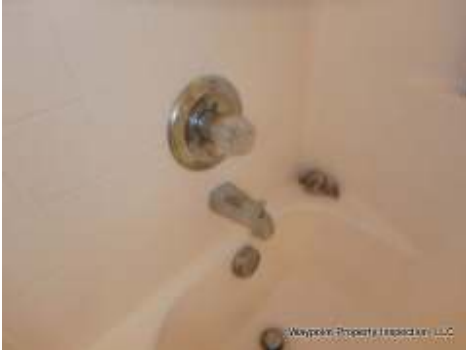
Hot and cold water supply lines were reversed at all bathrooms.

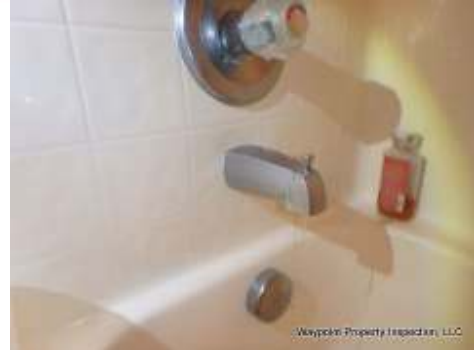
Bathtub water control was leaking at master bathroom.
