# Four Point Inspection Report

Inspector: David Vinas  
License #8427

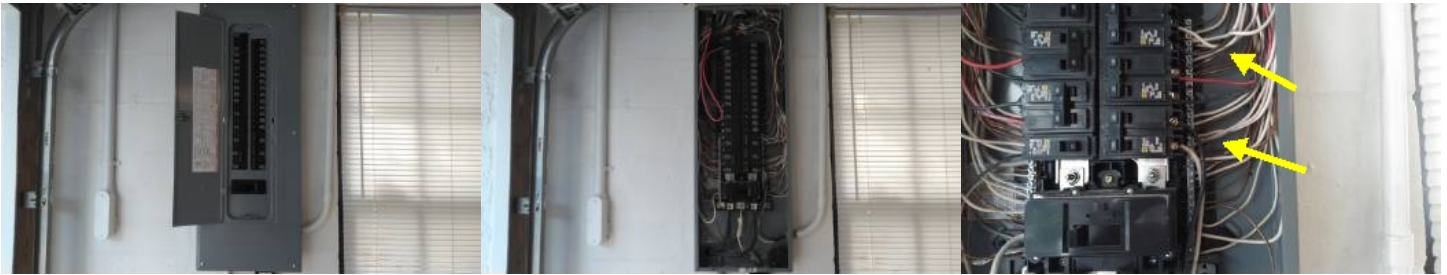
Two wires (double tap) connection was visible.

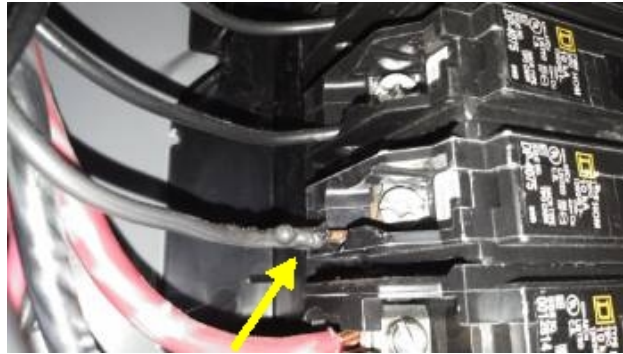
Damaged wiring was visible.

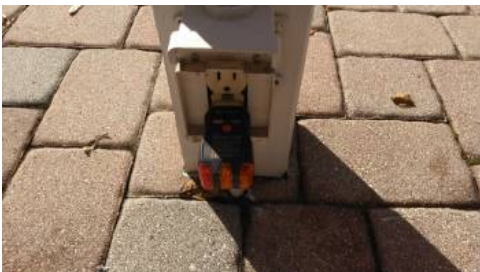
Outlet(s) were not operational at the porch.

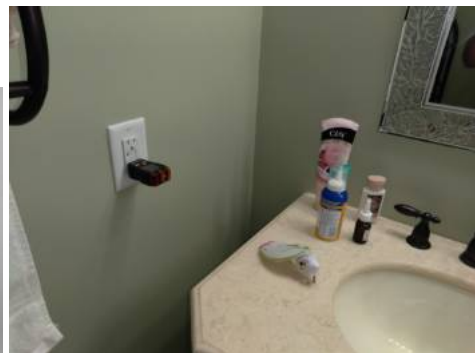
Outlet(s) tested not properly grounded at master bathroom.

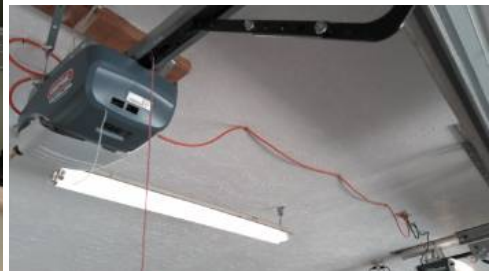
Extension cord was improperly used as hard/permanent wiring at garage.

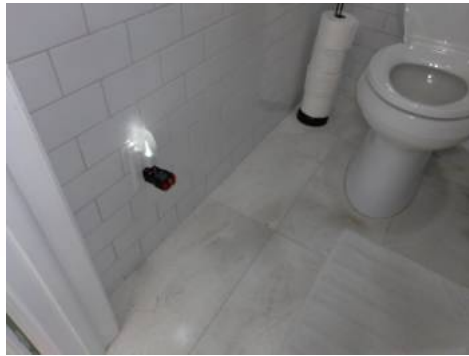
Outlet(s) tested not properly grounded at master bathroom.

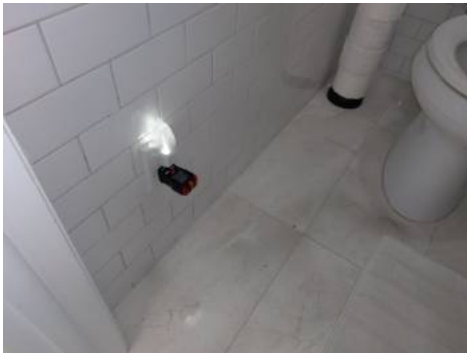
GFCI (Ground Fault Circuit Interrupter) outlet(s) was damaged at master bathroom.

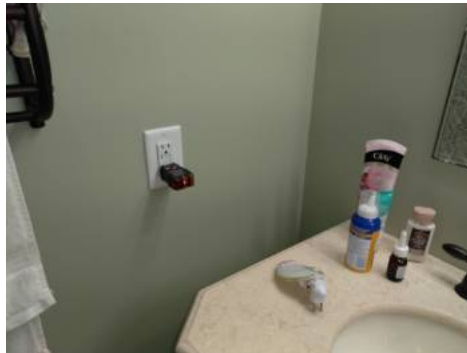
GFCI (Ground Fault Circuit Interrupter) outlet(s) was damaged at master bathroom.

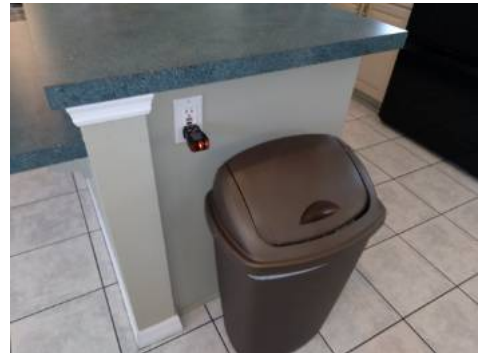
GFCI (Ground Fault Circuit Interrupter) outlet(s) was damaged at en suite kitchen island.

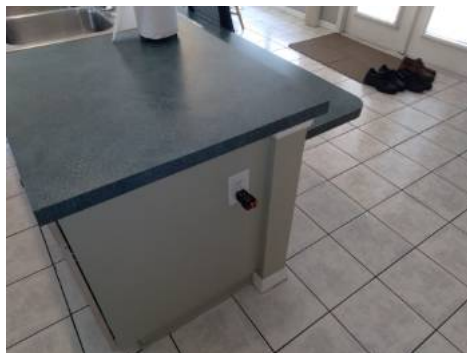
GFCI (Ground Fault Circuit Interrupter) outlet(s) should be installed at en suite kitchen island outlet.

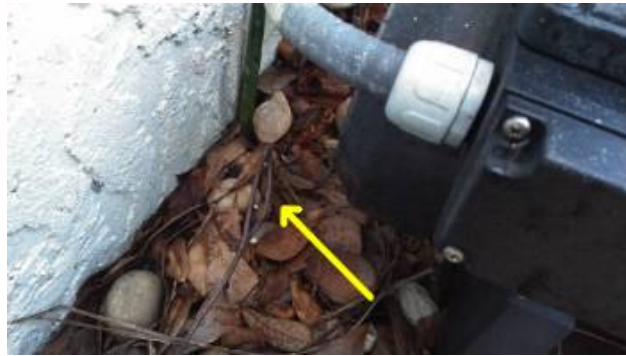
Body bond was loose/improperly secured at the pump.

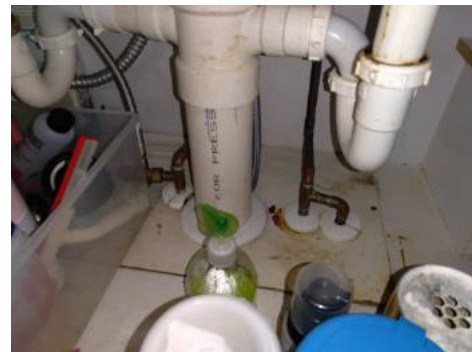
Minor corrosion was visible at the supply lines at master bathroom.

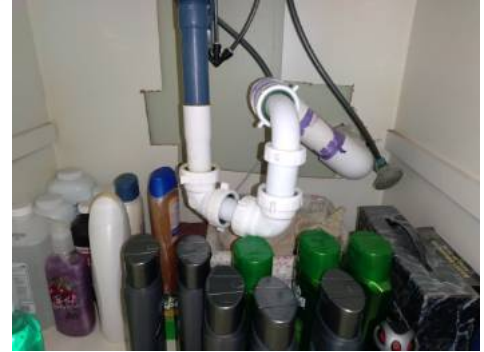
Traps were improper/not present at master bathroom.

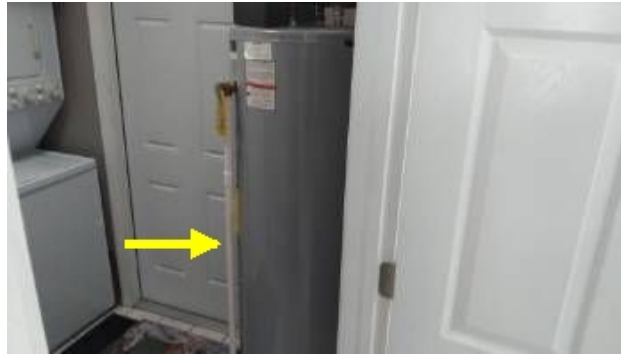
Temperature pressure relief valve (TPR Valve) piping was improper. (CPVC Required)

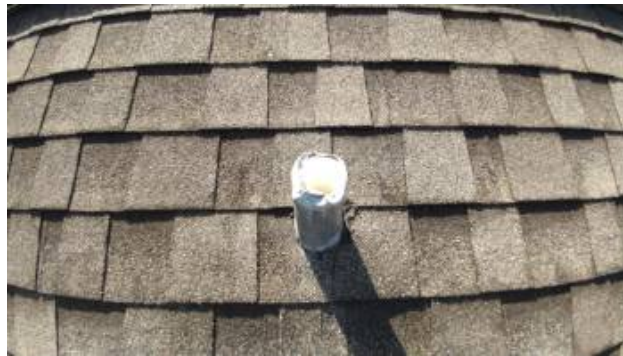
Vent cap(s) were damaged.
