# COMMERCIAL INSPECTION REPORT

Inspector: [REDACTED]  
License [REDACTED]  
Tampa, FL  
Phone: 813 486 8551  
Email: [info@waypointinspection.com](mailto:info@waypointinspection.com)  
[www.waypointwest.com](http://www.waypointwest.com)

## Summary of Findings

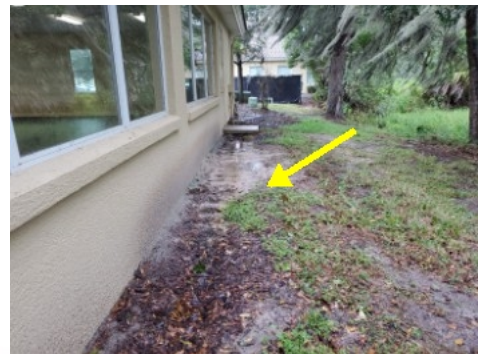
Visible signs of erosion were present.  
Suggest installing gutters for proper drainage.

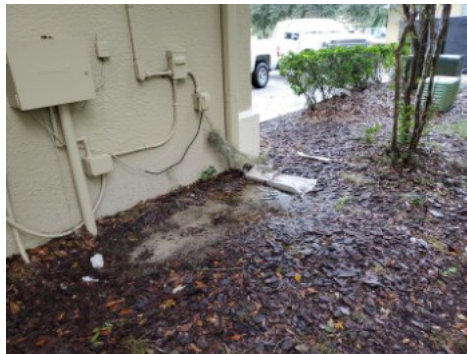
Downspouts should be routed away from the structure for proper draining.

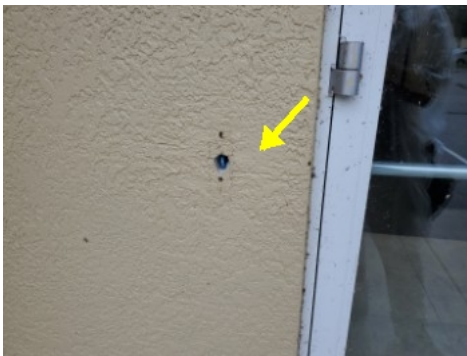
Doorbell was damaged/not installed

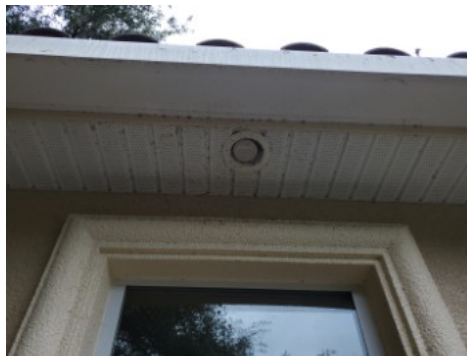
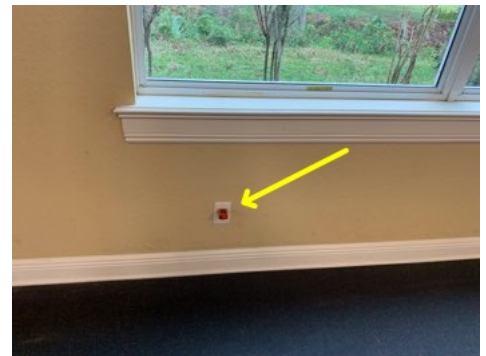
Outlet(s) were not operational.

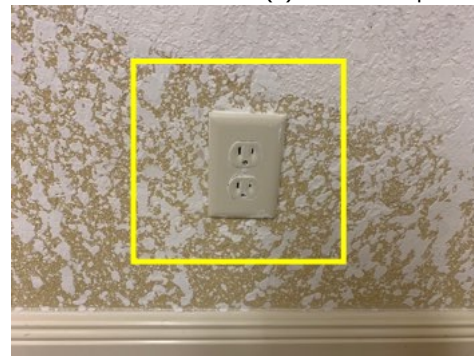
Outlet(s) were damaged.

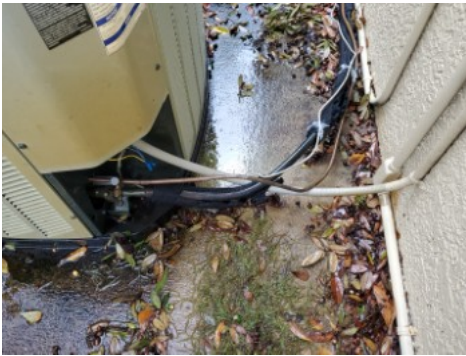
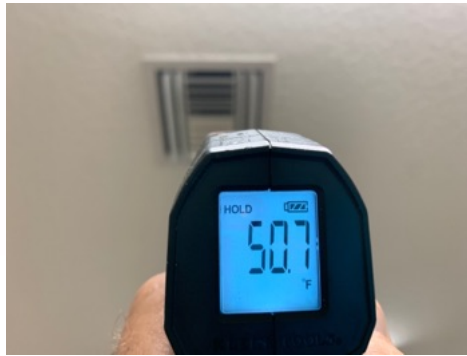
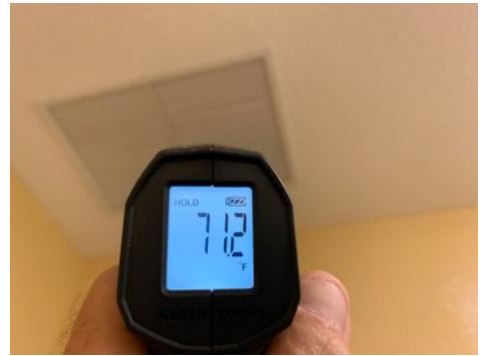
The insulation on refrigerant line was deteriorated.

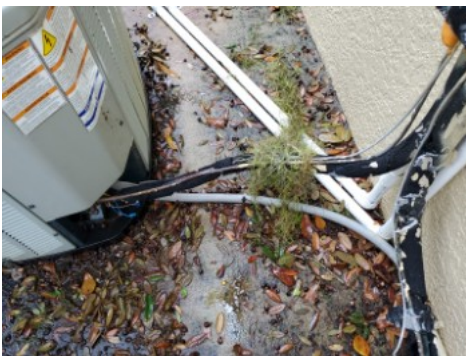
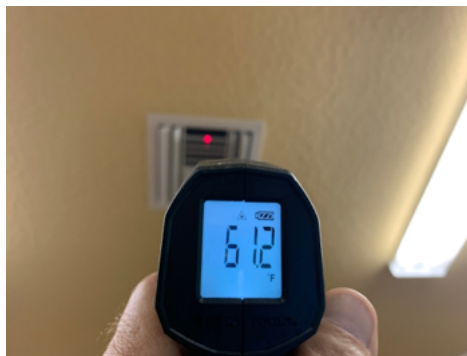
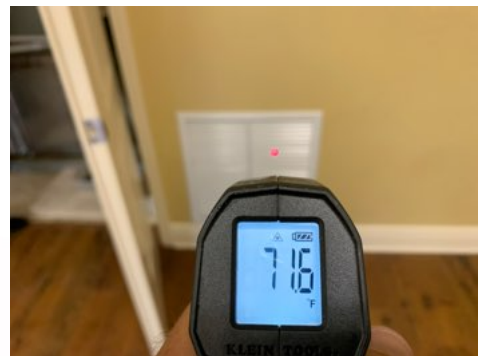
The insulation on refrigerant line was deteriorated.

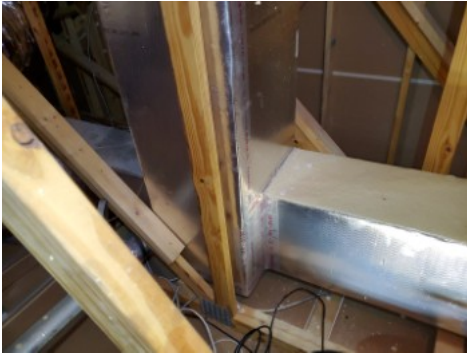
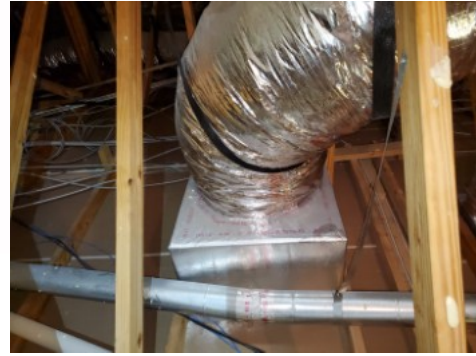
- Heating system operated: No
- Heating coils should be serviced and cleaned on a regular basis.
- Heating system did not operate.
- Heating coils were deteriorated/damaged.

- Based on the condition of the heating system(s), it should be evaluated by a licensed HVAC specialist.
- Heat was not detected in all rooms.

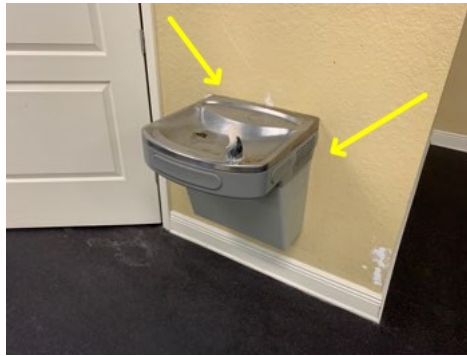
Water fountain was not properly secured to wall.

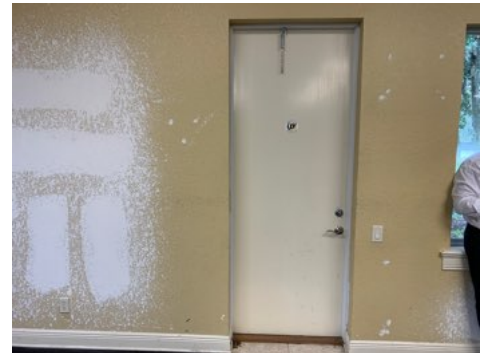
Weather-stripping did not properly seal the front door. Gap was visible.

Moisture damage was visible at the secondary door(s).

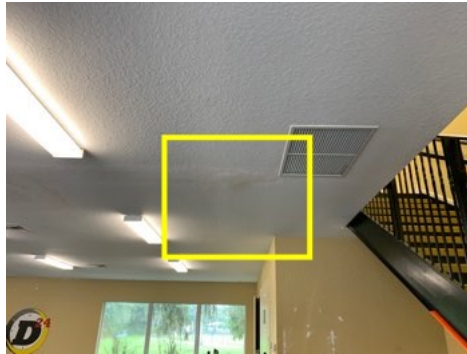
Although dry at the time of the inspection, the visible stain(s) indicated active leaks may be present.

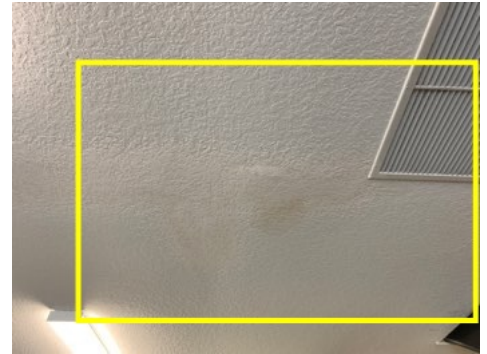
Moisture damage was visible.

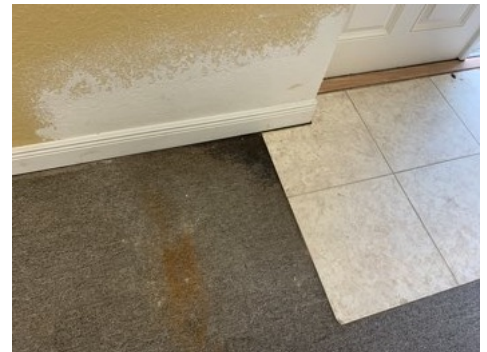
Carpet was deteriorated.

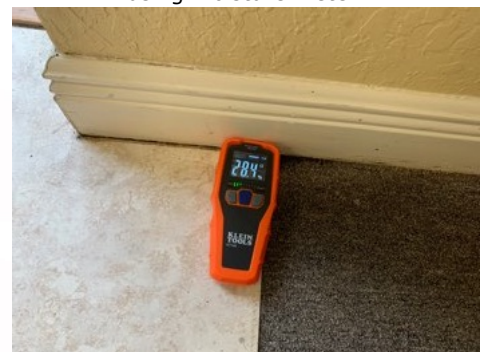
Flooring had visible moisture stains/damage. Stains/damage tested wet using moisture meter.

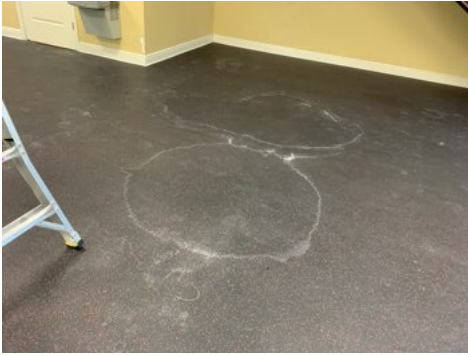
Flooring had visible moisture stains/damage. Stains/damage tested wet using moisture meter.

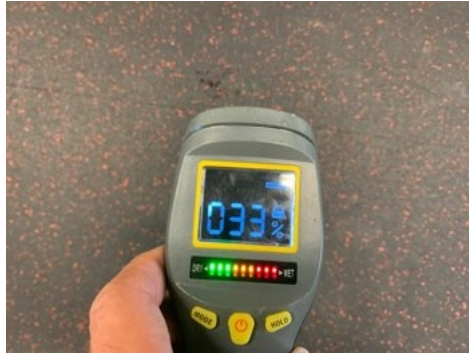
Flooring had visible moisture stains/damage. Stains/damage tested wet using moisture meter.

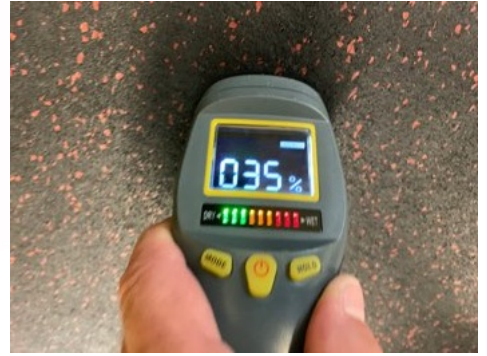
Flooring had visible moisture stains/damage. Stains/damage tested wet using moisture meter.

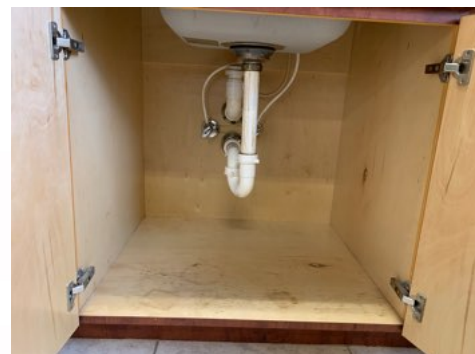
- Dry stain(s) were visible under kitchen sink.

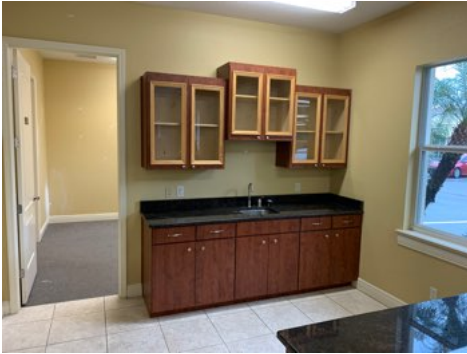
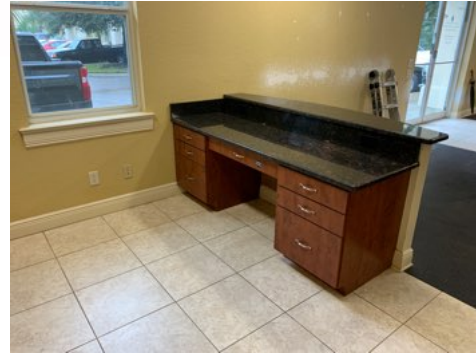
- Cabinets were worn.

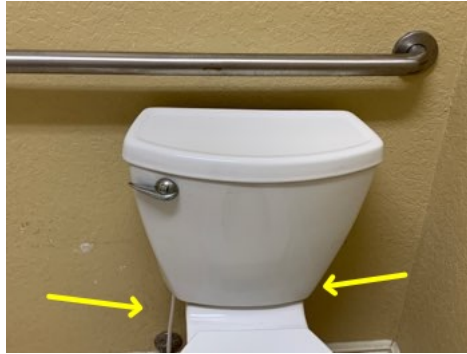
Toilet tank was loose at men's room left..

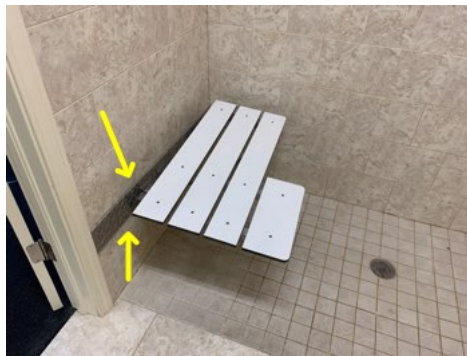
Bench was damaged/not properly secured at men's bathroom left.
