**WAYPOINT**  
Property Inspection, LLC

# INSPECTIONREPORT

Type of Structure: Restaurant • One story structure

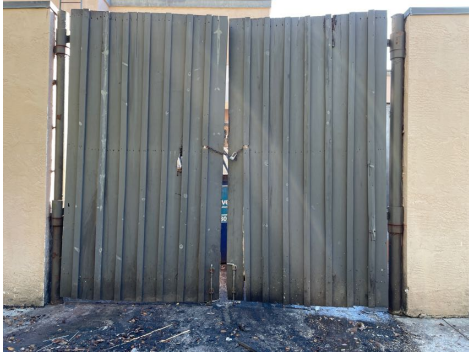
Gate(s) were damaged.

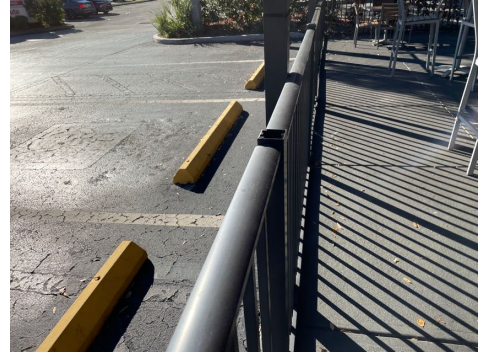
Fence post cap(s) were missing.

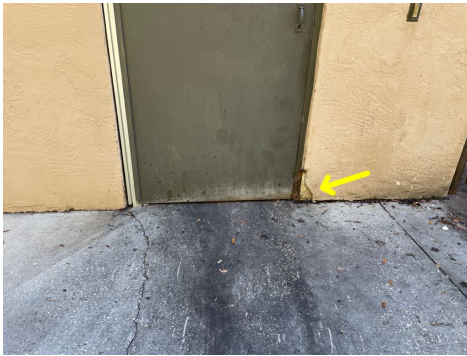
Exterior wall was damaged.

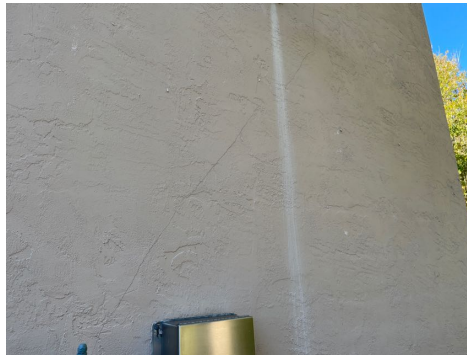
Settlement cracks were visible in various areas.

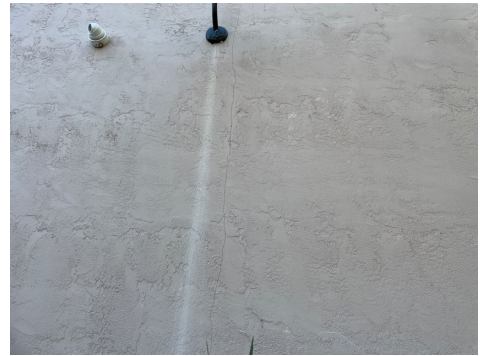
Settlement cracks were visible in various areas.

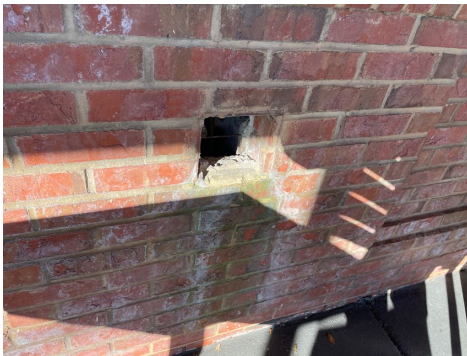
Gaps/holes should be sealed at the front.

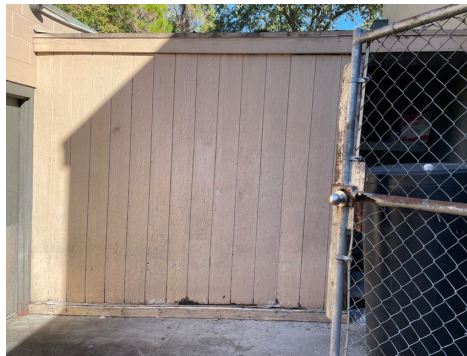
Exterior wall was damaged.

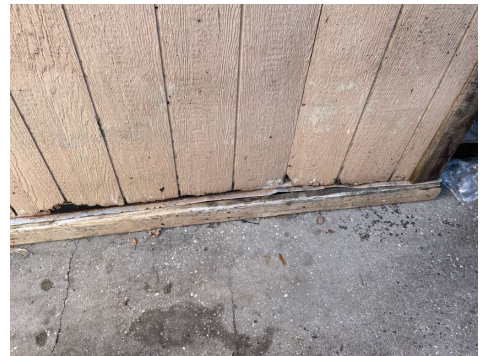
Exterior wall was damaged.

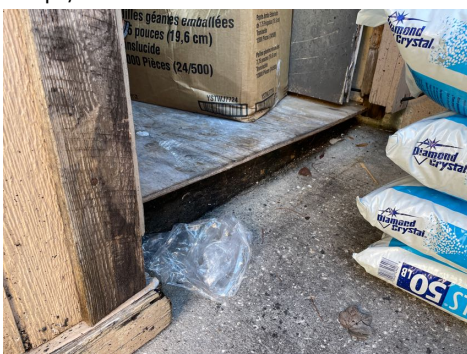
Exterior wall was damaged.

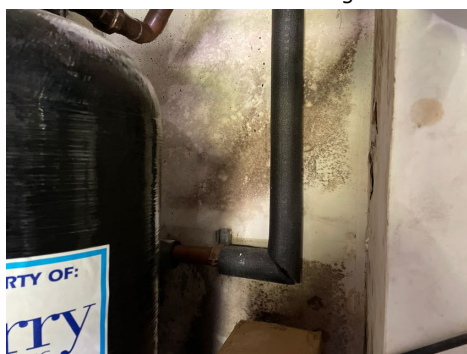
Microbial like growth was visible at the electrical room.

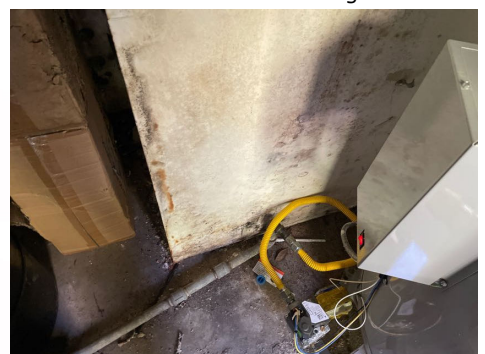
Microbial like growth was visible at the electrical room.

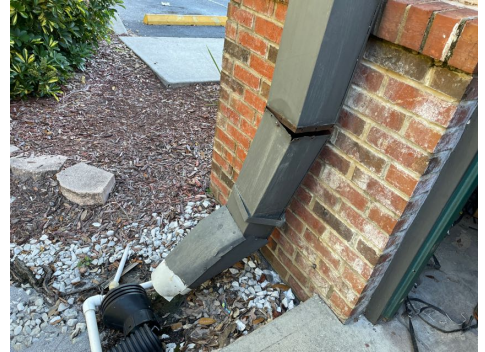
Gutters were deteriorated/damaged.

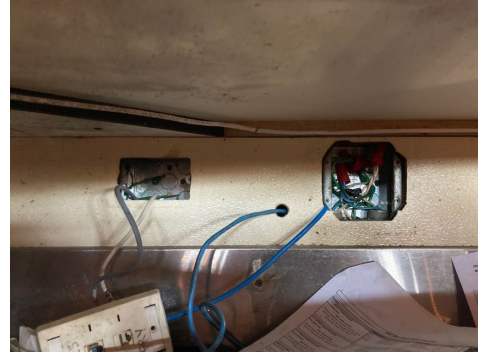
Cover plate(s) were not installed.

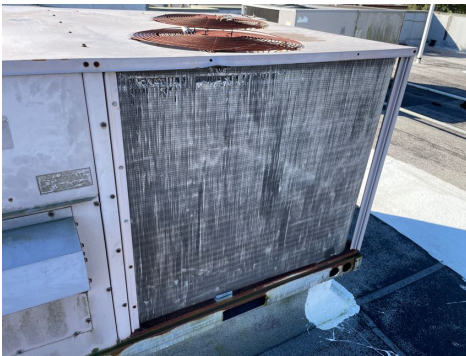
Cooling system was deteriorated.

- Cooling system should be evaluated, serviced and cleaned, including cleaning the condensate drain line to prevent clogging and backup.

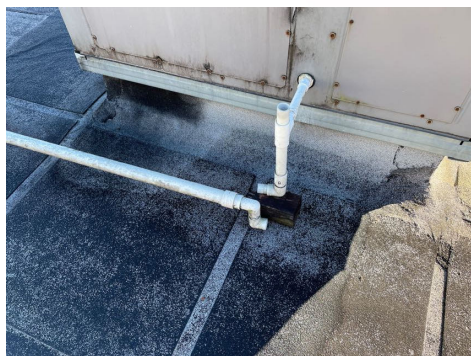
Condensate line was disconnected.

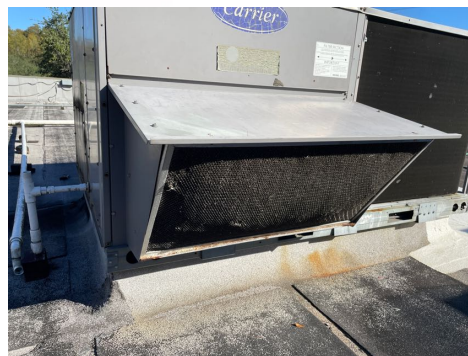
Cooling system was deteriorated.

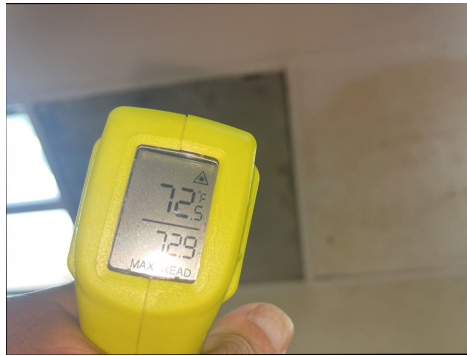
- Heating system operated: No

- Heating system should be evaluated, serviced and cleaned, including cleaning the condensate drain line to prevent clogging and backup. Additionally, the ducts should be serviced and cleaned as needed.

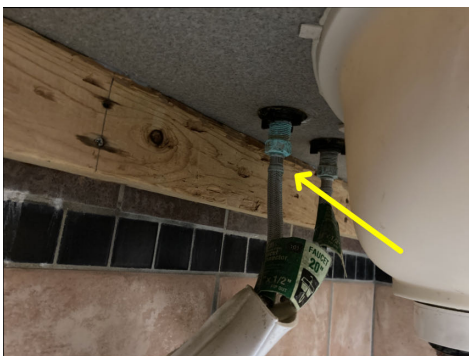
Minor corrosion was visible at the supply lines.

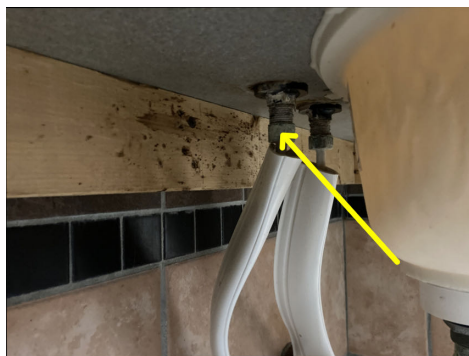
Minor corrosion was visible at the supply lines.

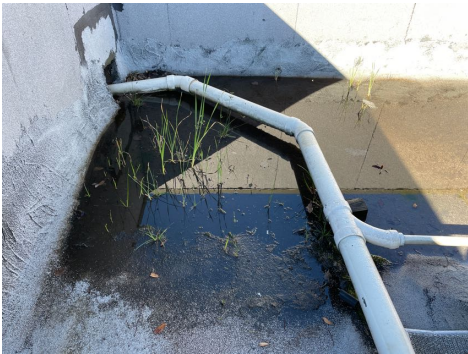
Improper drainage was visible at the rear section of roofing.

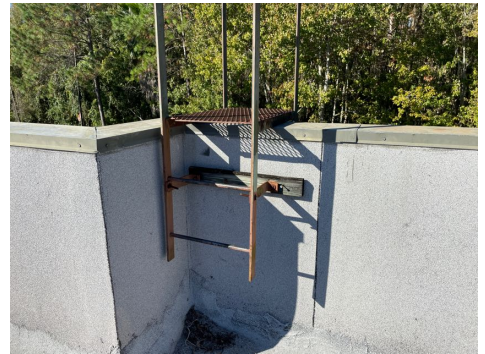
Roof access ladder was loose.

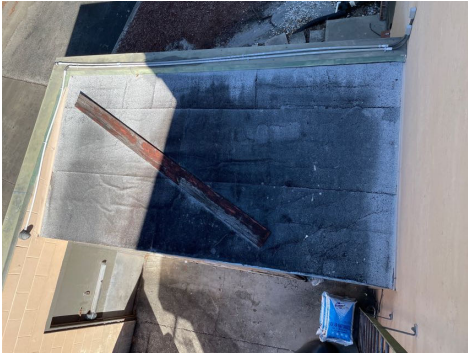
Damaged/deteriorated roof covering was visible.

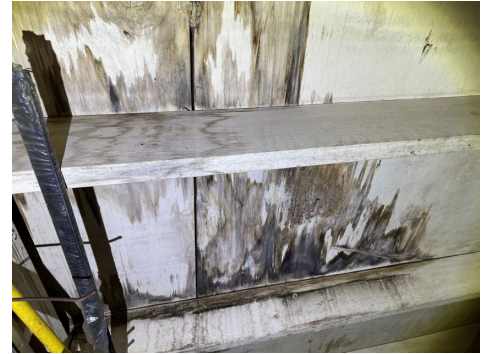
Based on the condition of the roof, a full evaluation should be completed by a qualified roofer.

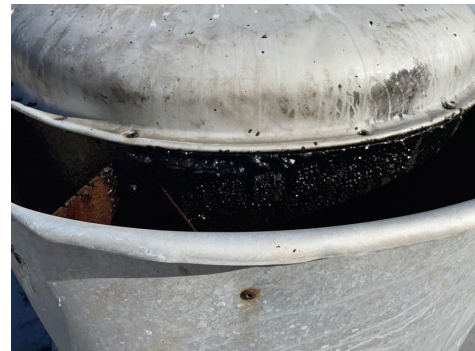
Exhaust hood with grease catch appear to be leaking.

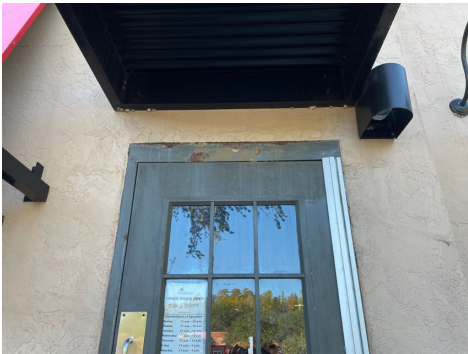
The right side secondary door(s) frame was damaged.

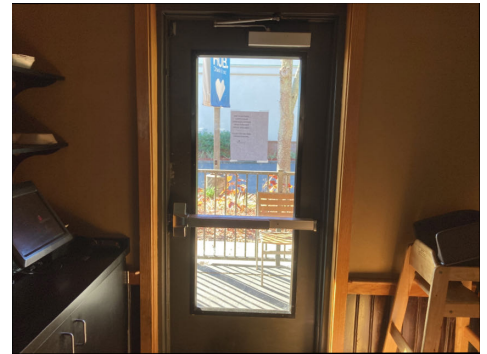
The right side secondary door(s) frame was damaged.

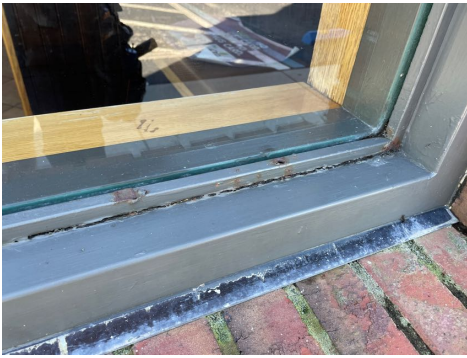
Window(s) frames were deteriorated/damaged.

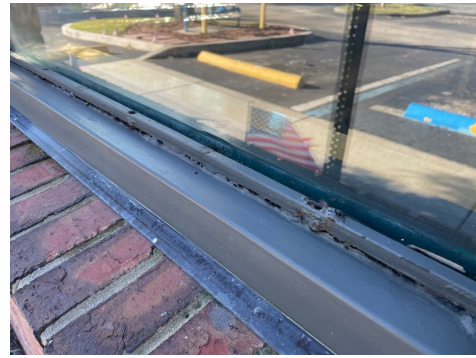
Window(s) frames were deteriorated/damaged.

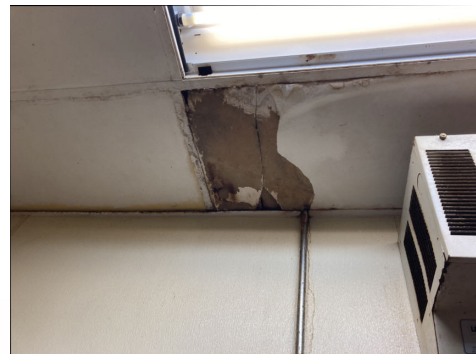
Although dry at the time of the inspection, the visible stain(s) indicated active leaks may be present.

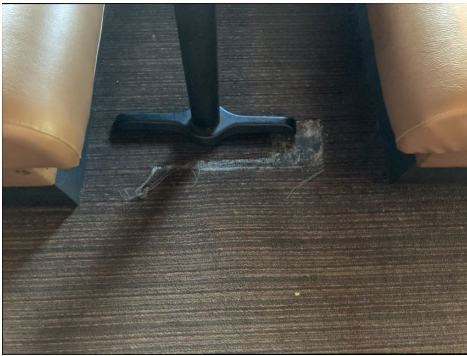
Carpet was worn/deteriorated at high traffic areas.
