# WAYPOINT

## INSPECTIONREPORT

1234 Easy Street Tampa, FL 33619

**4-Point Inspection Form**Insured/Applicant Name: James Smith Application / Policy #: \_\_\_\_\_Address Inspected: 1234 Easy StreetActual Year Built: 1998 Date Inspected: XXXXXX**Minimum Photo Requirements:**

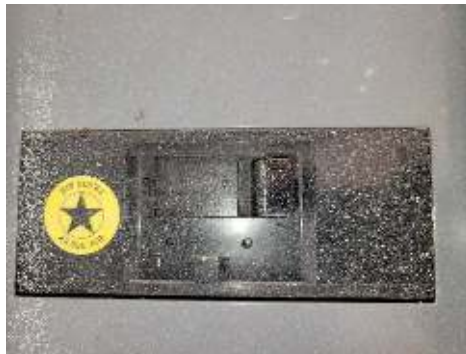
### 1. Electrical Service Condition

- Service wiring was in good condition: Yes.

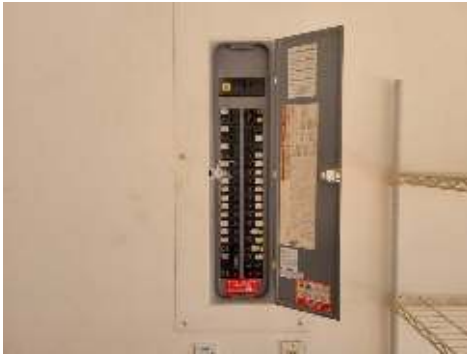
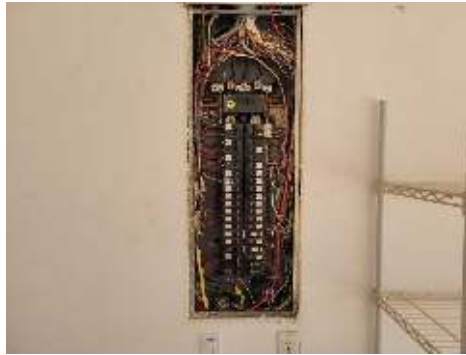
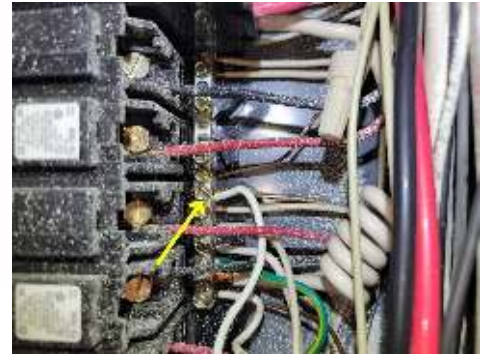
### 2. Main Panel Condition

- Electrical panel was in good condition: No.
- **Double Tap connection was visible.**

Double Tap connection was visible.

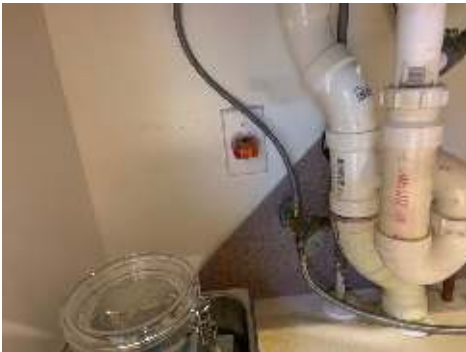
Outlet(s) were not operational at under kitchen sink.

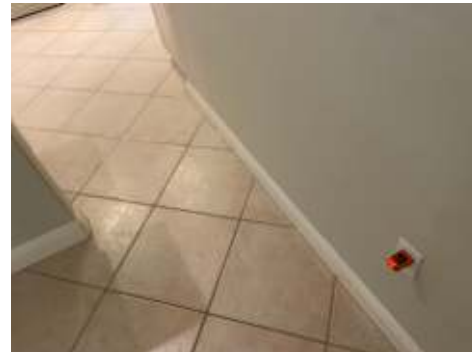
Outlet(s) tested as having improper polarity at interior.

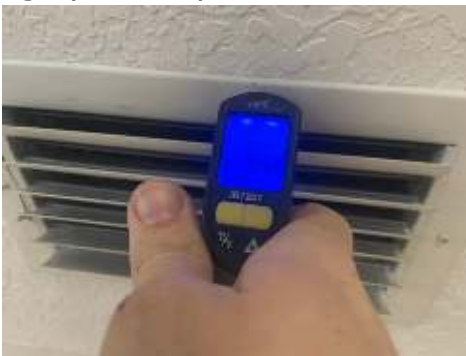
Supply air temperature

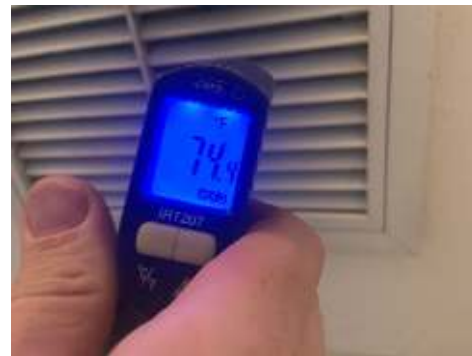
Return air temperature

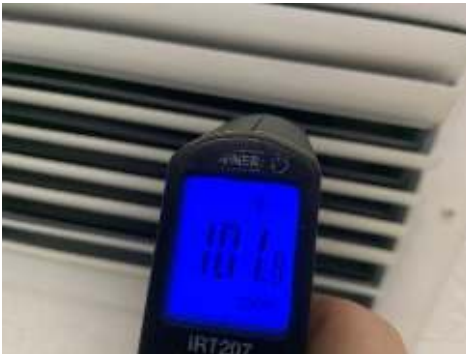
Supply air temperature

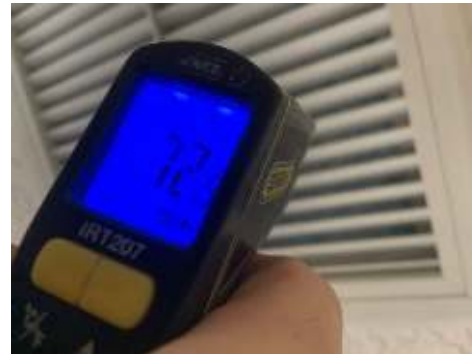
Return air temperature

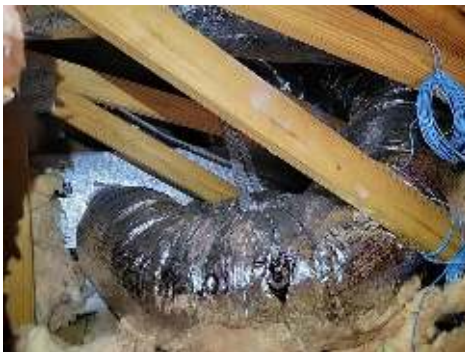
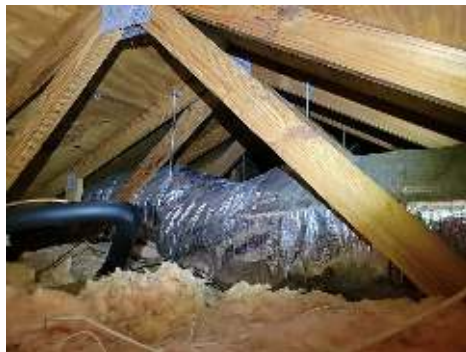
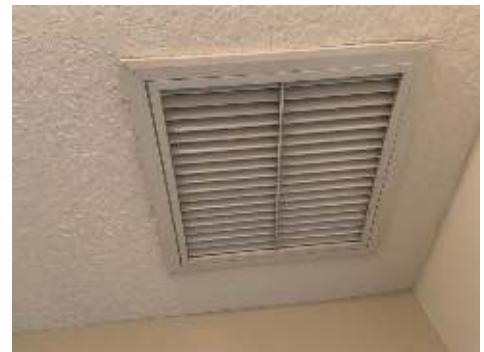
## 3. Distribution Condition

Registers were dirty with lint and dust.

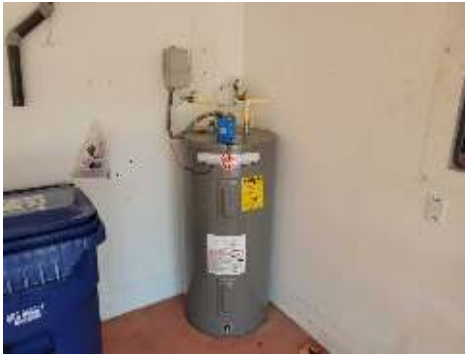
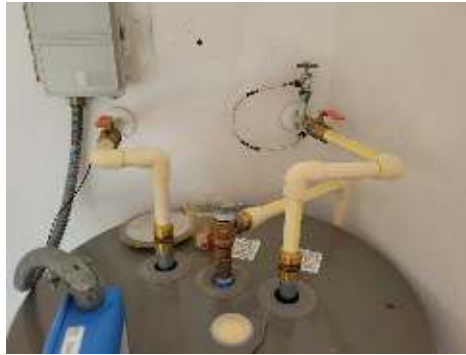
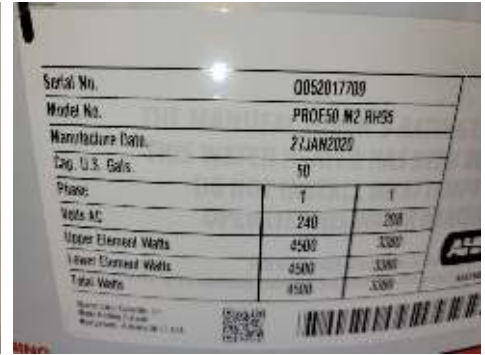
### 4. Water Heater 1

- Water heater was in good condition: Yes

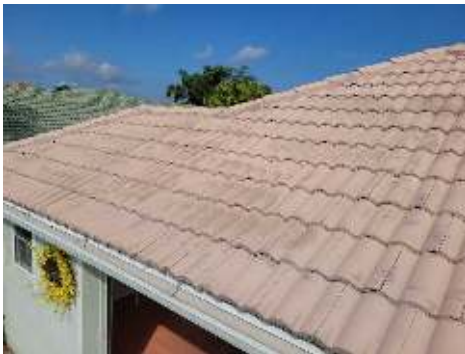
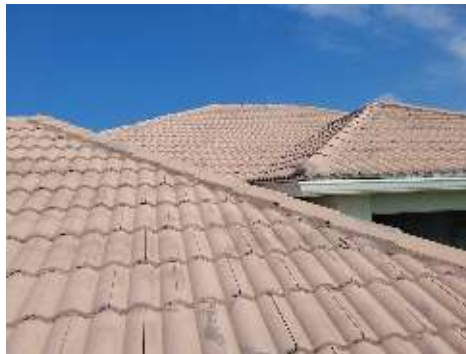
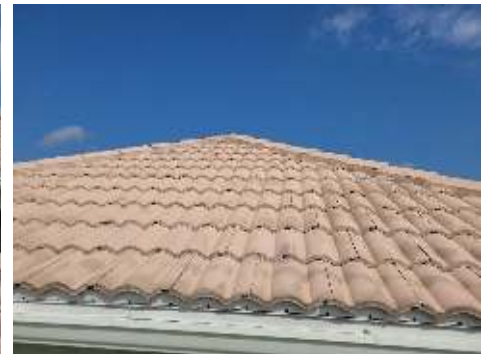
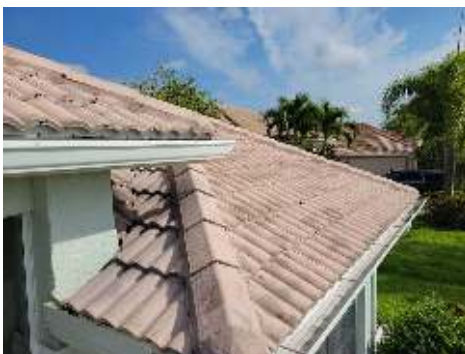
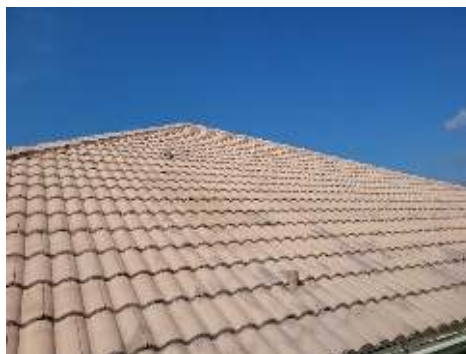
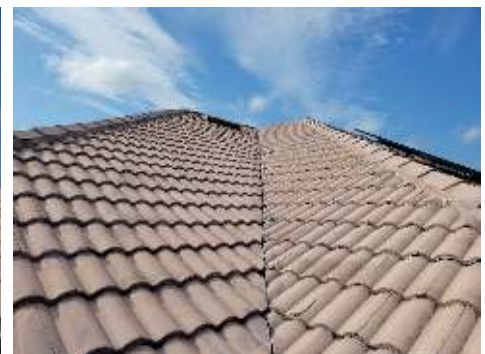
### 1. Main Roof Condition

Materials: Concrete/Clay Tile • Estimated age of the roof covering: 14 - 16 yrs. • Estimated remaining life of the roof covering: 16 yrs.

- Roof was viewed from a ladder.
