INSPECTION REPORT

0000 New Home Ct

Plant City, FL

Pre-Drywall Phase Inspection Description

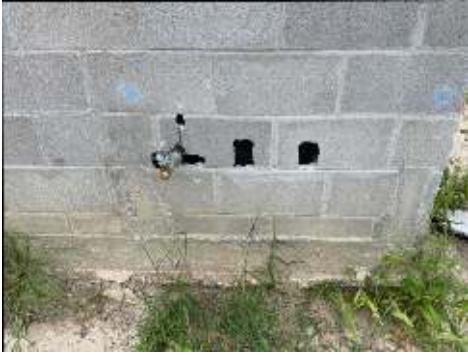
Holes were visible.

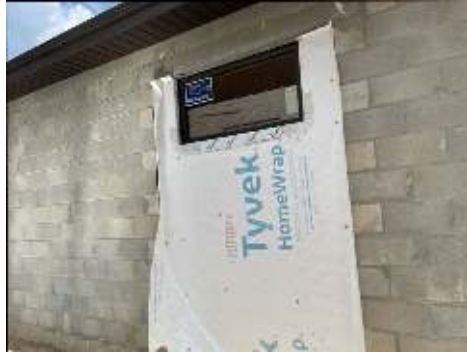
Housewrap/Moisture barrier was installed.

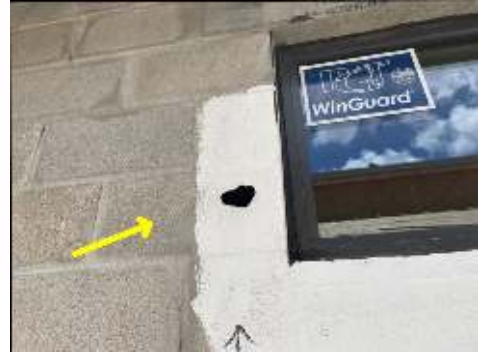
Holes were visible.

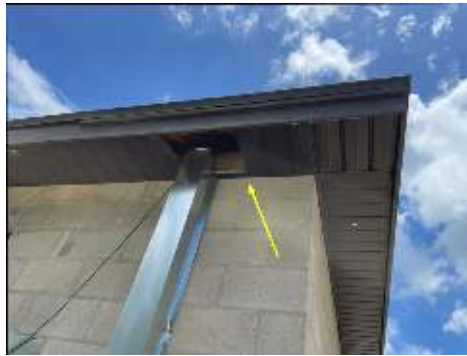
The soffits were damaged.

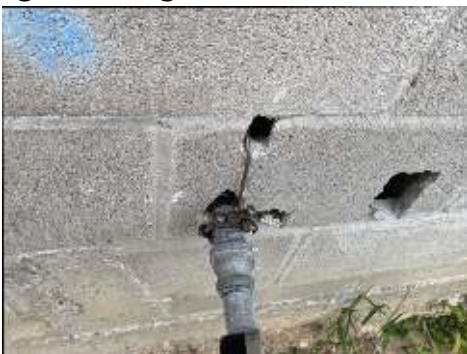
Grounding system was present.

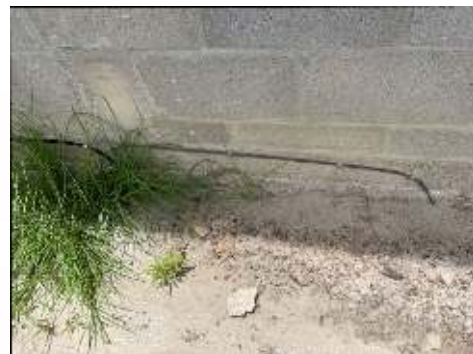
UFER grounding

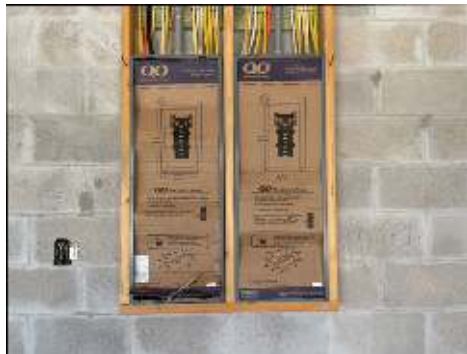
- Panel box appeared to be in serviceable condition.
- Panel box cover was not installed.

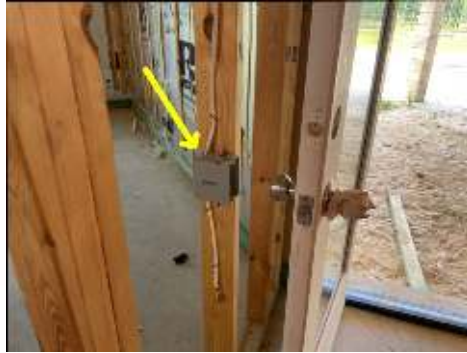
Outlet is in danger of being damaged.

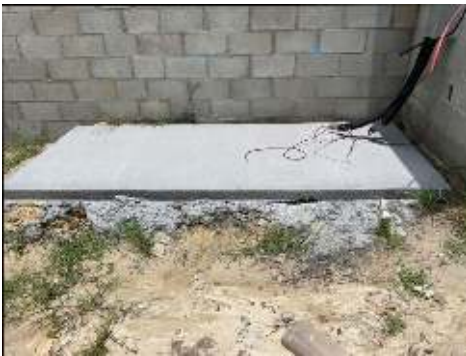
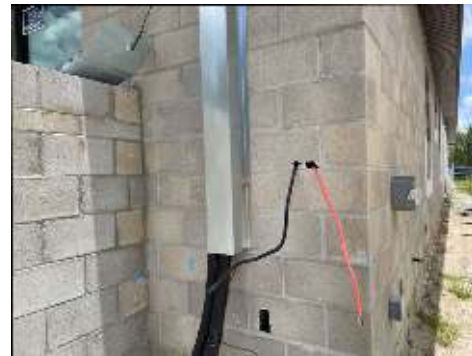
Electrical disconnect rough wiring appeared serviceable.

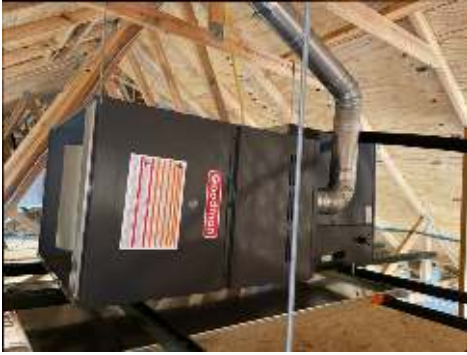
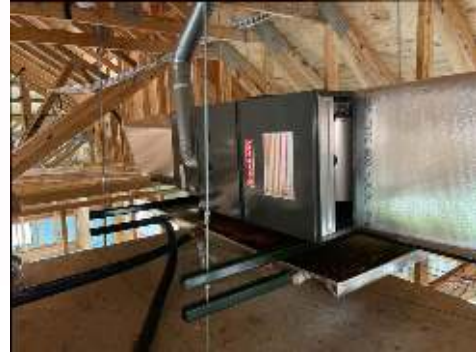
- Heating system platform appeared serviceable.
- Thermostat wiring at Hallway.
- **Rough plumbed refrigerant were not completely installed yet.**
- **Heating system 1 and 2 were in the process of being installed.**

Heating system 1 and 2 were in the process of being installed.

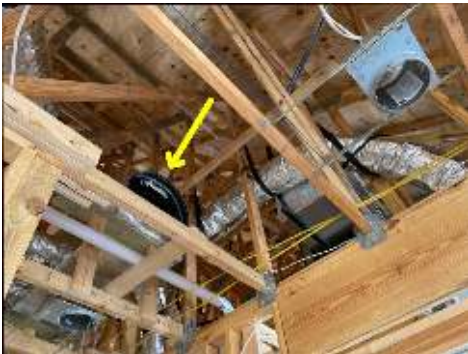
Ducts were not installed at various areas.

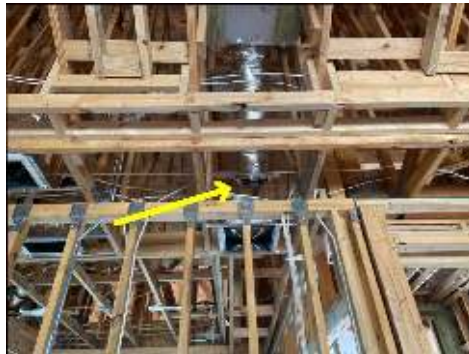
Ducts were not installed at various areas.

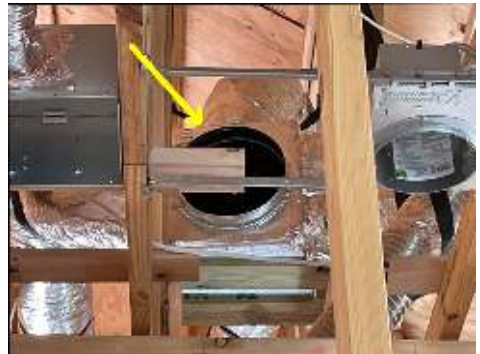
Ducts were not installed at various areas.

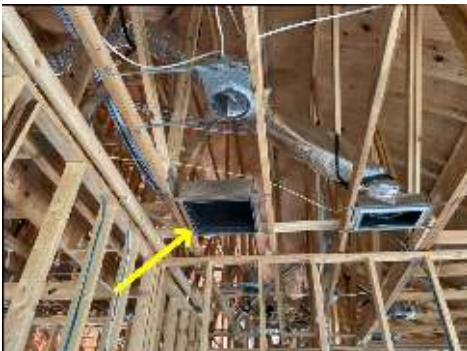
Ducts were not installed at various areas.

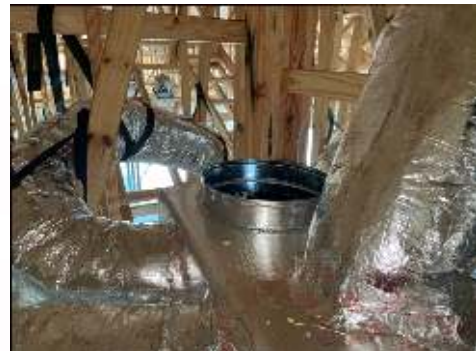
Ducts were not installed at various areas.

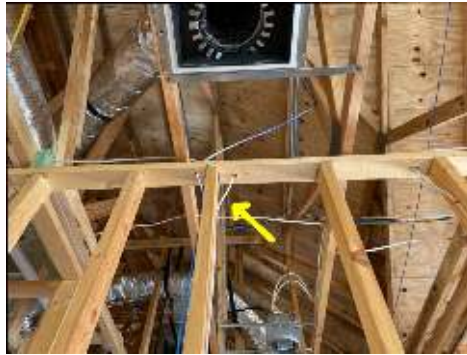
Fire block was not installed at the time of inspection

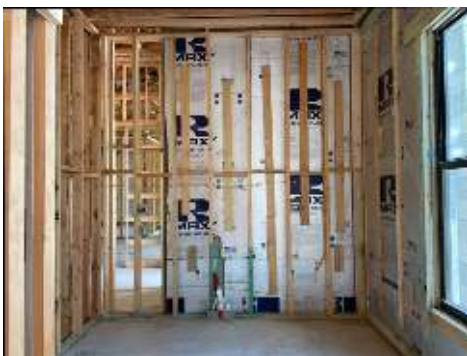
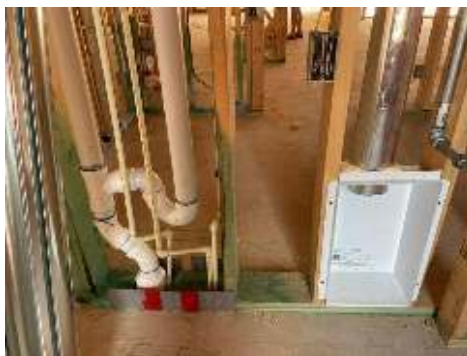
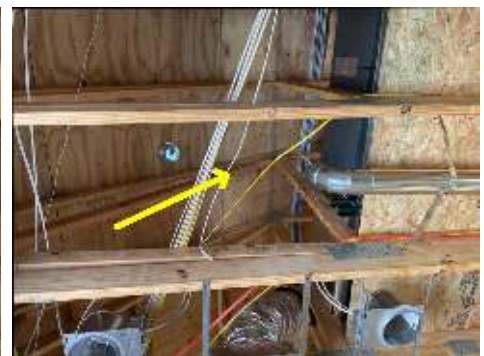
Dryer vent was not properly secured/sealed.

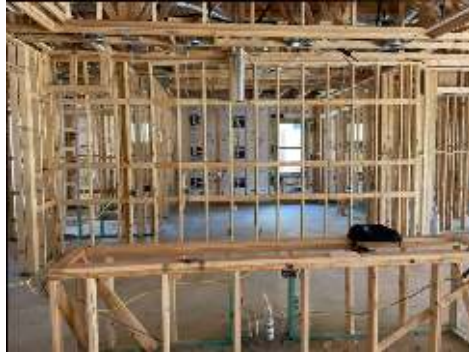
Kitchen sink rough plumbing appeared to be in serviceable condition.

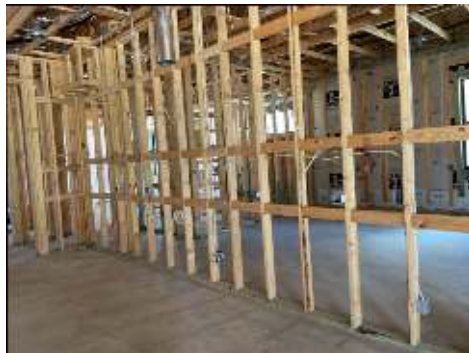
GFCI outlets rough wiring appeared serviceable.
