HOME INSPECTION REPORT

0000 New Home Way, Tampa, FL 33612
Inspection prepared for: Home Buyer
Date of Inspection: 6/24/2022 Time: 9:00 AM
Age of Home: 2022 Size: 1936
Weather: 85, Sunny

Inspector: Oliver Peebles
HI8650
3220 Parkside Center Cir., Tampa, FL 33619
Phone: (813) 486-8551
Email: info@waypointinspection.com

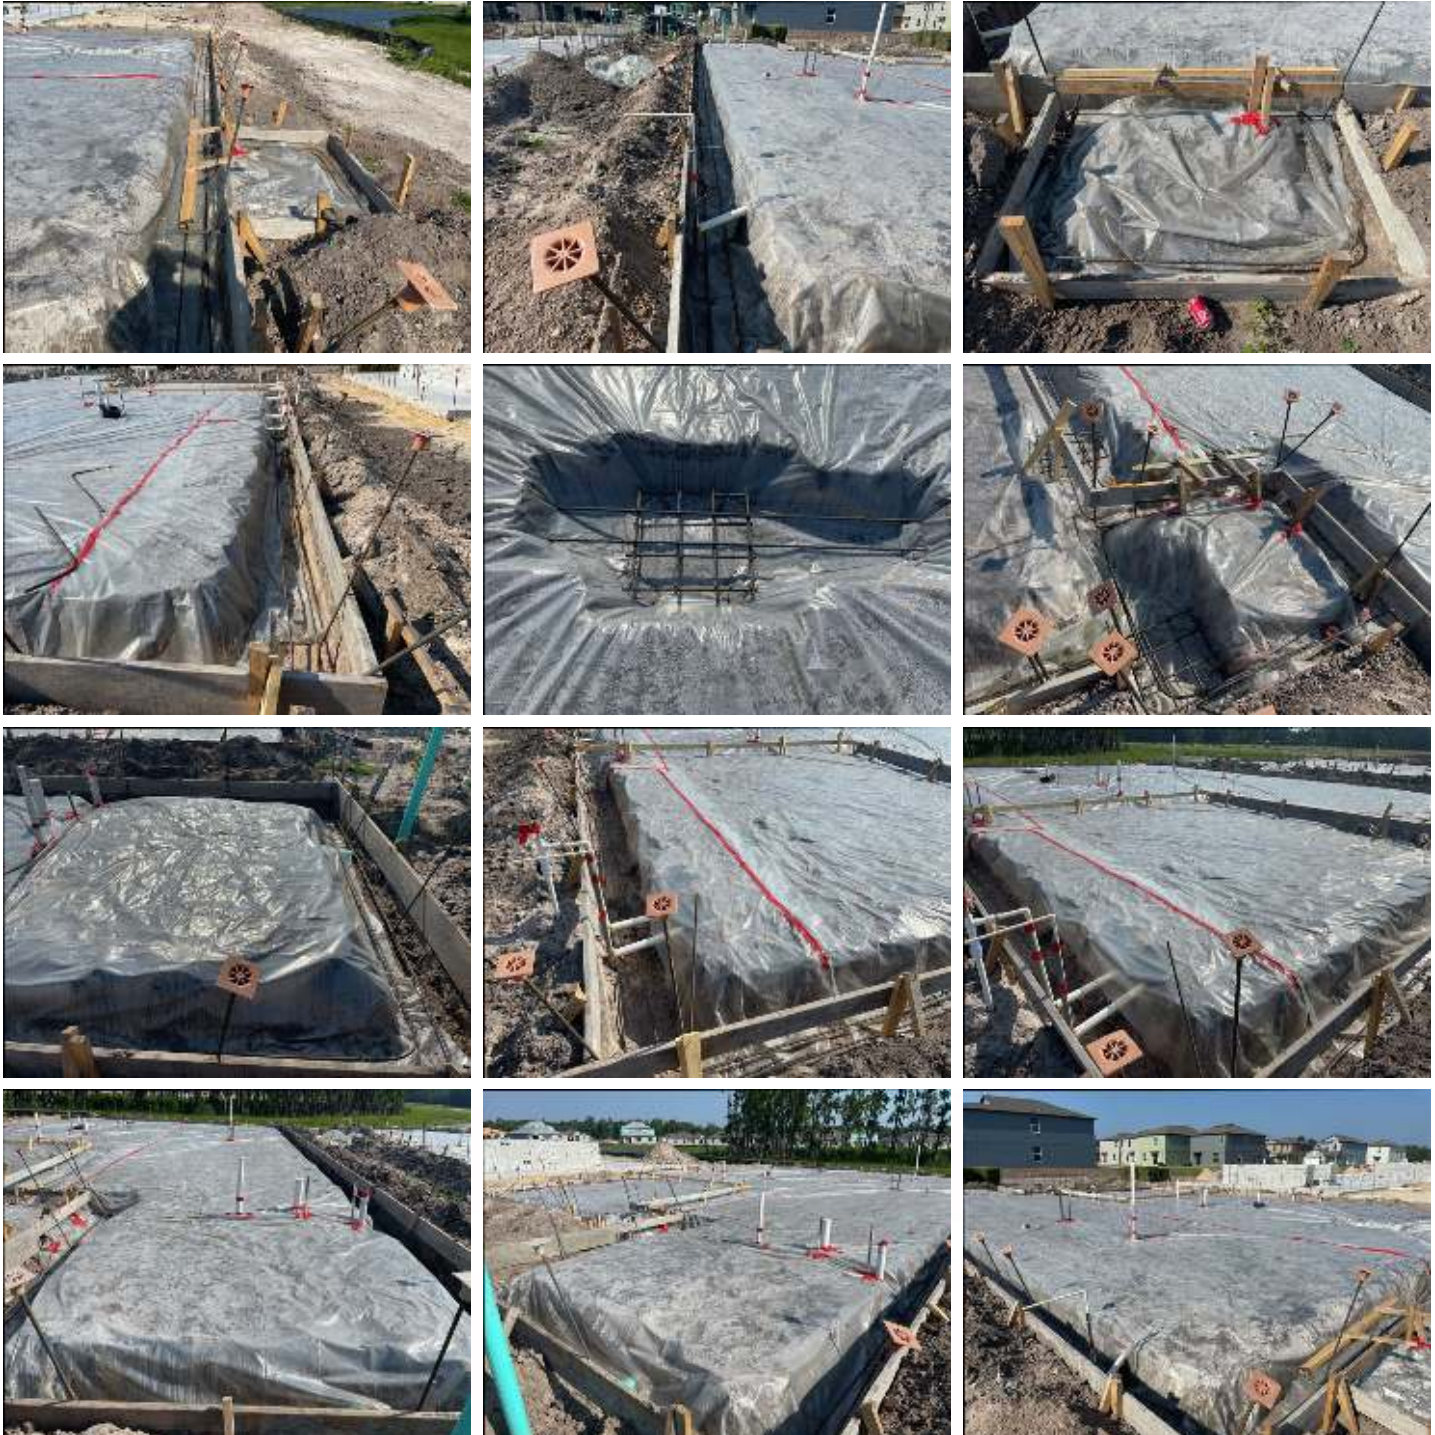
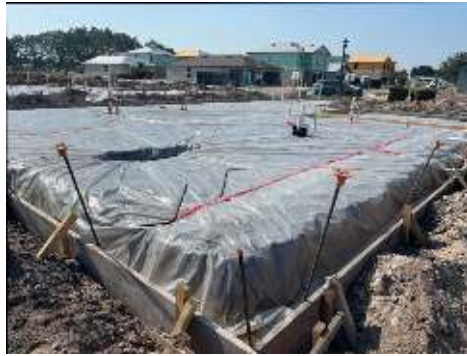
1. Foundation Condition

- Visible visqueen vapor barrier was in good condition
- Structural rebar support was in good condition.

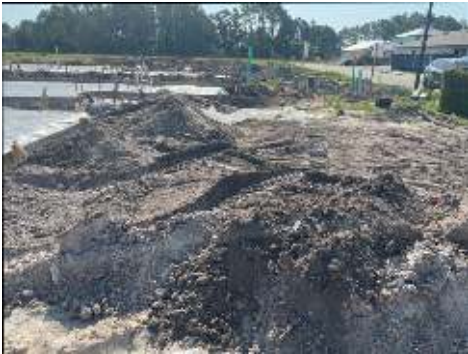
Front view

- The site was adequately graded and prepped for the structure. No vegetation/debris was visible.
- Rough grading appeared to be proper.

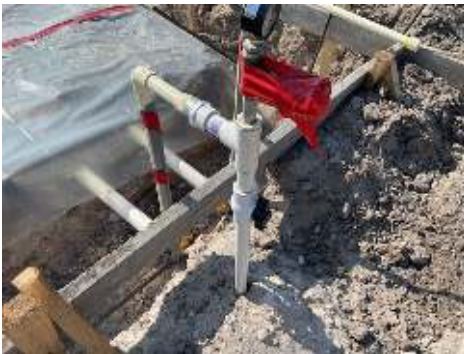
Main Valve

- Visible main line rough plumbing appeared to be proper.

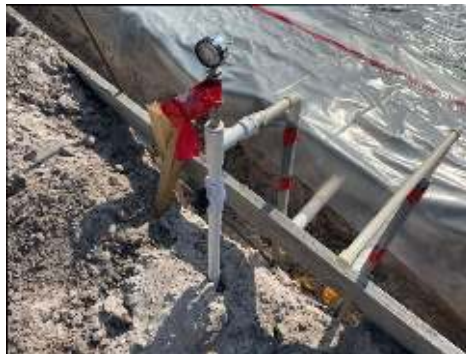
Visible main line rough plumbing appeared to be proper.

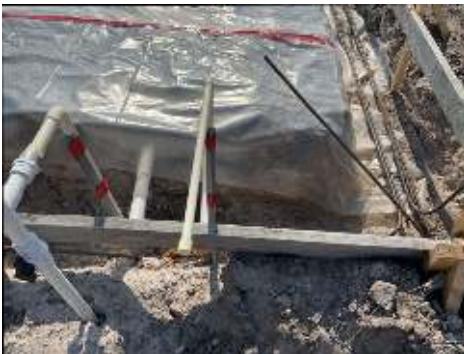
Exterior Faucet supply piping

- Visible supply piping was in good condition.

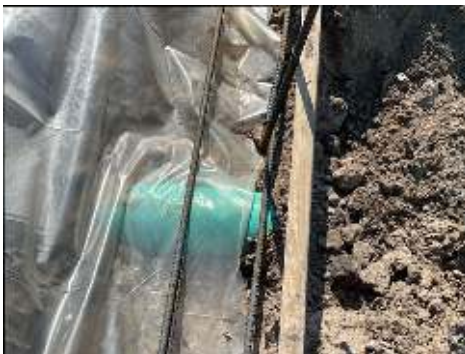
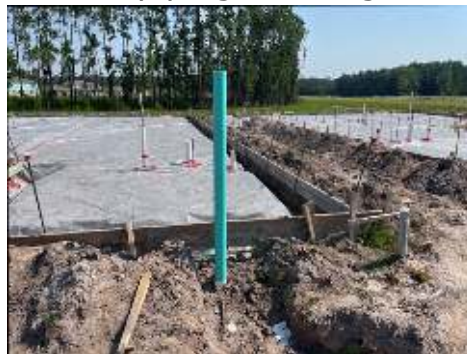
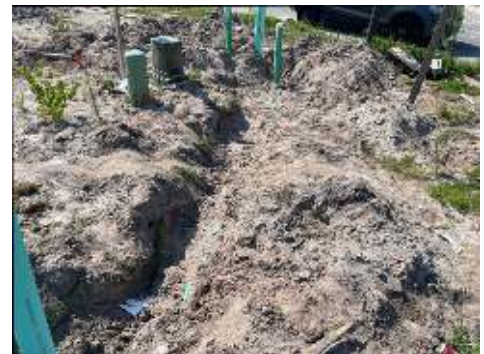
Drain Piping

- Visible drain/waste/vent piping was in good condition.
- Visible HVAC condensate drain line piping was in good condition.

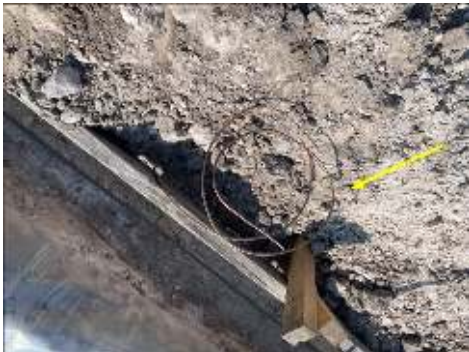
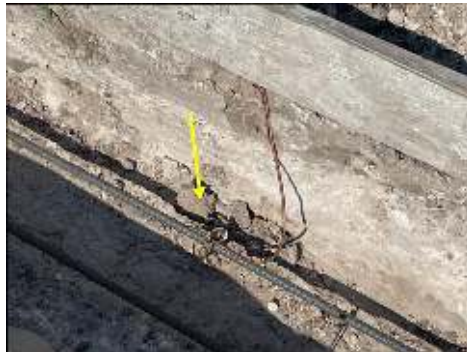
UFER Grounding

- Grounding system was present.
- UFER grounding
- Under slab conduit appeared to be proper.
