WAYPOINT

INSPECTIONREPORT

Bradenton, 34207

Inspection Date: 11/30/2023

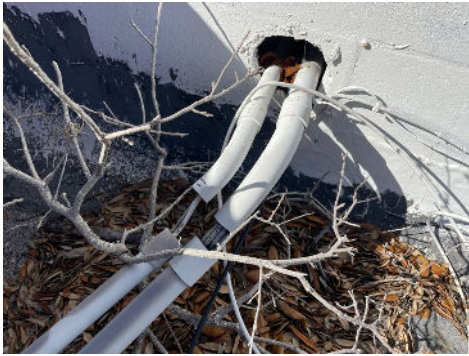
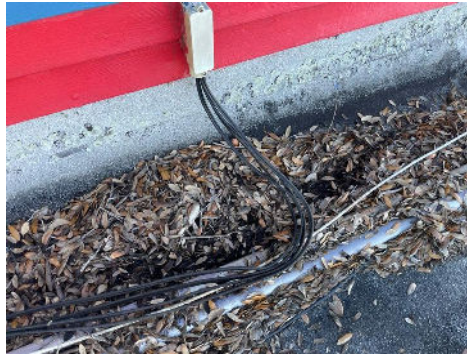
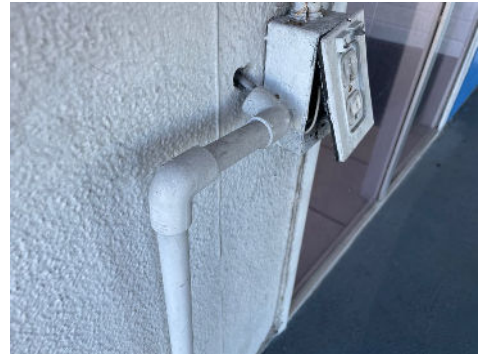
Exposed wiring was not properly protected at multiple locations.

Exposed wiring was not properly protected at multiple locations.
Garage

Exposed wiring was not properly protected at multiple locations.
Not properly secured.

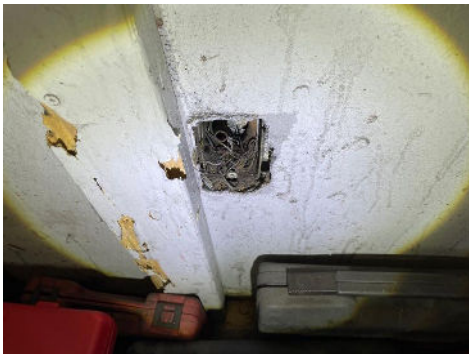
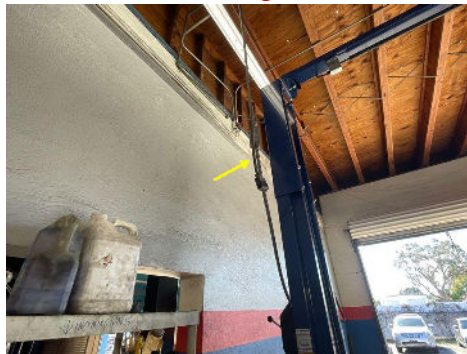
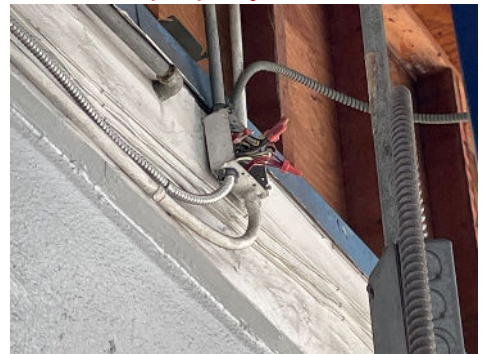
Junction box cover(s) were missing at multiple locations.
Garage

Exposed wiring was not properly protected at multiple locations.
Not properly secured.

Junction box cover(s) were missing at multiple locations.

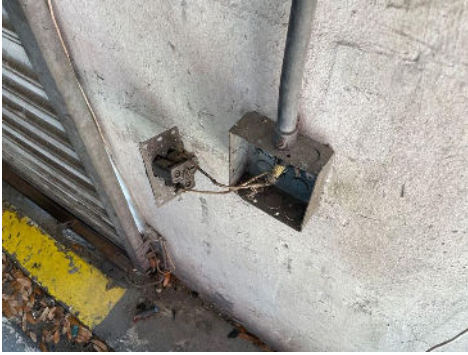
Exposed wiring was not properly protected at multiple locations.

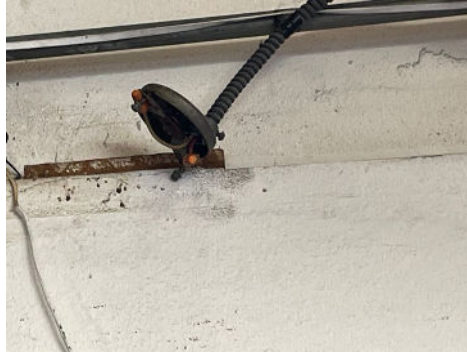
Junction box cover(s) were missing at multiple locations.

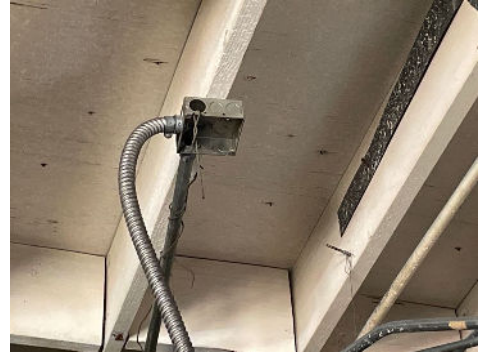
Junction box cover(s) were missing at multiple locations.

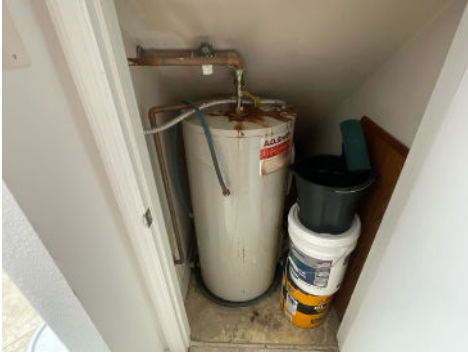
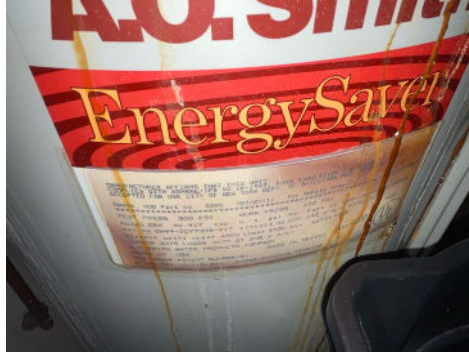
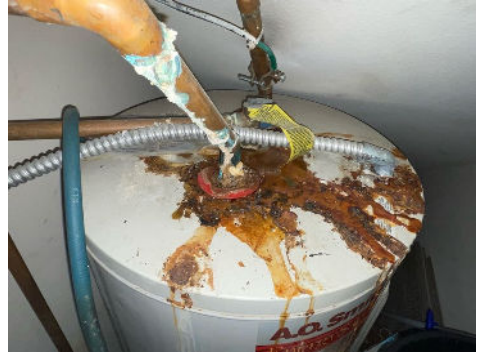
- Water heater was in good condition: No
- **Water heater was damaged.**
- **Water heater was leaking.**

Water heater was leaking.

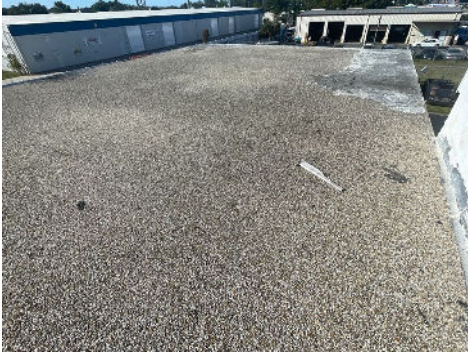
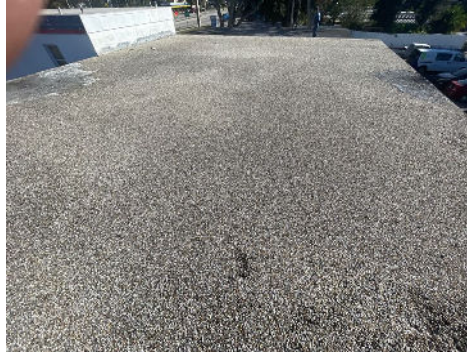
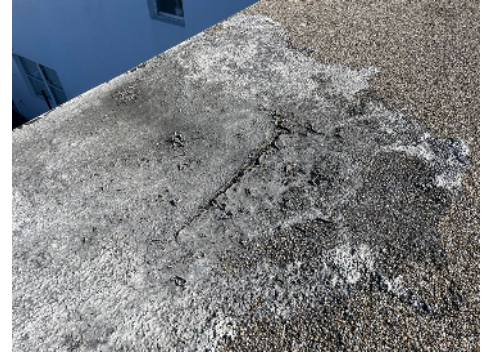
Damaged/Loose roofing material(s) were visible at multiple locations. An evaluation and repair should be completed by a qualified licensed roofer.

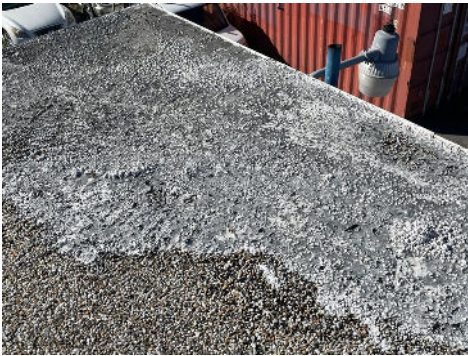
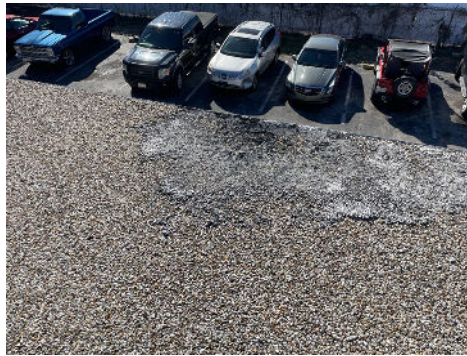
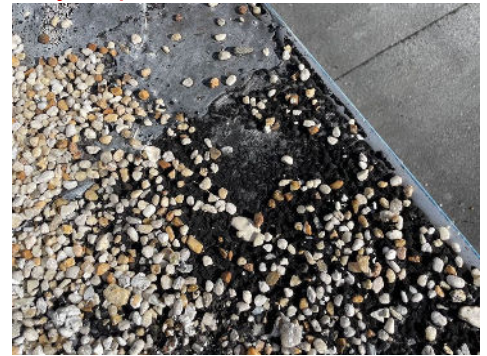
Damaged/Loose roofing material(s) were visible at multiple locations. An evaluation and repair should be completed by a qualified licensed roofer.

Missing roof material(s) were visible at multiple locations. An evaluation and repair should be completed by a qualified licensed roofer.

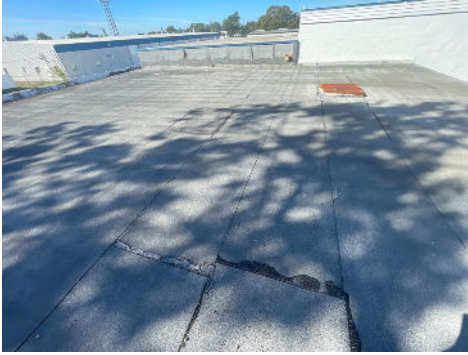
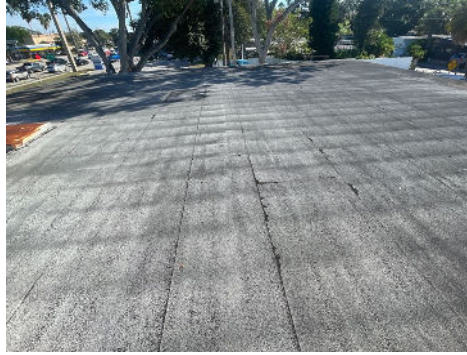
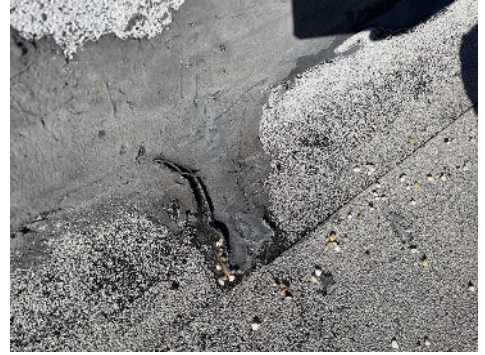
Damaged/Loose roofing material(s) were visible at multiple locations. An evaluation and repair should be completed by a qualified licensed roofer.

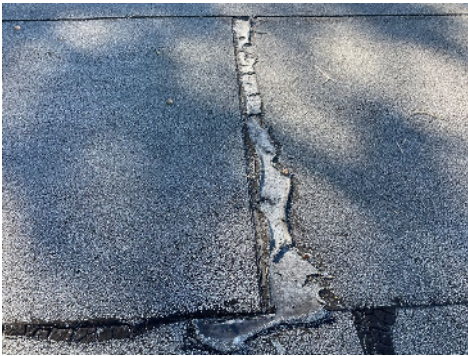
Damaged/Loose roofing material(s) were visible at multiple locations. An evaluation and repair should be completed by a qualified licensed roofer.

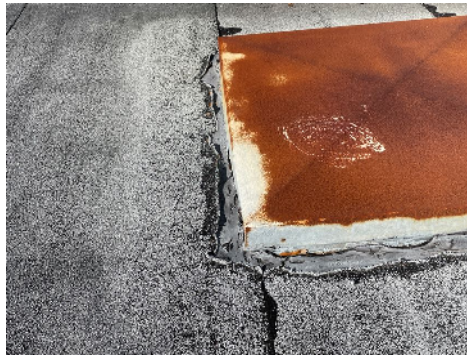
Damaged/Loose roofing material(s) were visible at multiple locations. An evaluation and repair should be completed by a qualified licensed roofer.

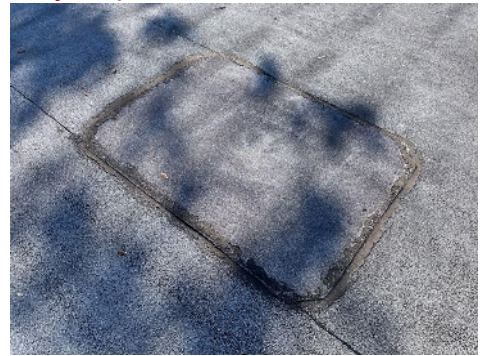
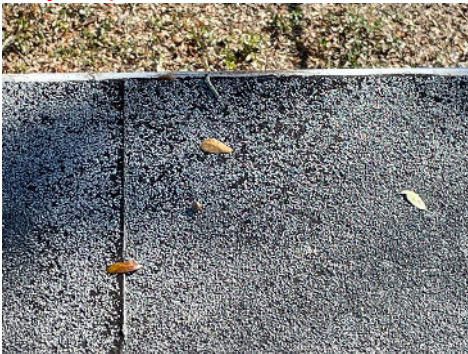
Missing roof material(s) were visible at multiple locations. An evaluation and repair should be completed by a qualified licensed roofer.

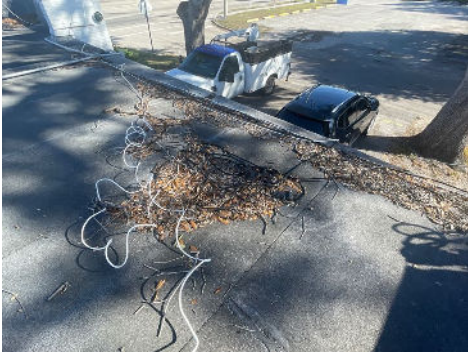
Conduit should be raised off of the roof surface.

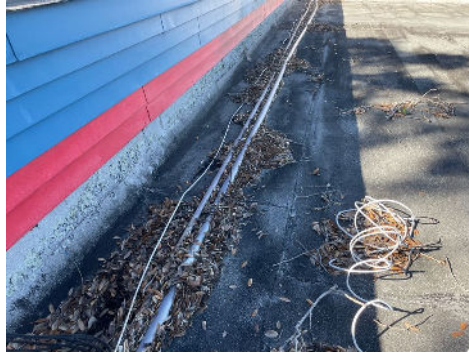
Trees and other vegetation should be trimmed away from the roof to prevent damage and premature deterioration.

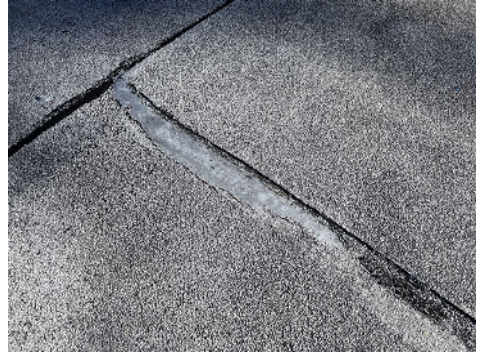
Missing roof material(s) were visible at multiple locations. An evaluation and repair should be completed by a qualified licensed roofer.

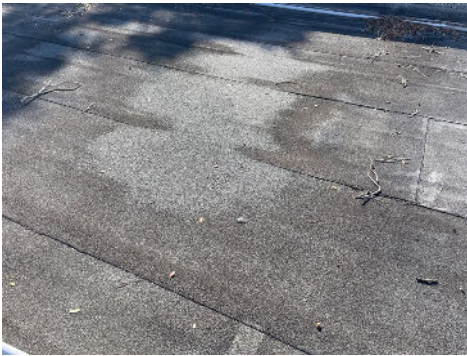
Missing roof material(s) were visible at multiple locations. An evaluation and repair should be completed by a qualified licensed roofer.

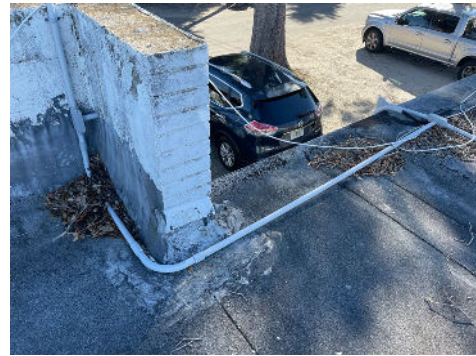
Conduit should be raised off of the roof surface.

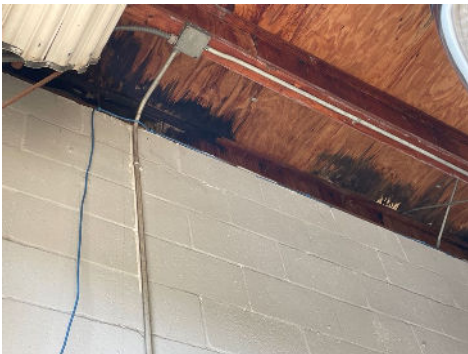
Moisture stains and damage were visible at multiple locations at the accessible areas of the attic.

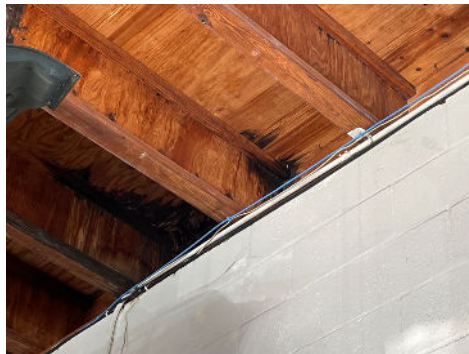
Moisture stains and damage were visible at multiple locations at the accessible areas of the attic.

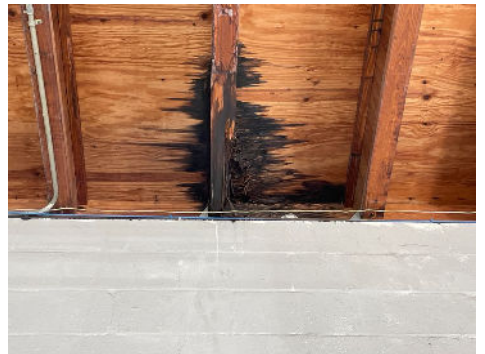
Moisture stains and damage were visible at multiple locations at the accessible areas of the attic.
