INSPECTION REPORT

SAMPLE REPORT - 123 Main Street Orlando, FL 54321

Age: 2013 Heated Sq Ft: 8292

Inspection Date: 10/19/2023

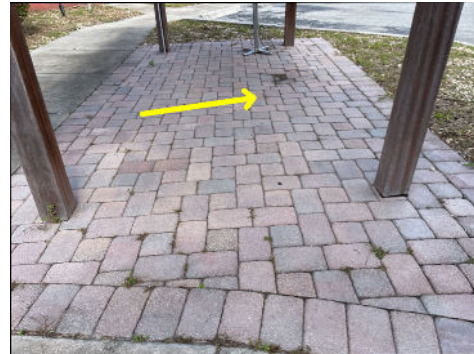
Patio/Terrace has settled.

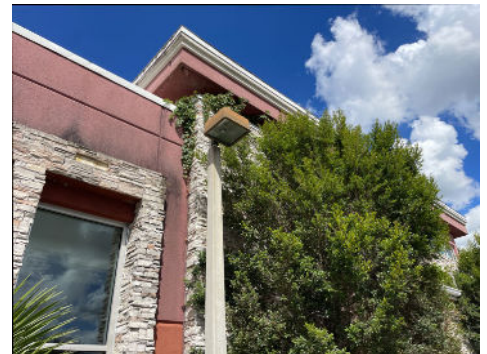
Vegetation/Shrubs/Trees appeared to be planted too close to foundation and structure of the house.

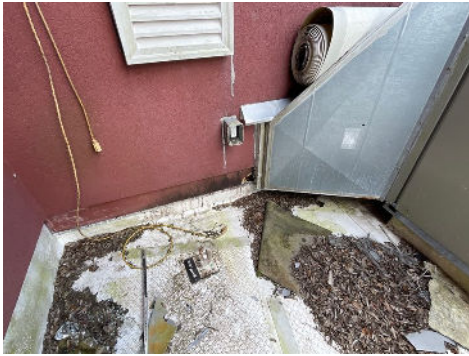
Moisture stains and damage were visible at the roof area near the package system.

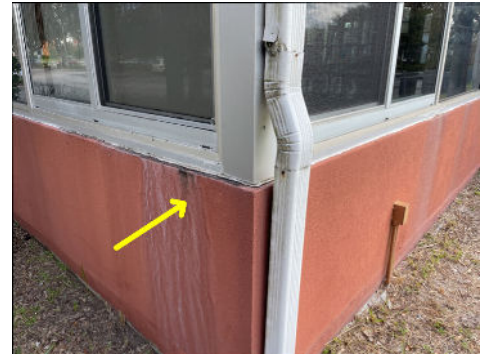
Gaps/holes was visible at various locations.

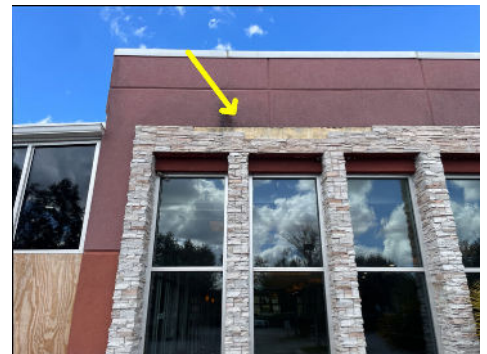
Exterior wall was damaged at front.

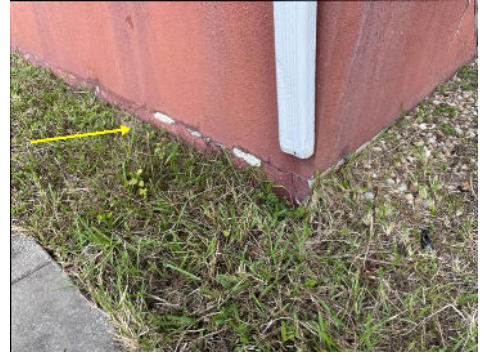
Exterior wall was damaged at front.

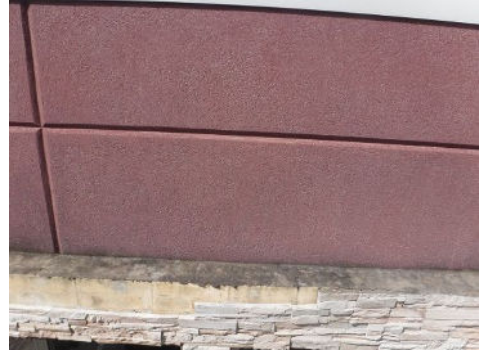
Front rock veneer top cap was missing proper flashing. Deterioration was visible.

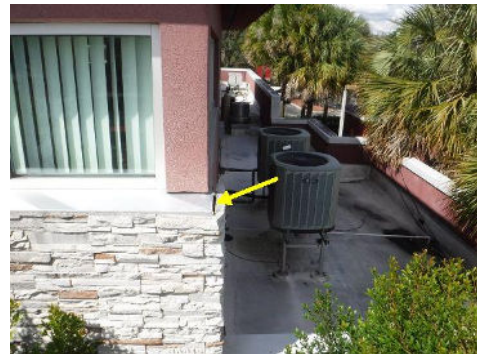
The front right rock veneer was separating from wall.

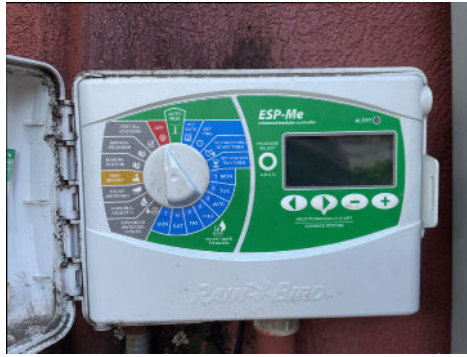
- Sprinkler system did not operate.

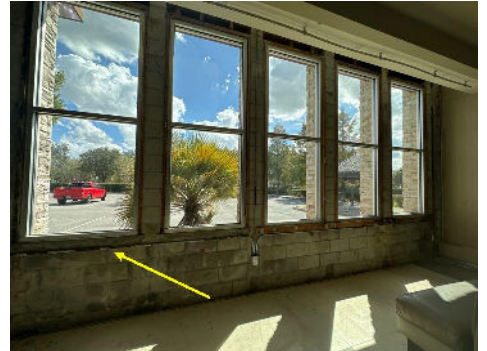
Outlet(s)/conduit were damaged at interior.

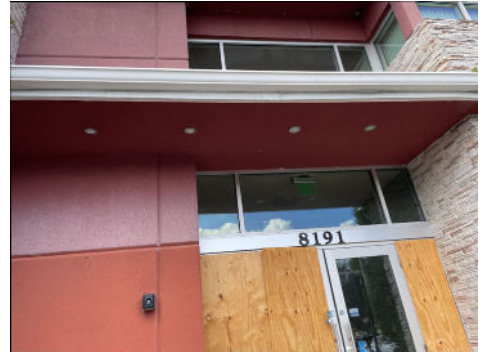
Light(s) were tested and not operational at multiple locations.

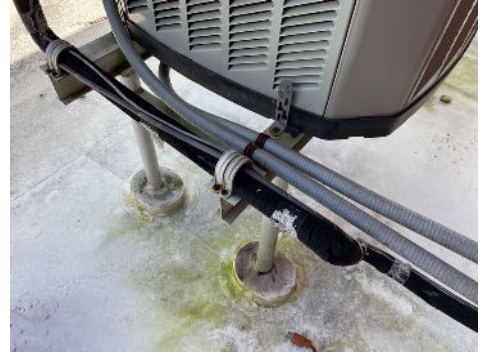
Insulation on refrigerant line was damaged .

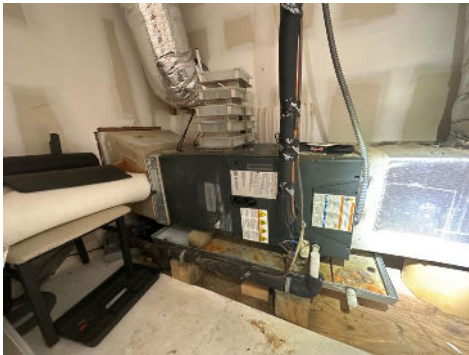
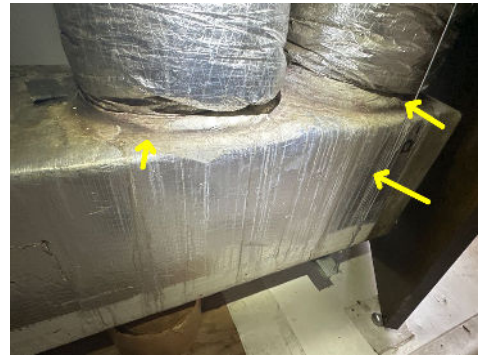
Microbial-like growth was visible at the exterior.

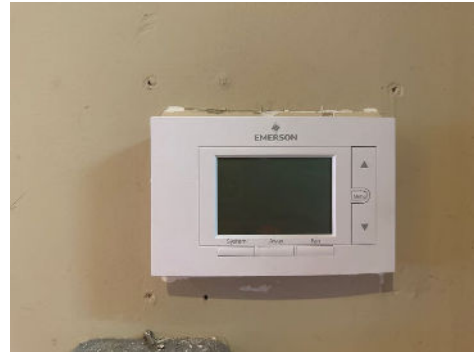
Thermostat(s) was damaged.

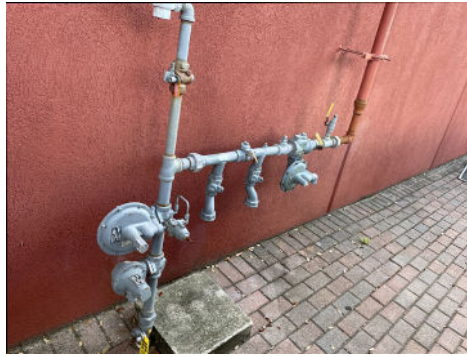
Meter was missing and gas was off at the time of inspection.

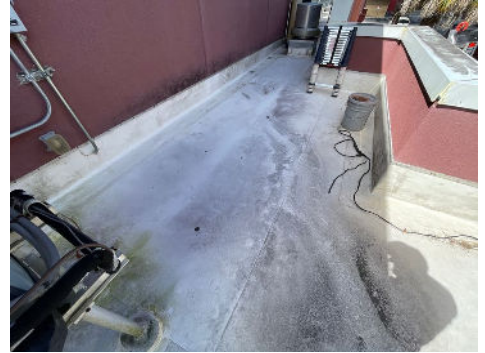
Evidence of water pooling was visible.

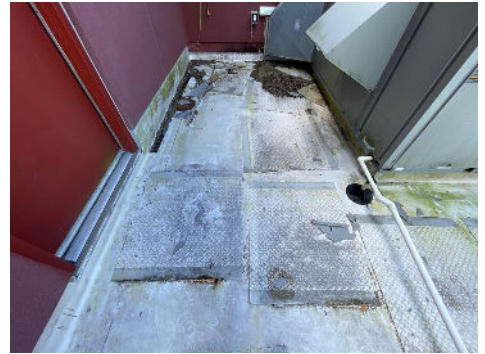
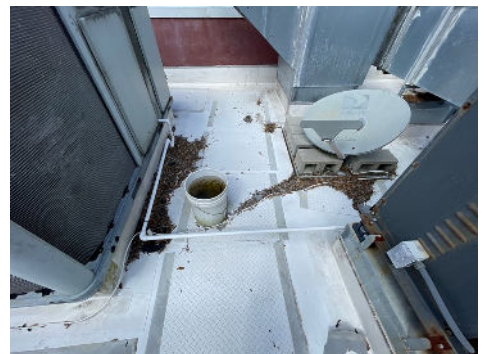
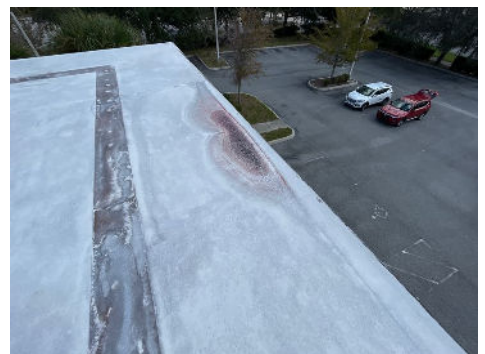
Damaged/Loose roofing material(s) were visible.

Evidence of water pooling was visible.

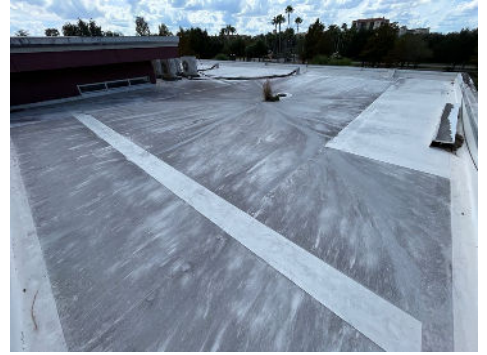
Evidence of water pooling was visible.

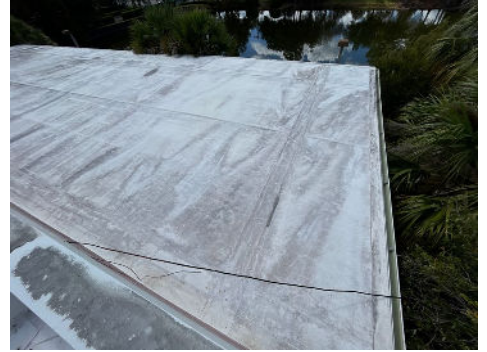
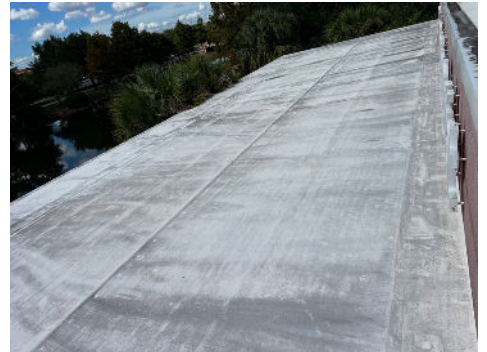
Damaged/Loose roofing material(s) were visible.

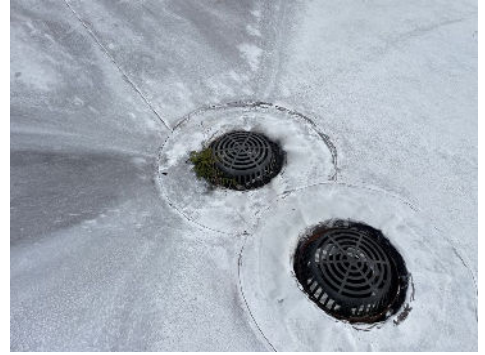
Top cap flashing was damaged. Moisture stains and damage were visible at the wood structure below.

Roof drains should be cleared of all debris and vegetation.

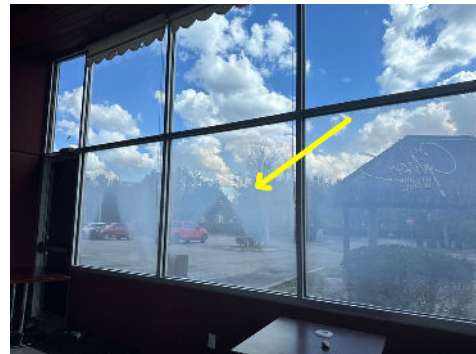
Window pane was not fully sealed in multiple locations.

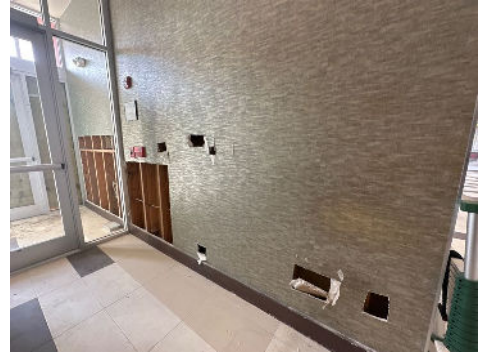
Damaged wall(s) were visible at multiple locations.

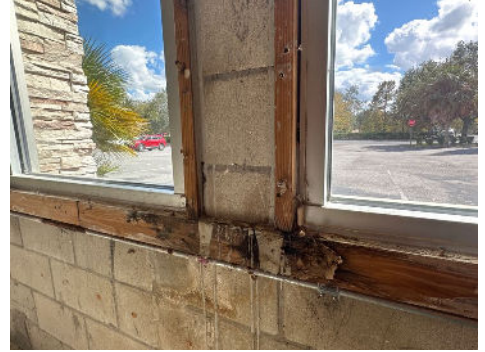
WDO-Like damage was visible at multiple locations.

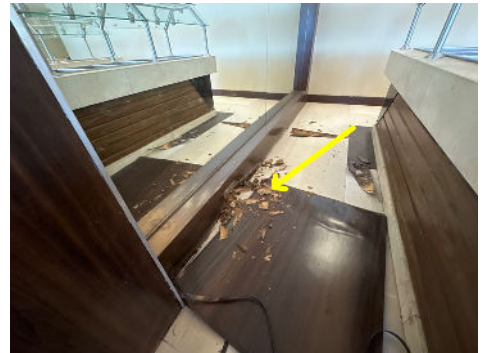
Damaged wall(s) were visible at multiple locations.

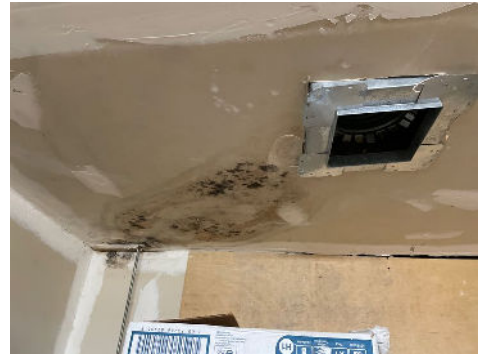
Microbial like growth was visible at the subfloor storage area in the kitchen.

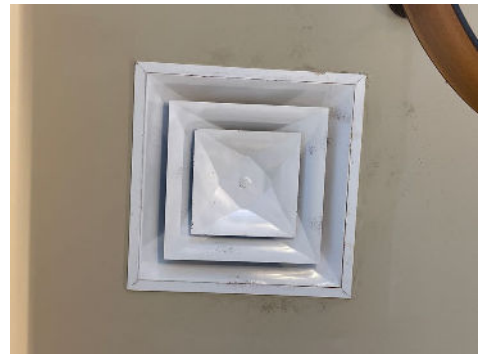
Damage was visible at multiple locations.

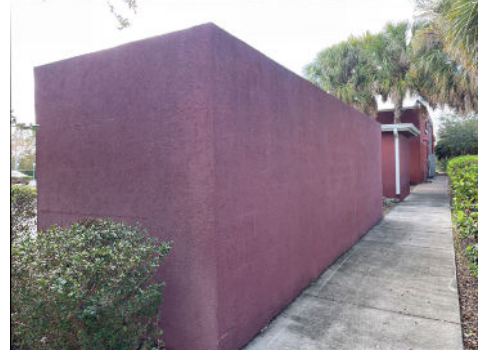
Damage was visible at various locations.

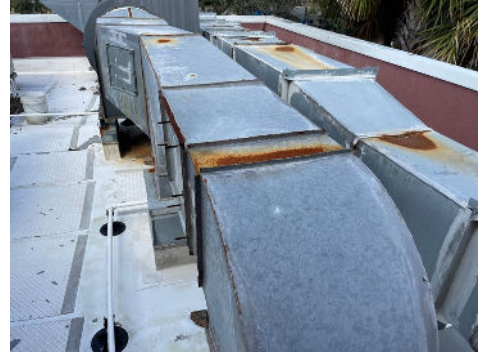
Kitchen ventilation system was present. Vent ducts at the roof were deteriorated/damaged.

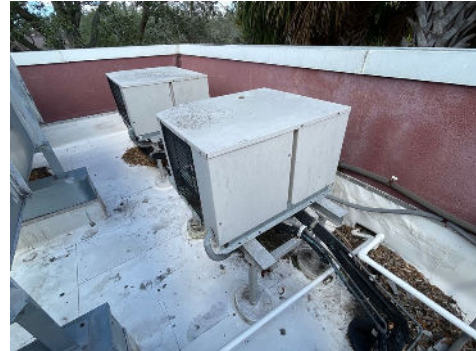
Wine cooler was installed was present.
