**WAYPOINT**  
Property Inspection, LLC

Prepared for: Pre-drywall Inspection **SAMPLE**

# INSPECTIONREPORT

**SAMPLE** Pre-drywall Inspection  
Jupiter, FL  
32588

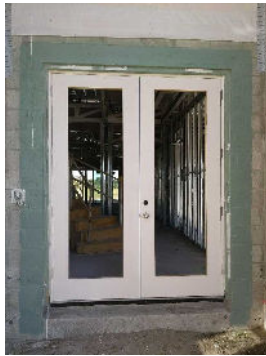
Door hardware was not installed.

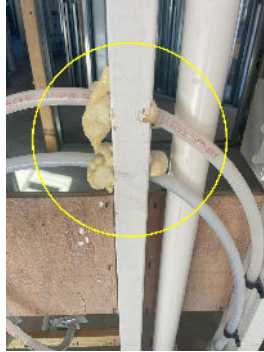
- General condition of the interior walls appeared to be in serviceable condition.
- Nail plate should be installed to prevent damage to pex lines.

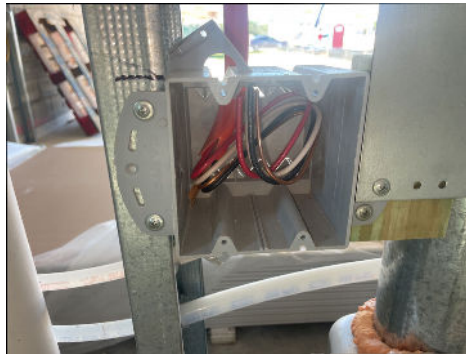
220 volt outlet wiring appeared serviceable.

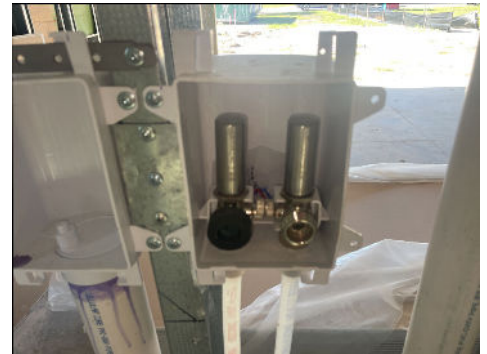
Visible piping (supply & waste) appeared to be in serviceable condition.

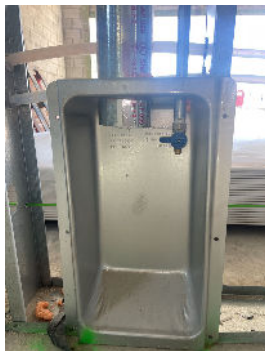
Dryer vent appeared to be properly installed.

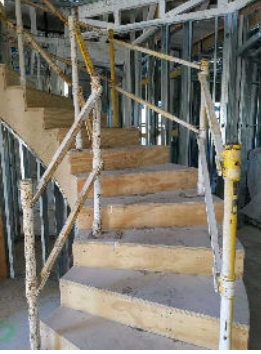
Rails were not installed at the time of inspection.

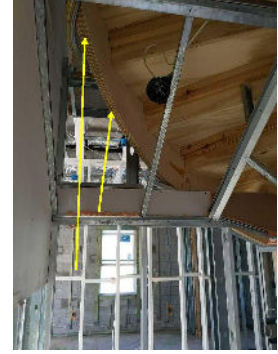
Stairway appeared to be safe. Unsure if support boards was missing inside closet area. Recommend a further evaluation.

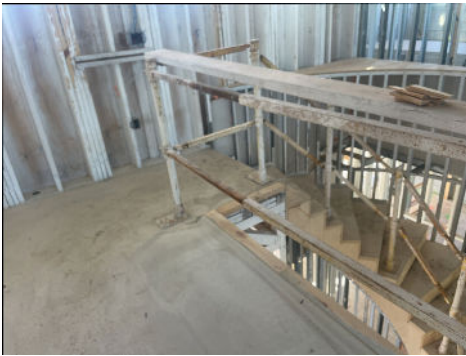
Rails were not installed at the time of inspection.

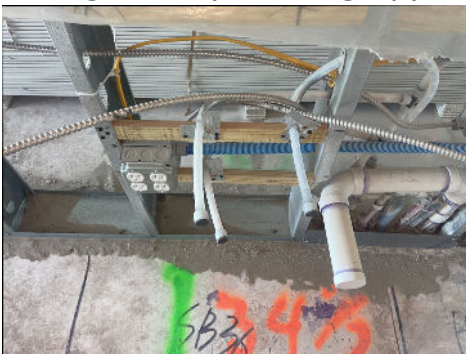
Island rough sink plumbing appeared to be in serviceable condition.

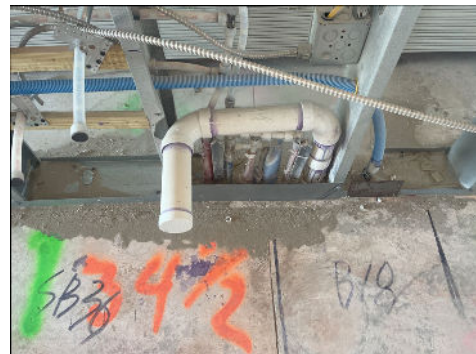
Island rough sink plumbing appeared to be in serviceable condition.

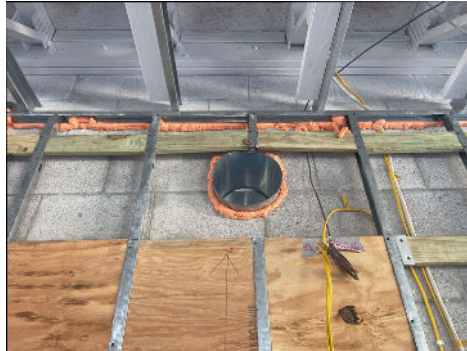
Ventilation appeared to be in serviceable condition in the kitchen.

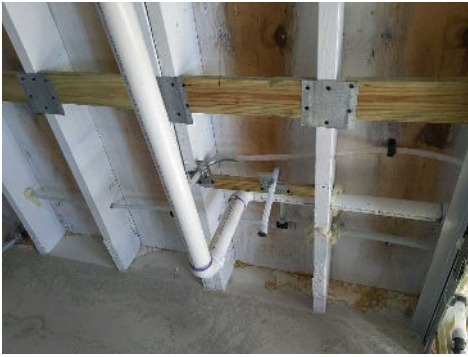
Sink supply plumbing appeared to be in serviceable condition.

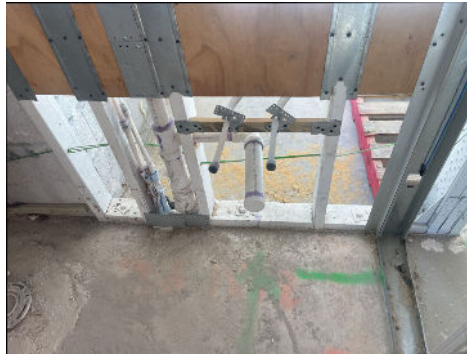
Sink supply plumbing appeared to be in serviceable condition.

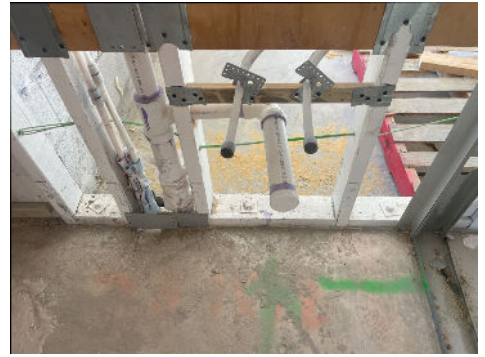
Sink drain plumbing appeared to be in serviceable condition.

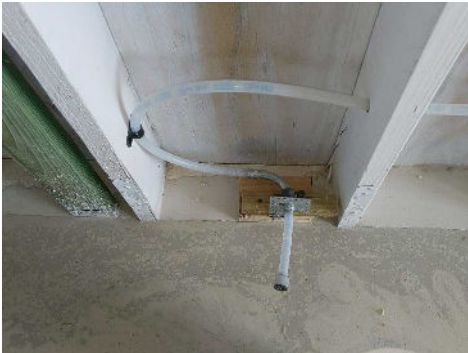
Toilet(s) supply plumbing appeared to be in serviceable condition.

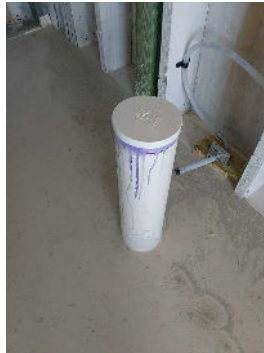
Toilet(s) supply plumbing appeared to be in serviceable condition.

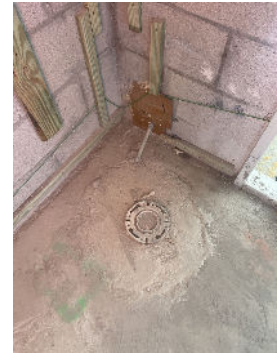
Toilet(s) supply plumbing appeared to be in serviceable condition.

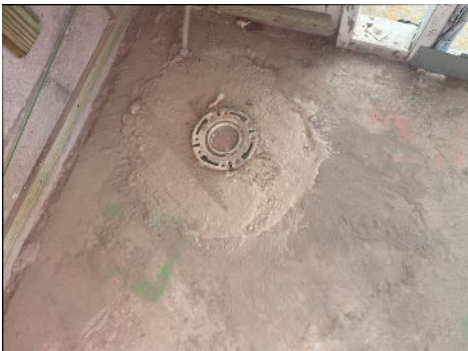
Toilet(s) drain plumbing appeared to be in serviceable condition.

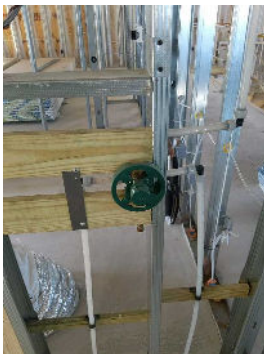
Shower(s) supply plumbing appeared to be in serviceable condition.

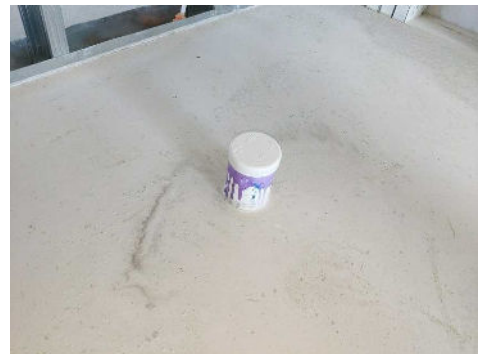
Shower(s) drain plumbing appeared to be in serviceable condition.

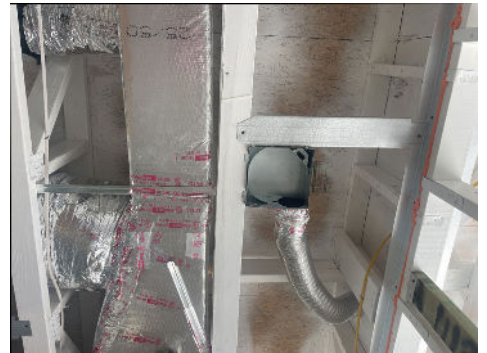
Bathroom #2

Ventilation fan housing and vent piping appeared to be in serviceable condition.

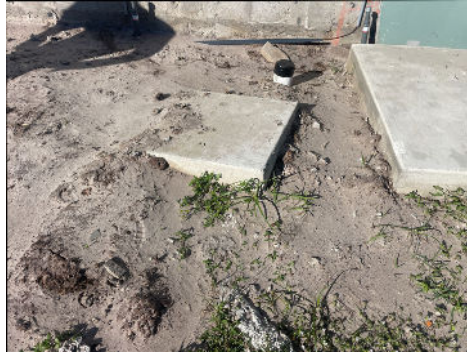
- Rough grading was not complete.
- Pad for irrigation pump should be leveled.

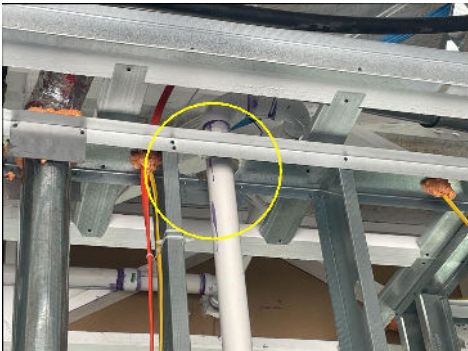
Fire-rated material should be sprayed in gaps.

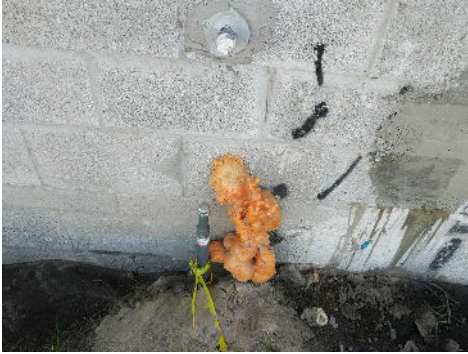
Rough plumbing for the fuel system appeared serviceable.

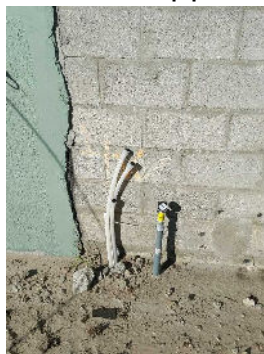
Water heater rough plumbing connections appeared to be in serviceable condition.

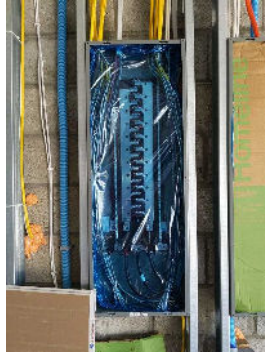
Panel box cover was not installed.

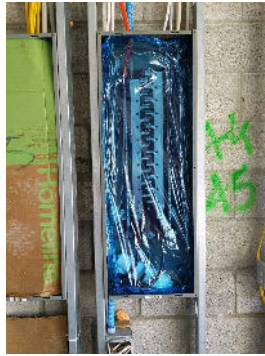
Panel box cover was not installed.

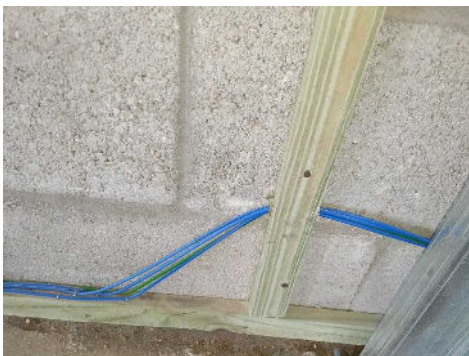
Missing nail strike plates at master and secondary bedrooms for low voltage wires.

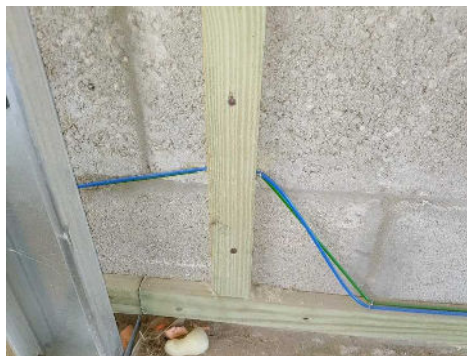
Missing nail strike plates at master and secondary bedrooms for low voltage wires.

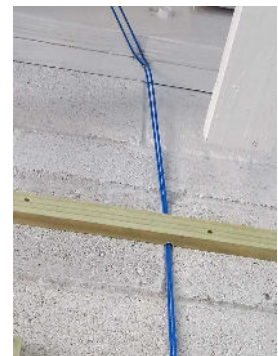
Missing nail strike plates at master and secondary bedrooms for low voltage wires.

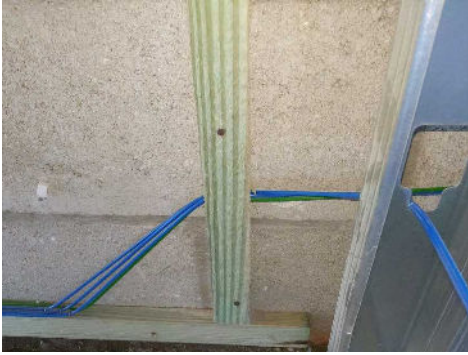
Missing nail strike plates at master and secondary bedrooms for low voltage wires.

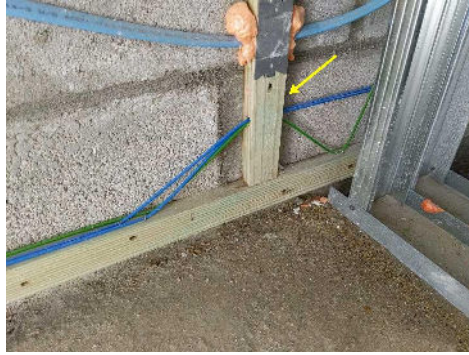
Missing nail strike plates at master and secondary bedrooms for low voltage wires.

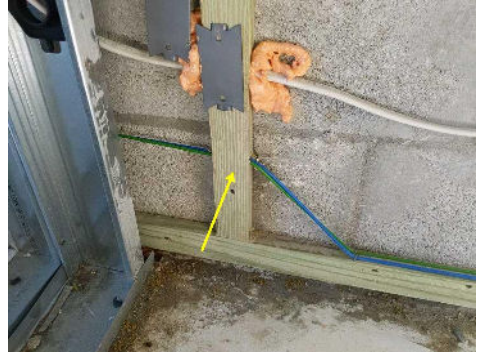
Missing nail strike plates at master and secondary bedrooms for low voltage wires.

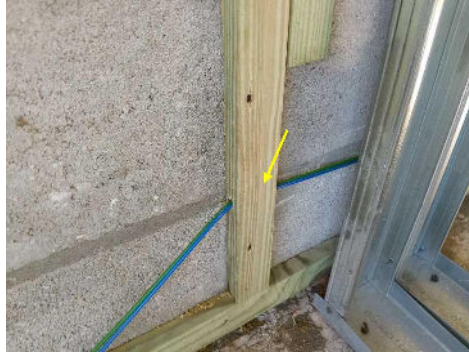
Missing nail strike plates at master and secondary bedrooms for low voltage wires.
