# WAYPOINT

Inspection Date: 12/27/2023

## INSPECTIONREPORT

SAMPLE Pre-pour Inspection

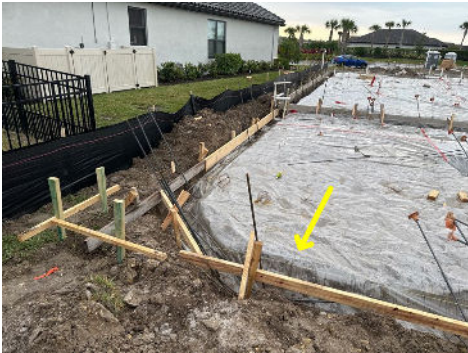
Damaged visqueen vapor barrier was visible.

Page 2 Item: 2	Foundation Condition	• Damaged visqueen vapor barrier was visible.
----------------	----------------------	---

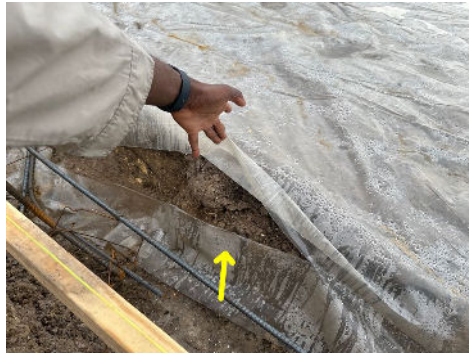
Damaged visqueen vapor barrier was visible.

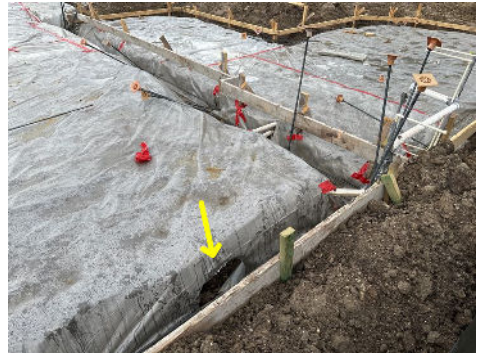
Damaged visqueen vapor barrier was visible.

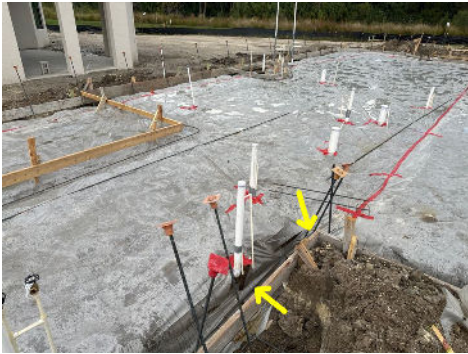
Damaged visqueen vapor barrier was visible.

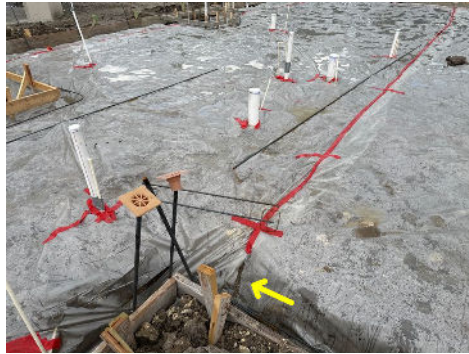
Damaged visqueen vapor barrier was visible.

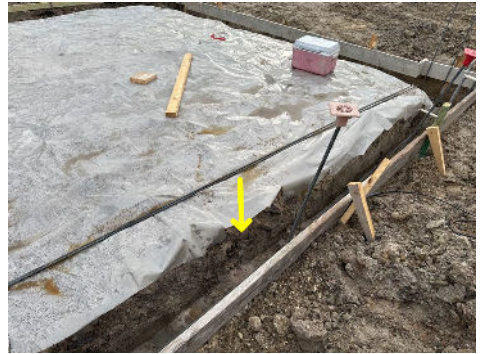
Damaged visqueen vapor barrier was visible.

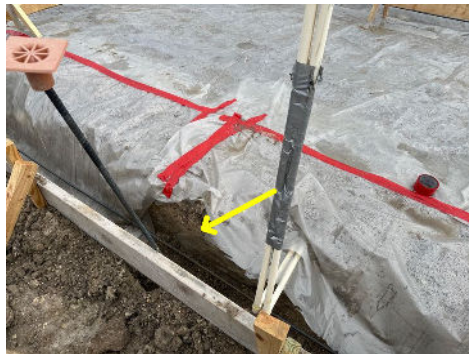
Damaged visqueen vapor barrier was visible.

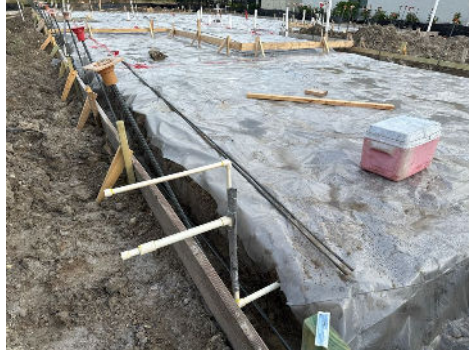
- Visible main line rough plumbing appeared to be proper.

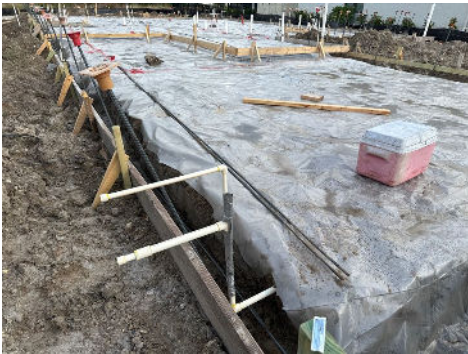
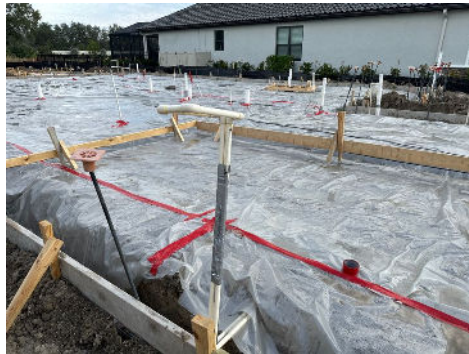
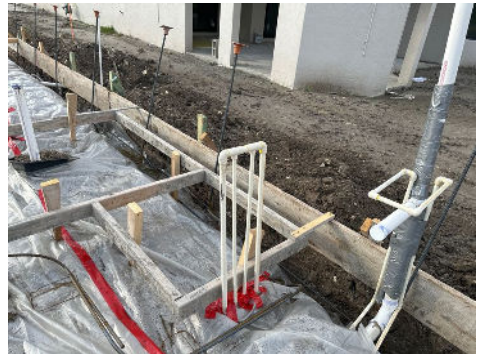
- Visible supply piping was in good condition.

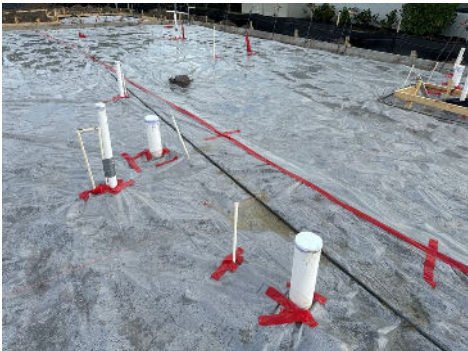
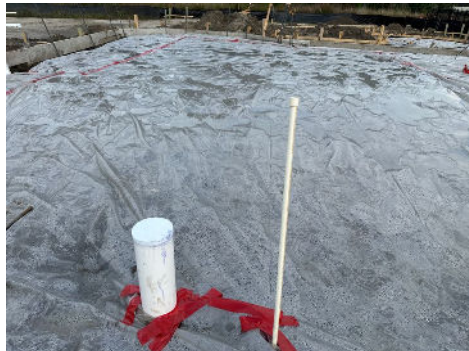
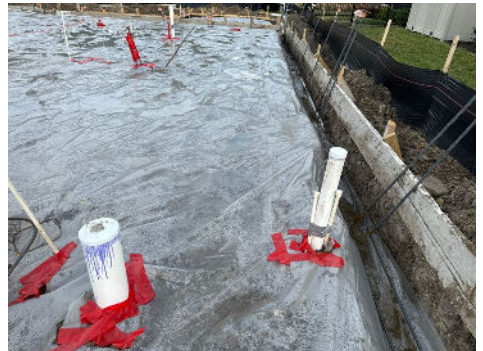
- Visible drain/waste/vent piping was in good condition.

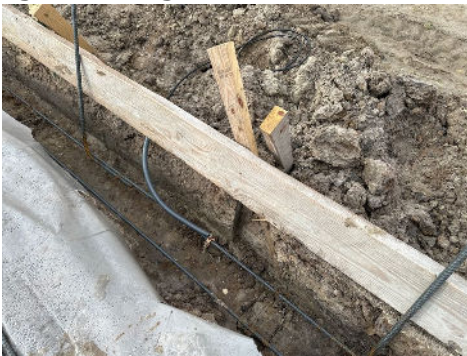
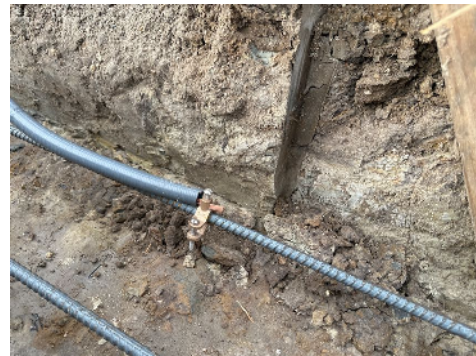
- Grounding system was present.
- UFER grounding

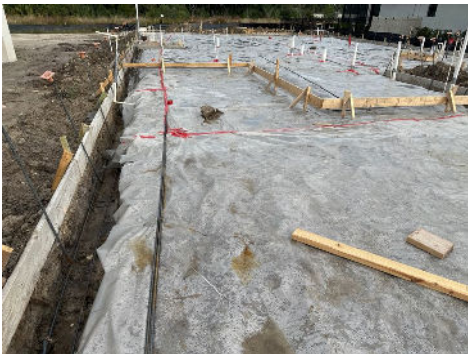
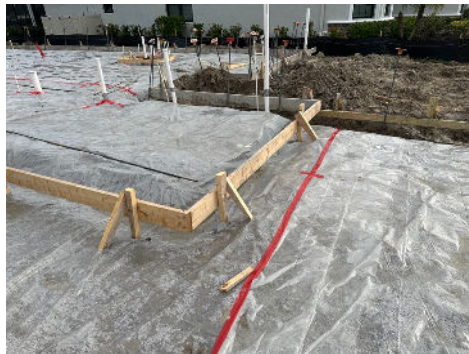
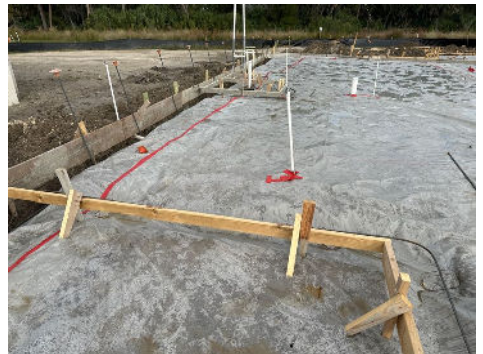
- Post pour concrete slab was not true level at multiple locations.

Page 5 Item: 1	Pre Pour Photos	• Post pour concrete slab was not true level at multiple locations.
----------------	-----------------	---
