# WAYPOINT

## INSPECTIONREPORT

Age: 1986 Heated Sq Ft: 39515

Inspection Date: 9/4/2023

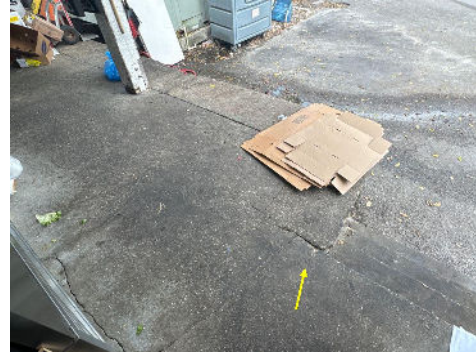
Patio had large and/or displaced cracks were visible.

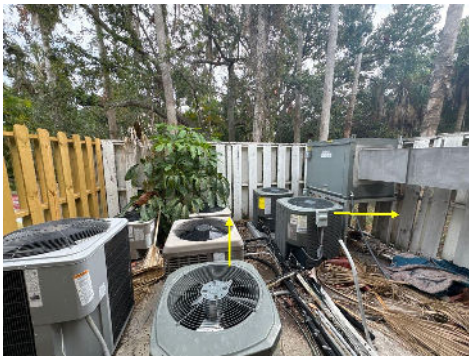
Fence were damaged.

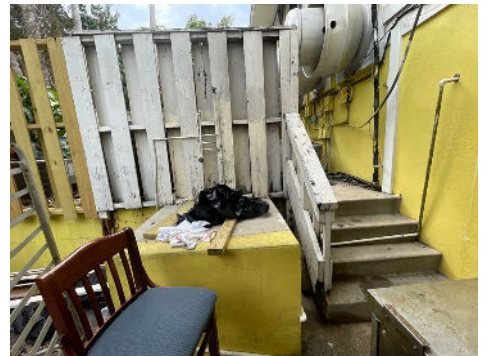
Fence were damaged.

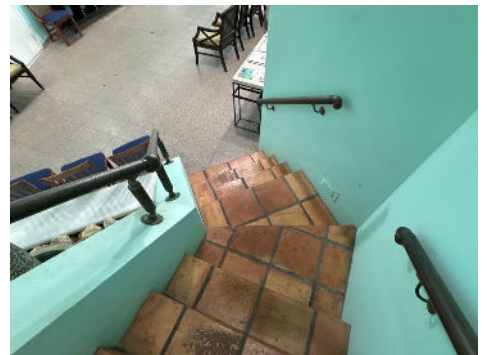
Rails were damaged.

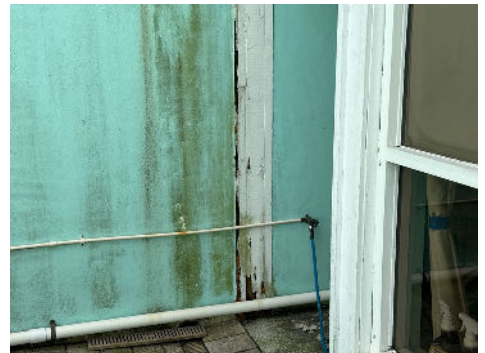
Trim pieces had visible damage at multiple locations.

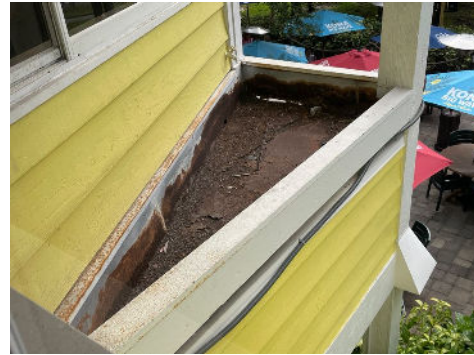
Trim pieces had visible moisture damage at various locations.

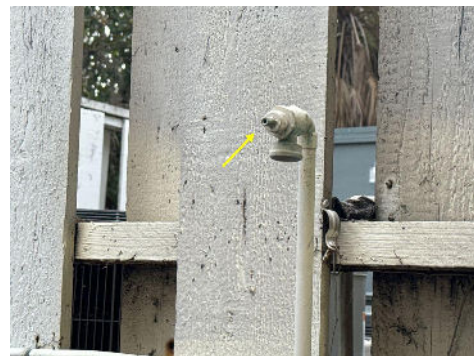
Faucet handle(s) were damaged.

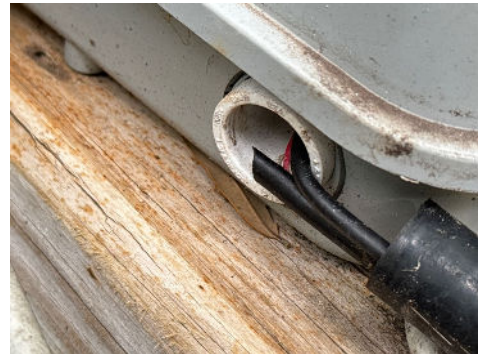
Sprinkler control box was damaged.

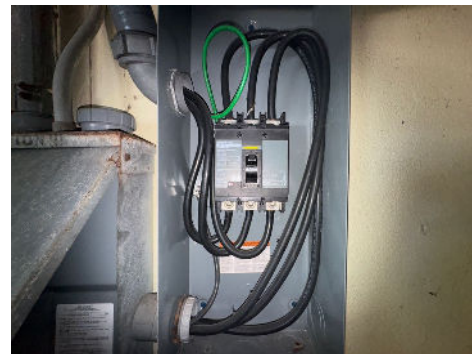
Electrical Main Panel 1 was in good condition: No. **Neutral conductor was not identified/taped white.**

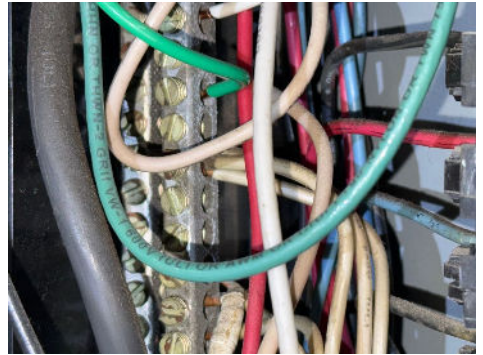
Double Tap connection was visible.

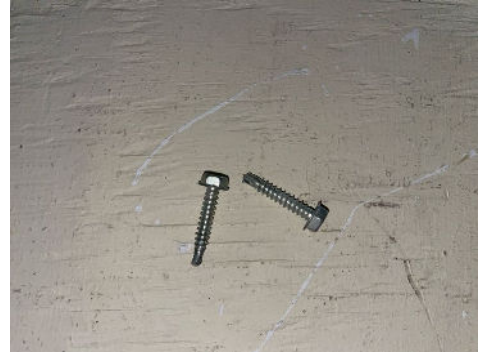
Fasteners should be rated for panel type to prevent damage to wiring.

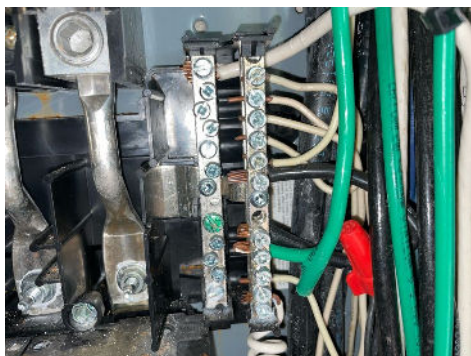
Neutral and ground wires improperly shared the same buss bar.

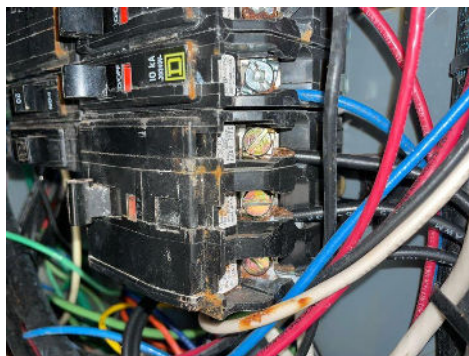
Panel wiring appeared to be corroded/discolored.

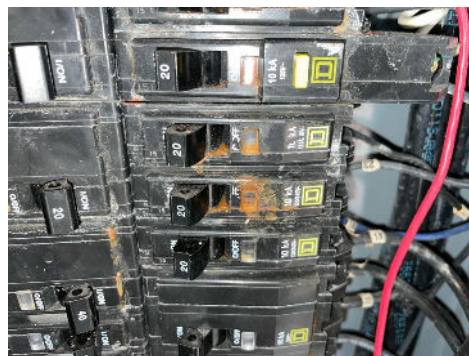
Defective breaker(s) were present. Rust/corrosion present.

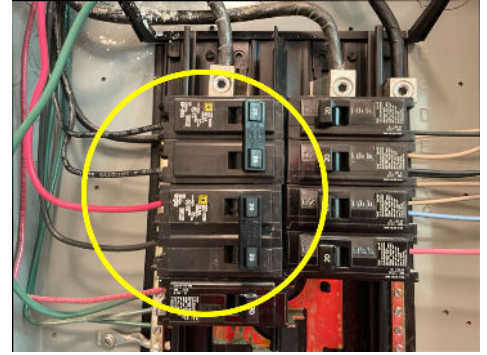
Breakers did not have a brand matching the brand of the panel box.

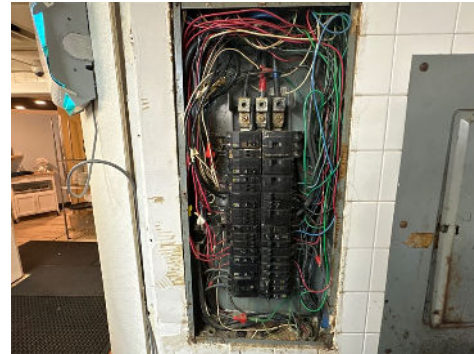
Breakers had grease contamination. Fire hazard.

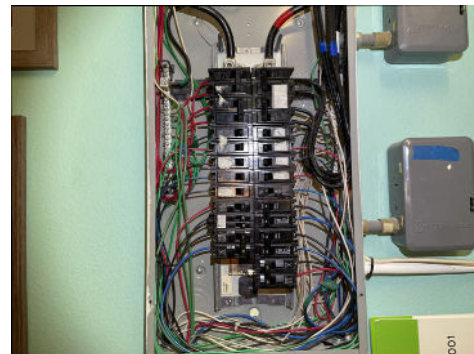
Challenger service panels and breakers were present. These panels are outdated and should be evaluated by licensed electrician.

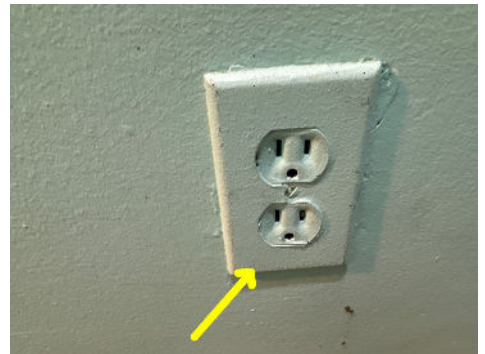
Outlet(s) were damaged at exterior.

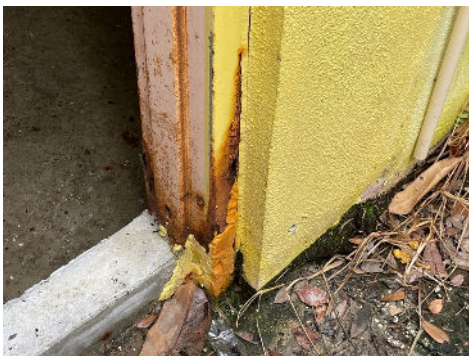
The front door had visible moisture damage.
