Property Inspection, LLC

INSPECTION REPORT

SAMPLE- 9876 Commercial Blvd Suite 600 Tampa, FL 32824

Inspection Date: 2/23/2024

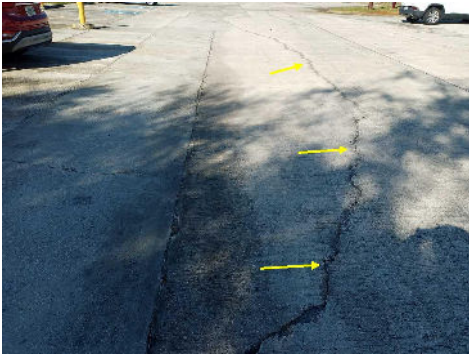
Parking lot had large crack(s) visible.

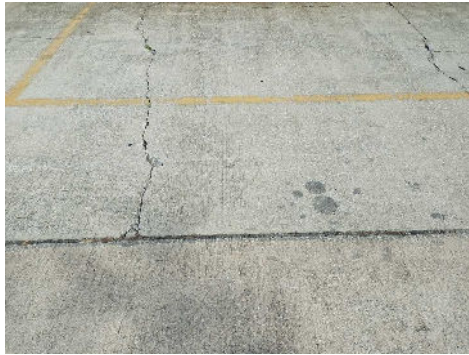
Parking lot had large crack(s) visible.

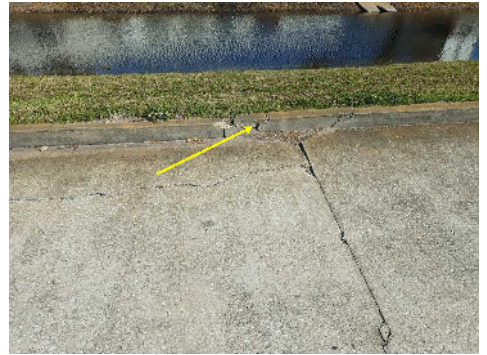
Curb had visible damage.

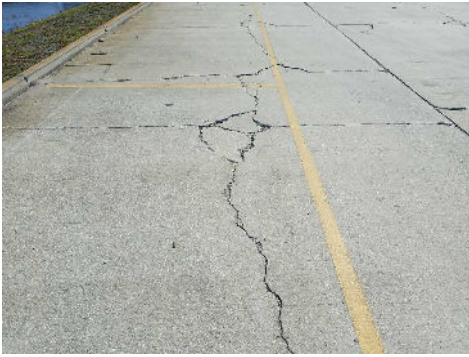
Parking lot had large crack(s) visible.

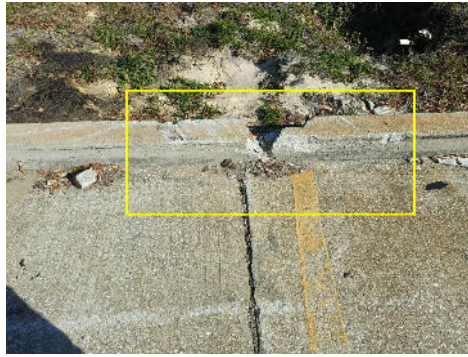
Curb had visible damage.

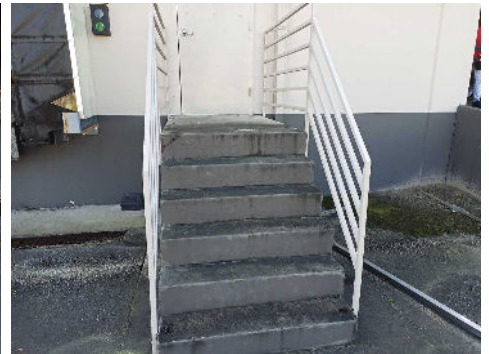
Stairs were damaged.

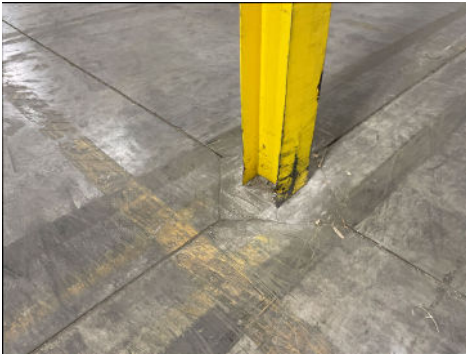
Columns had visible damage.

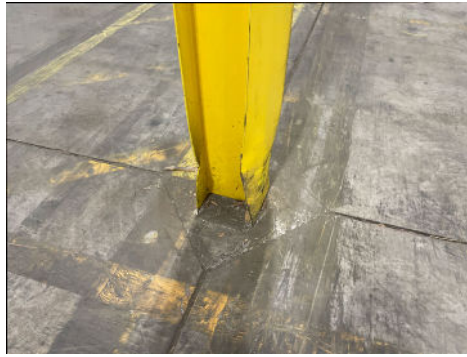
Columns had visible damage.

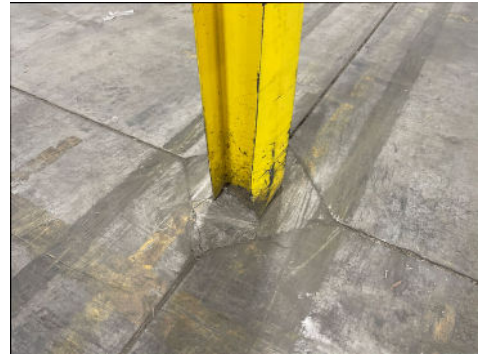
Columns had visible damage.

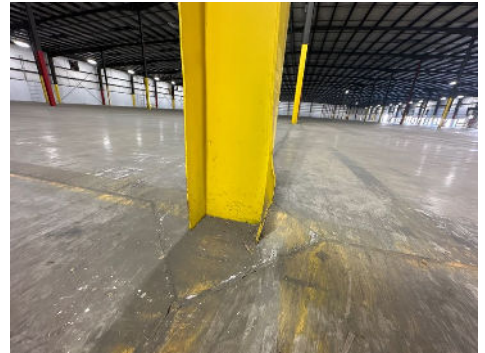
Columns had visible damage.

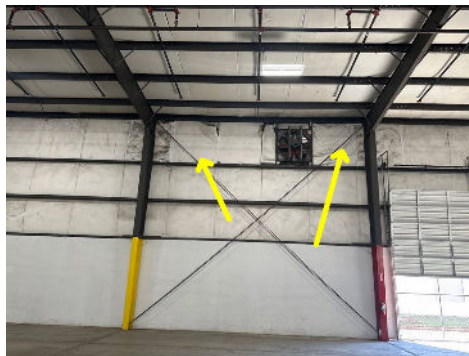
Insulation has been disturbed.

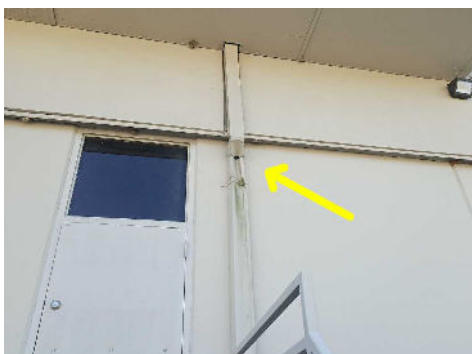
Downspout(s) were damaged.

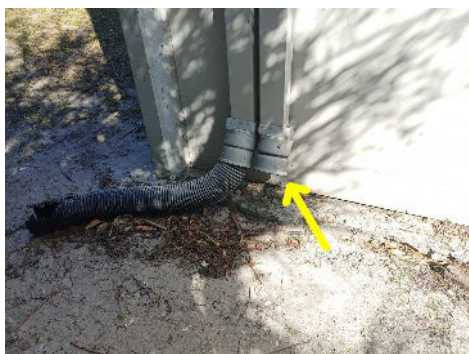
Extensions should be installed to channel drainage away from the foundation.

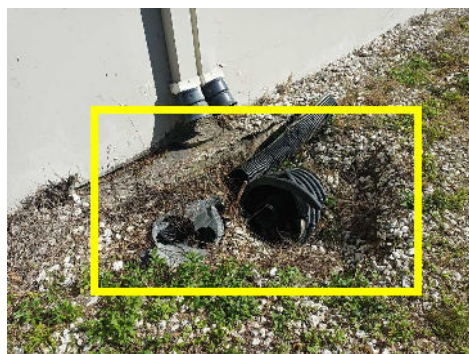
Extensions should be installed to channel drainage away from the foundation.

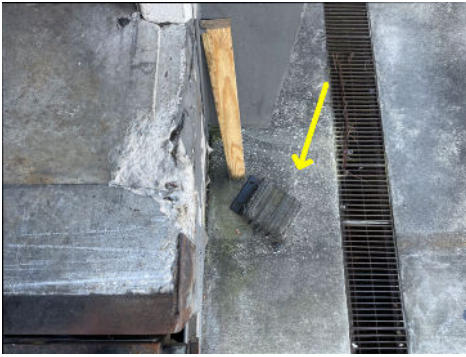
Damage that bumper door, 16

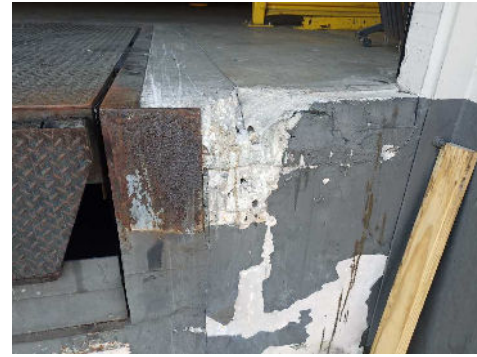
Damage that bumper door, 16

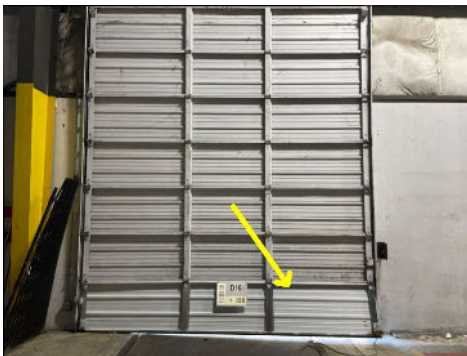
Dock door tracks were damaged.

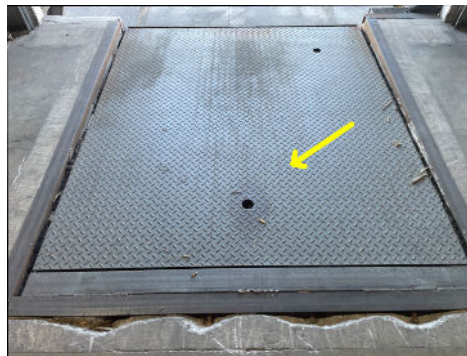
Dock plate was not operational at door 20.

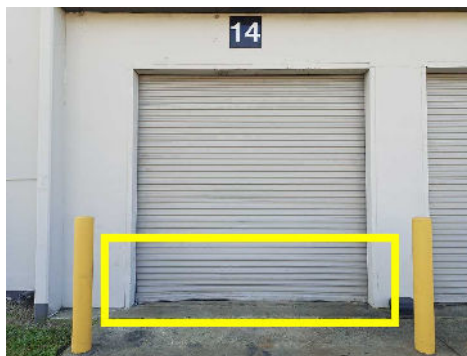
Dock door had minor damage visible.

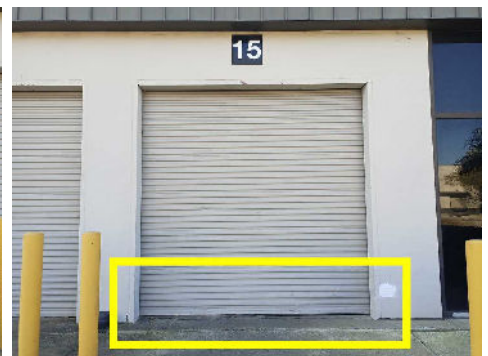
Dock door had minor damage visible.

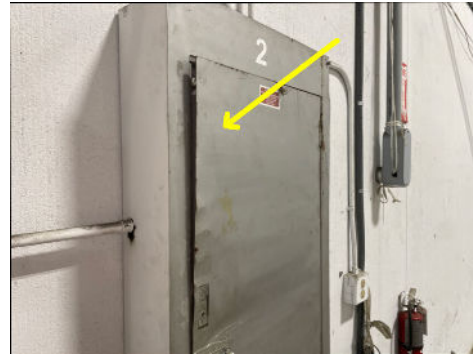
Panel cover was damaged.

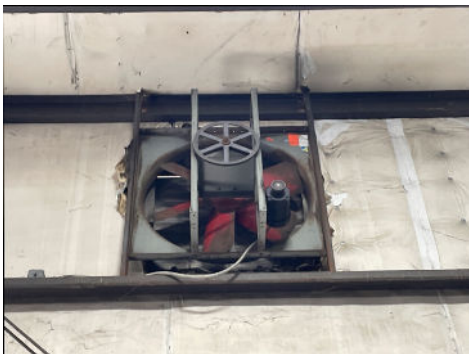
Exhaust fans were not operational.

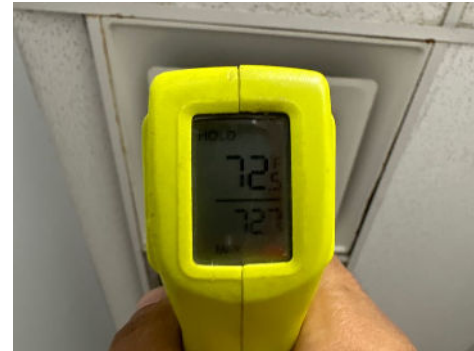
• Heating system did not operate properly. Air temperature differential was below manufacturer range of 25 - 30 degrees.

Supply air temperature

• Based on the condition of the heating system(s), it should be evaluated by a licensed HVAC specialist.

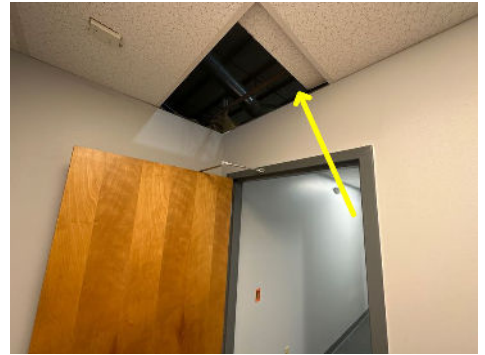
Ceiling tiles were cracked at multiple locations.

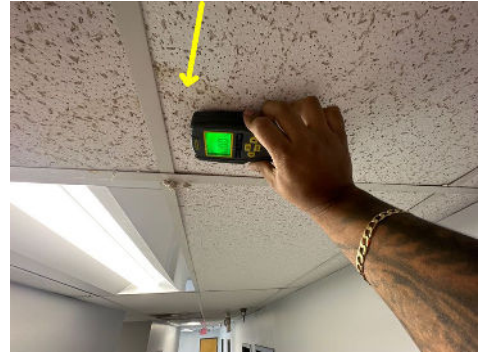
Although dry at the time of the inspection, the visible stain(s) indicated active leaks may be present at multiple locations.

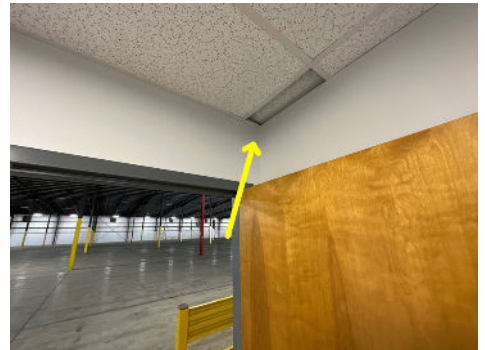
Ceiling tiles were cracked at multiple locations.

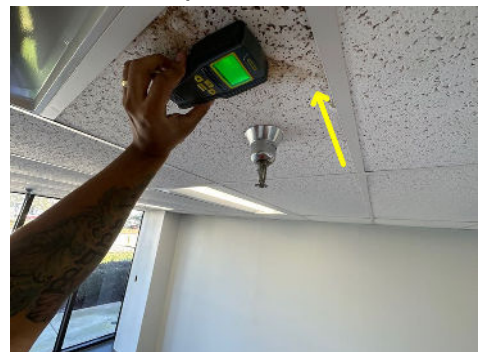
Although dry at the time of the inspection, the visible stain(s) indicated active leaks may be present at multiple locations.

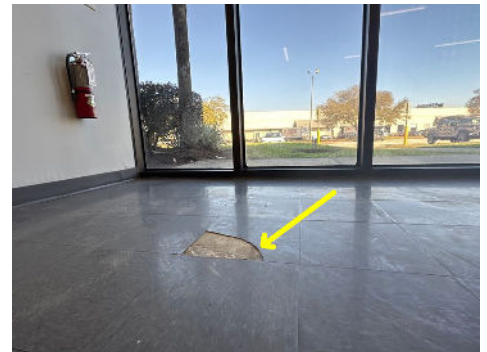
Cracked tiles were visible.

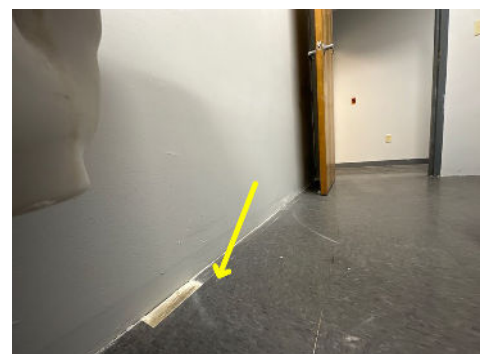
Cracked tiles were visible.

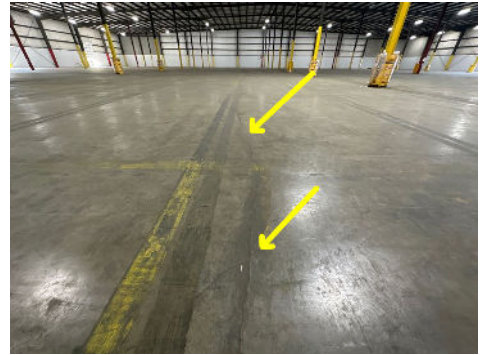
Settlement cracks were visible.

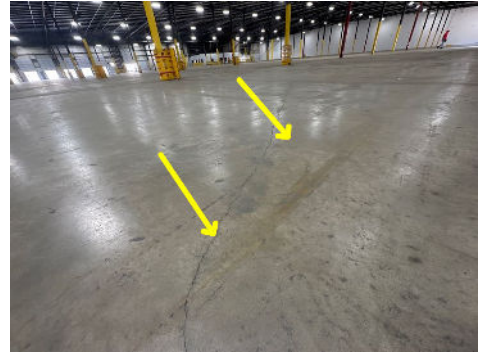
Settlement cracks were visible.

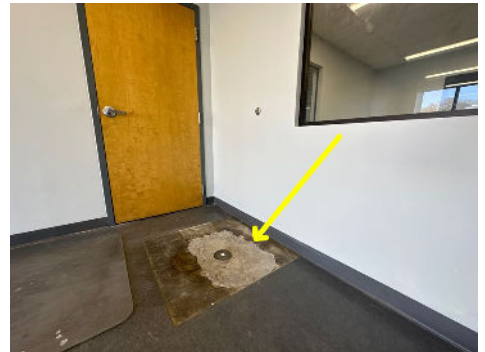
Flooring was damaged at front reception area~~#multiple locations.
