WAYPOINT

INSPECTION REPORT

1234 Easy Street Tampa, FL 33619

Inspection Date: 1/20/2024

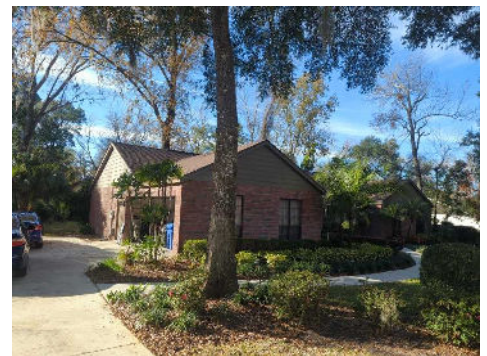
Vegetation/Shrubs/Trees appeared to be planted too close to foundation and structure of the house.

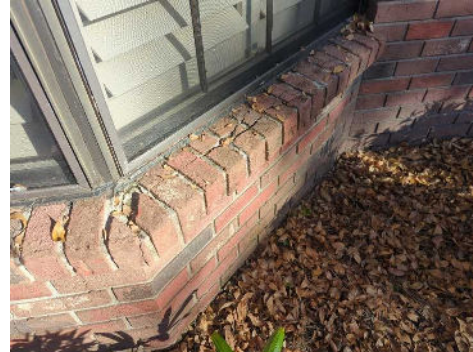
Exterior wall was damaged at rear.

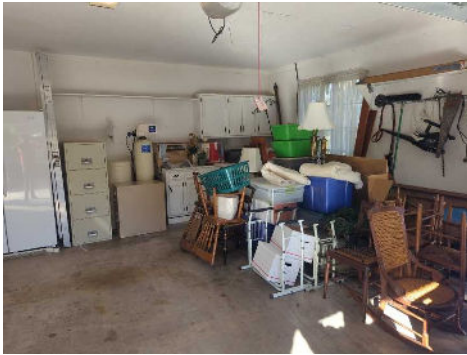
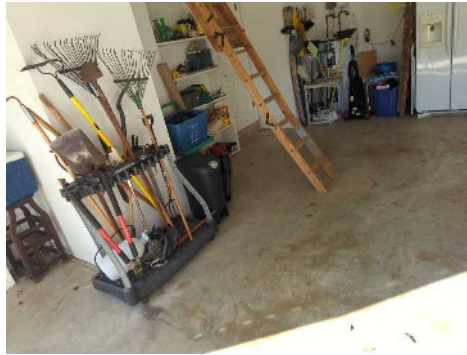
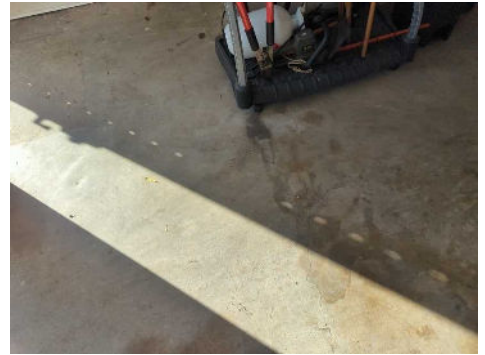
Settlement cracks were visible.

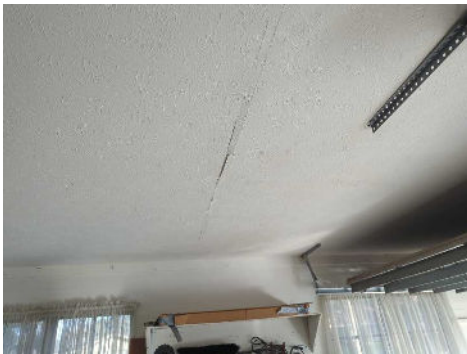
Settlement cracks up to 1/8 inch and/or ceiling seam separation was visible.

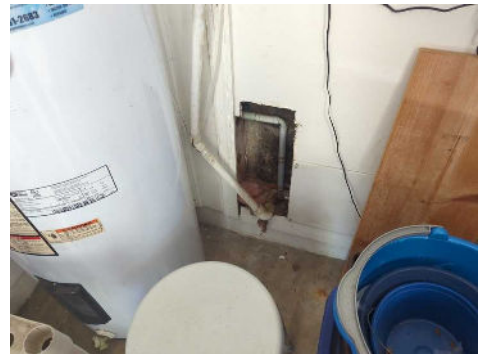
Damage was visible.

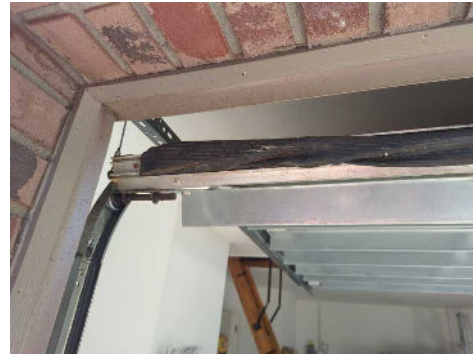
Weatherstripping was deteriorated/damaged and should be replaced.

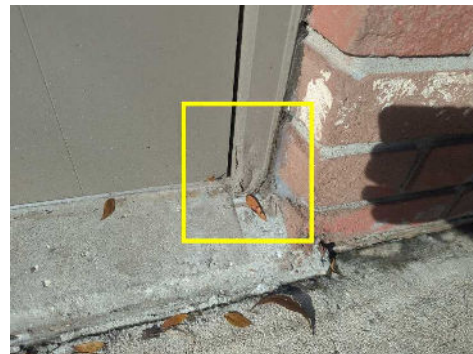
Moisture damage was visible at the door and/or door jamb.

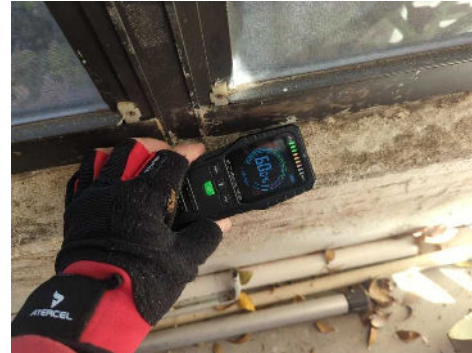
Visible moisture stain(s) indicated active leak(s) were present.

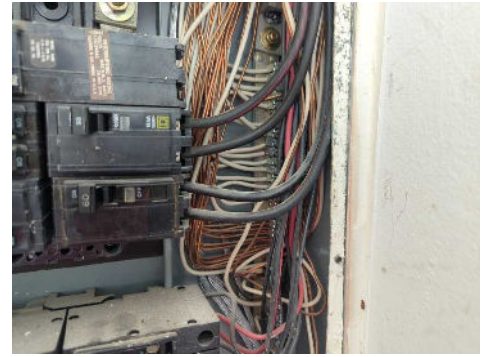
Fasteners were missing.

Fasteners were missing and improper.

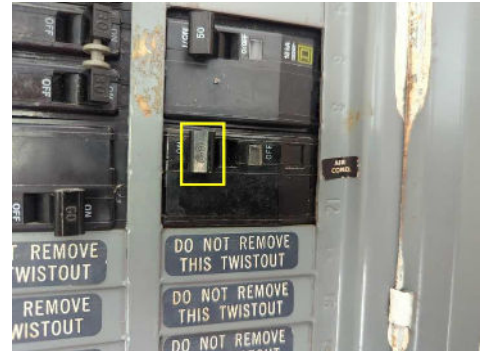
Breaker size at panel exceed the max rating (over fused) at the AC Condenser Unit

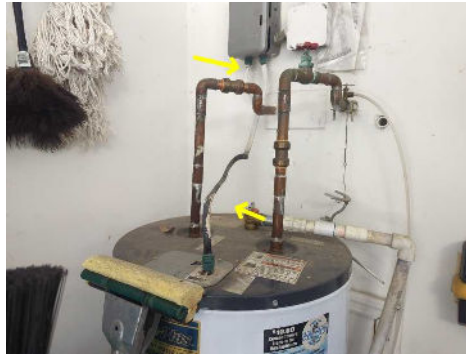
Wiring was exposed visible at water heater.

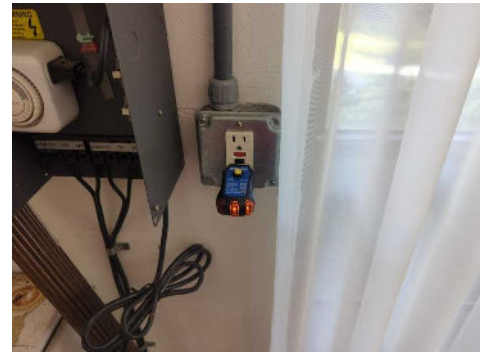
GFCI (Ground Fault Circuit Interrupter) outlet(s) was damaged at garage outlets.

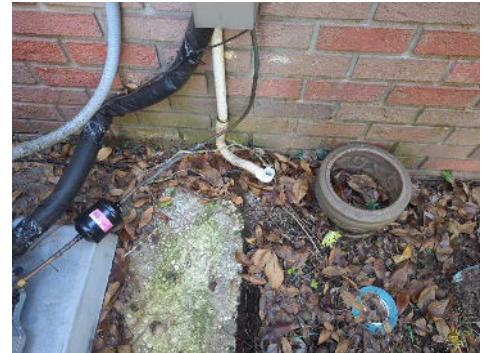
Condensate line should be routed away from foundation.

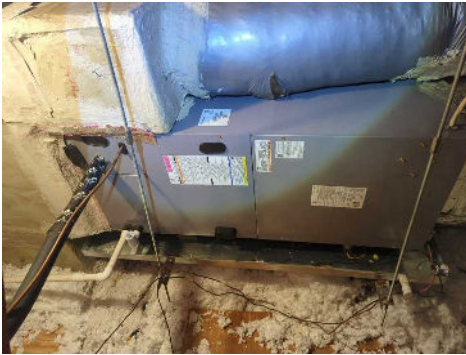
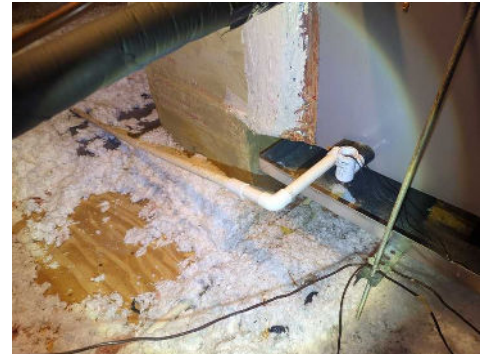
Insulation should be installed on the condensate line.

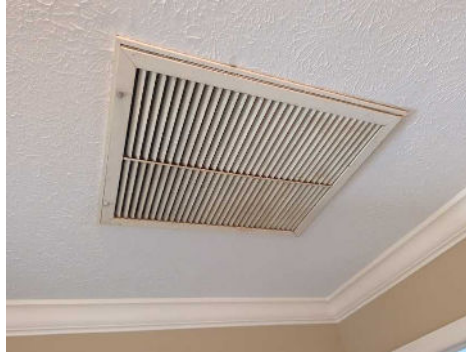
- Returns were dirty.

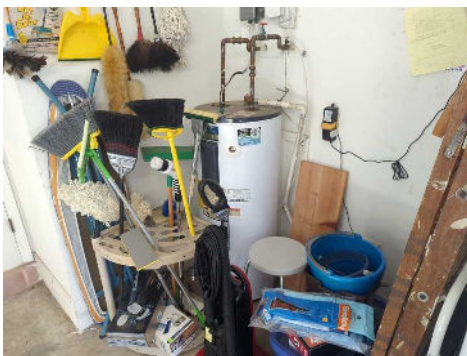
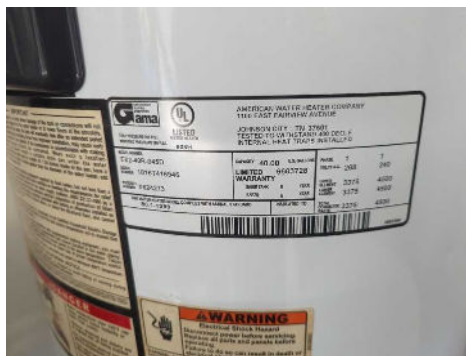
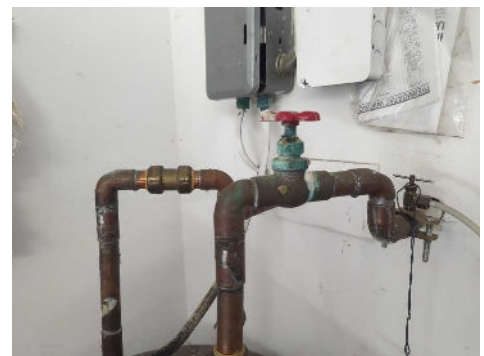
Corrosion was visible at the water heater.

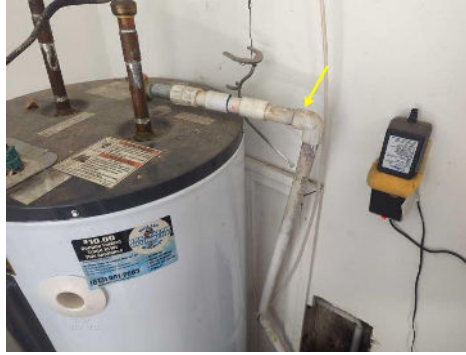
Temperature pressure relief valve (TPR Valve) piping was improper.

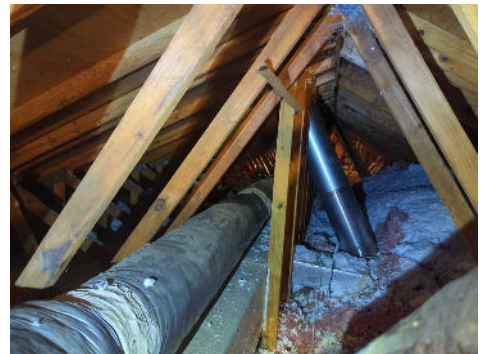
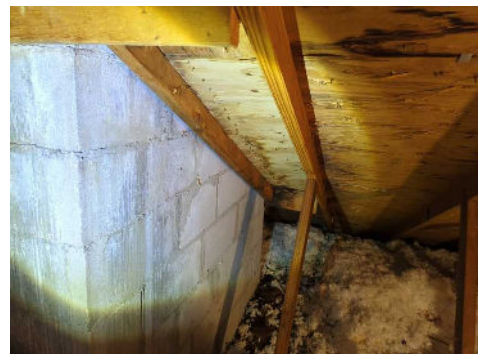
Insulation had been moved/disturbed, leaving low coverage areas.

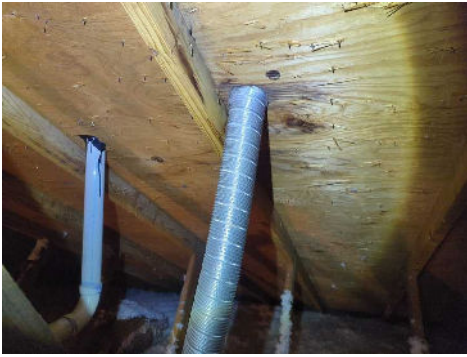
Although dry at the time of the inspection, visible stain(s) indicated active leaks may be present. Unable to determine the underlying condition.

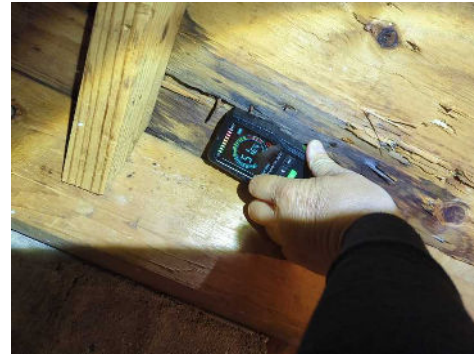
Moisture stain(s) were visible at the accessible areas of the attic. Stains tested wet at the time of inspection.

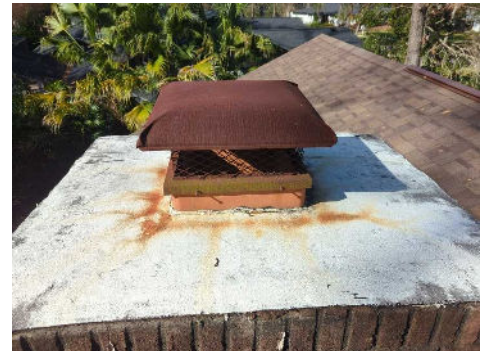
Spark screen was damaged/deteriorated.

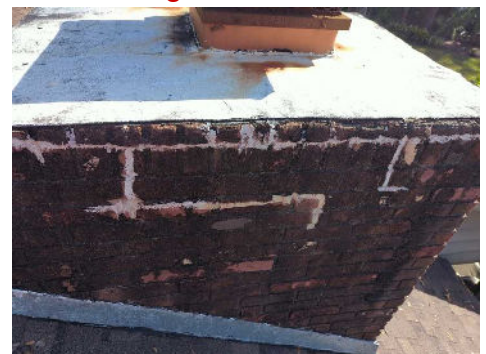
Brick/mortar at chimney was damaged.

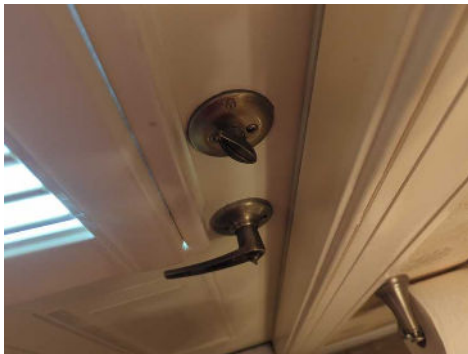
The secondary door(s) hardware was hard to operate.

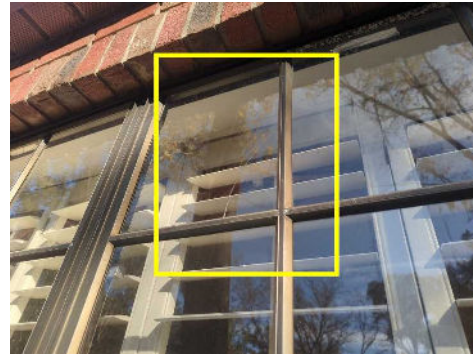
Cracked/damaged glass was present at primary bedroom.

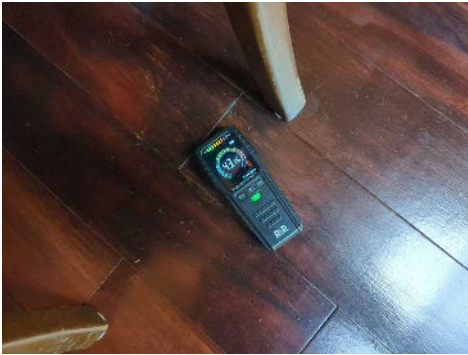
Flooring had visible moisture stains/damage. Stains/damage tested wet Unable to determine underlying condition at living and dining rooms.

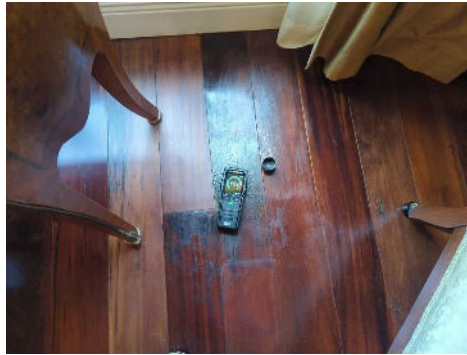
Flooring had visible moisture stains/damage. Stains/damage tested wet Unable to determine underlying condition at living and dining rooms.

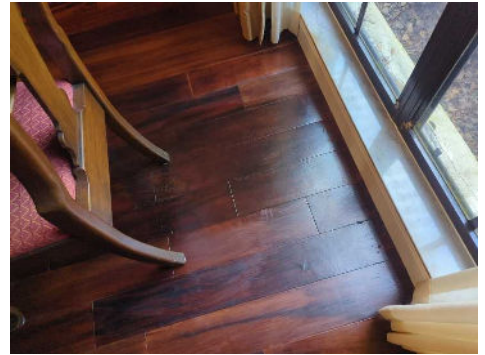
Flooring had visible moisture stains/damage. Stains/damage tested wet Unable to determine underlying condition at living and dining rooms.

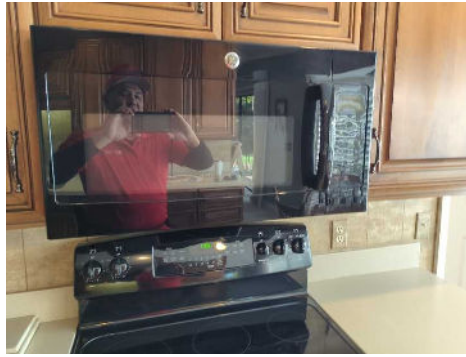
- Manufacturer: GE
- Microwave was near or exceeded the end of its useful life and may need replacement in the near future.

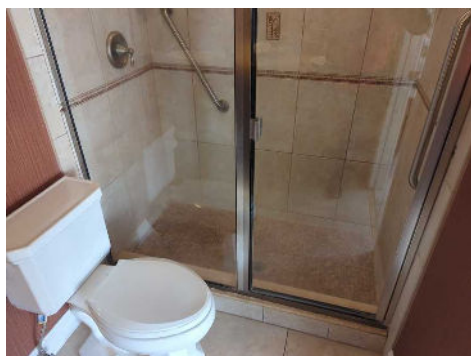
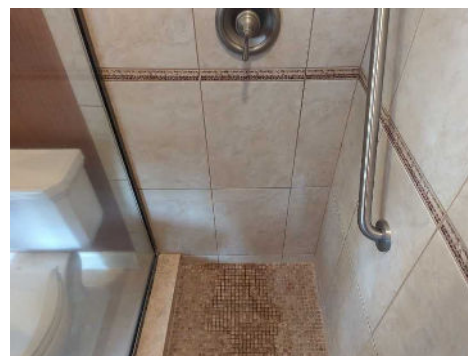
Water control valves were leaking at primary bathroom.

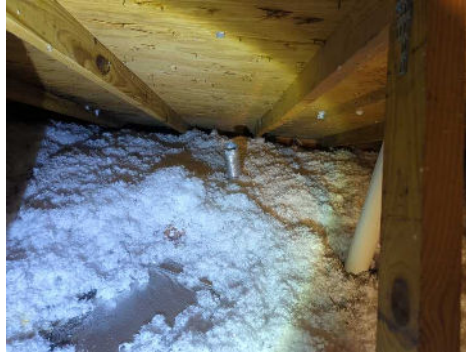
Exhaust fan(s) improperly vented into the attic at hallway bathroom.
