# WAYPOINT

## INSPECTIONREPORT

1234 Seller Street Tampa, FL 33619

Inspection Date: 1/20/2024

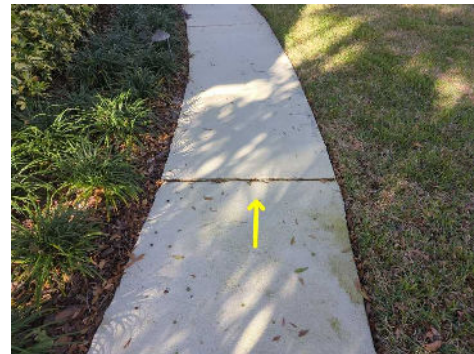
Walkway surface was uneven.

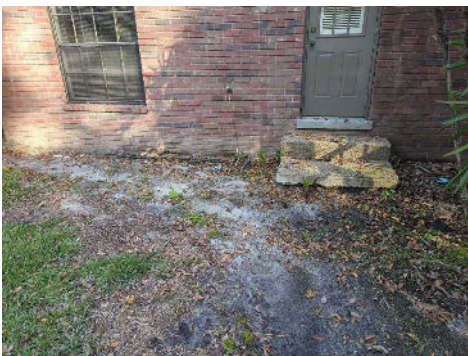
Visible signs of erosion were present. Suggest installing gutters for proper drainage.

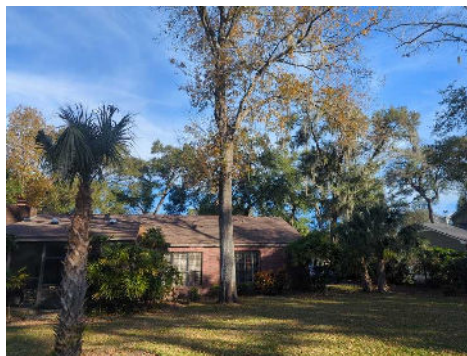
Vegetation/Shrubs/Trees appeared to be planted too close to foundation and structure of the house.

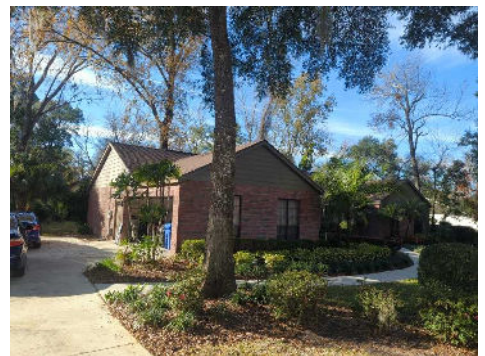
Vegetation/Shrubs/Trees appeared to be planted too close to foundation and structure of the house.

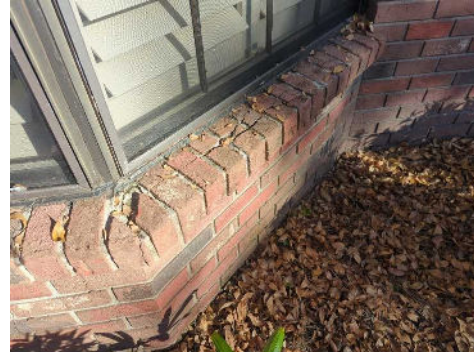
Settlement up to 1/8" cracks were visible at front.

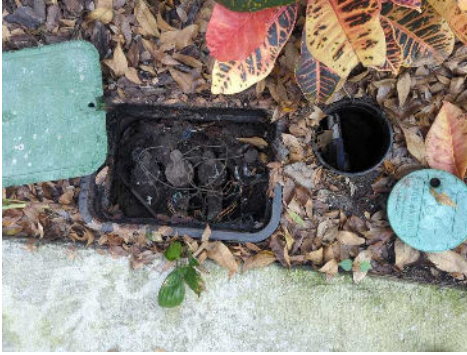
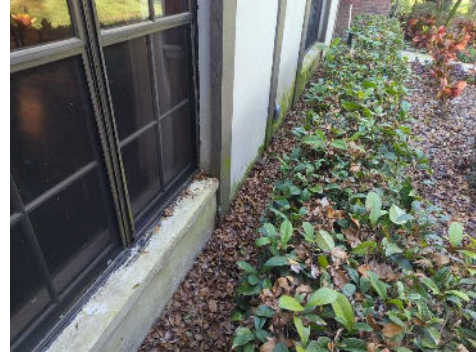
Based on water stains at the exterior walls  
sprinkler heads should be adjusted away from the  
home. Moisture damaged was visible at the  
interior flooring.

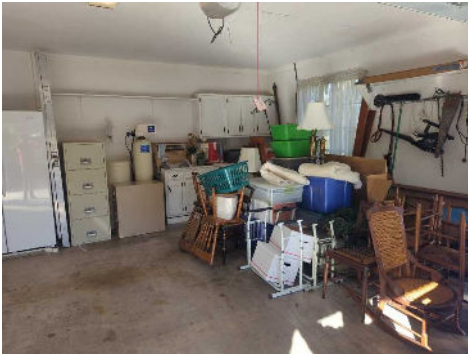
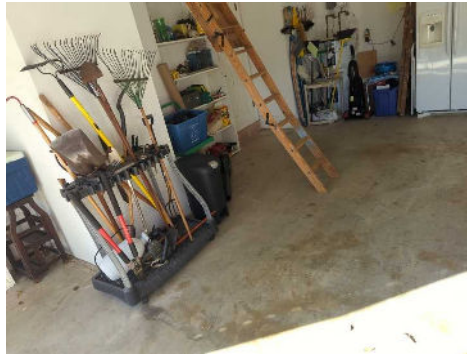
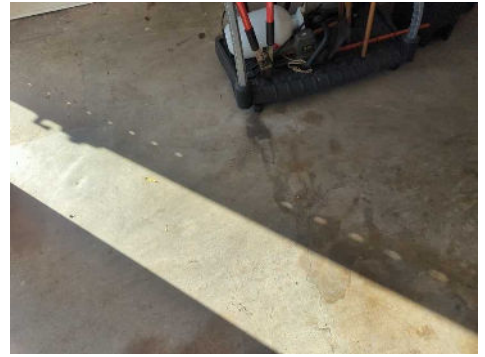
Settlement cracks were visible.

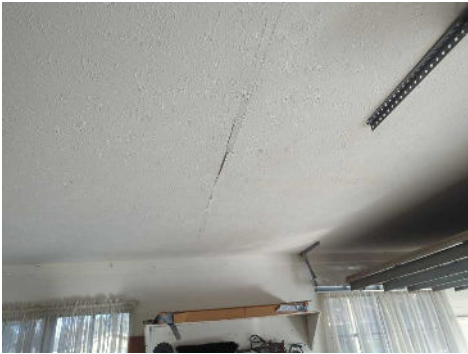
Settlement cracks up to 1/8 inch and/or ceiling seam separation was visible.

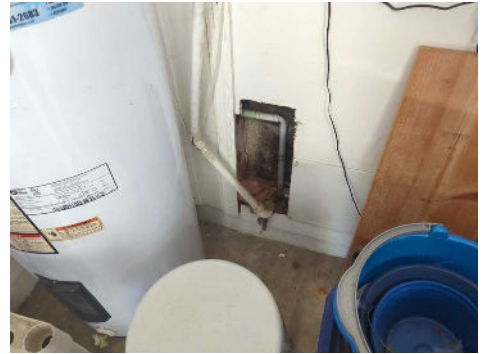
Damage was visible.

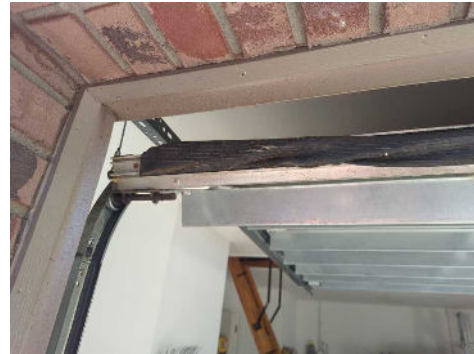
Weatherstripping was deteriorated/damaged and should be replaced.

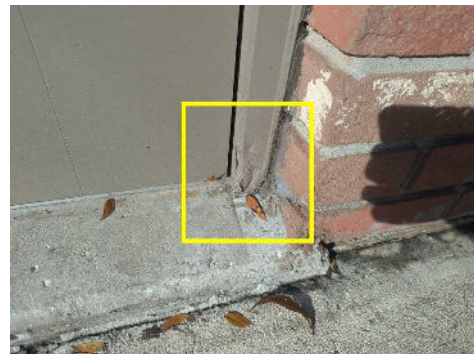
Moisture damage was visible at the door and/or door jamb.

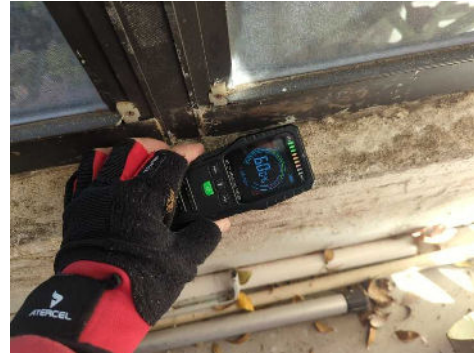
Visible moisture stain(s) indicated active leak(s) were present.

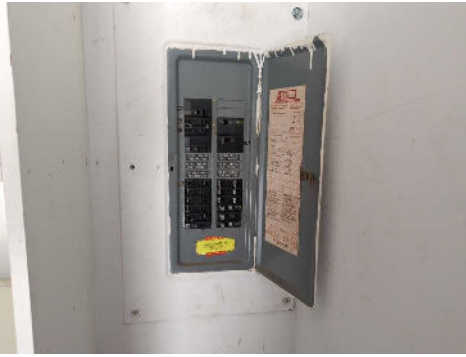
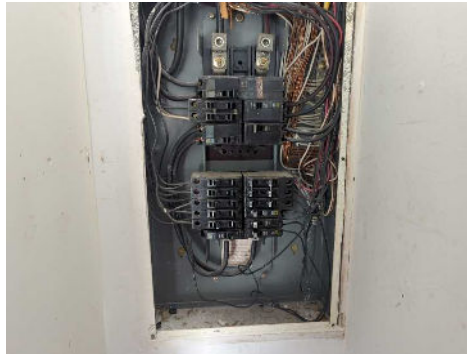
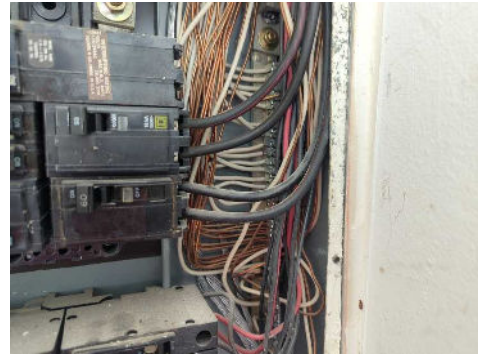
Fasteners were missing.

Fasteners were missing and improper.

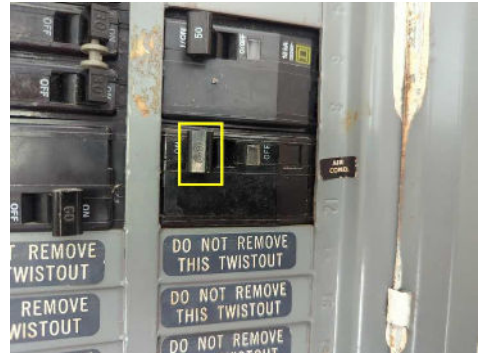
Breaker size at panel exceed the max rating (over fused) at the AC Condenser Unit

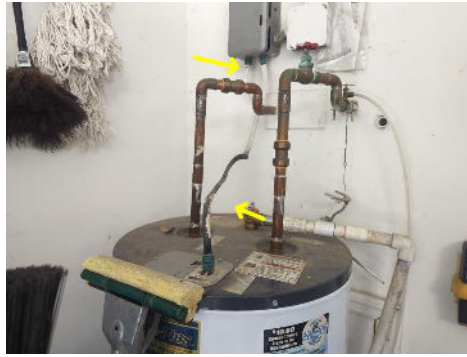
Wiring was exposed visible at water heater.

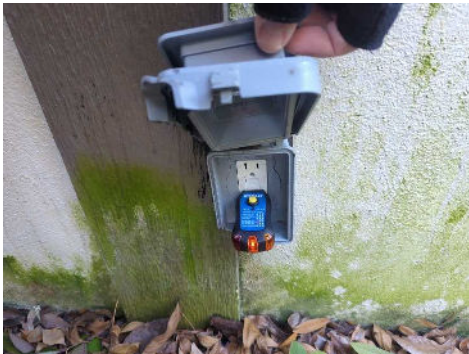
GFCI (Ground Fault Circuit Interrupter) outlet(s) tested as not grounded at exterior outlets.

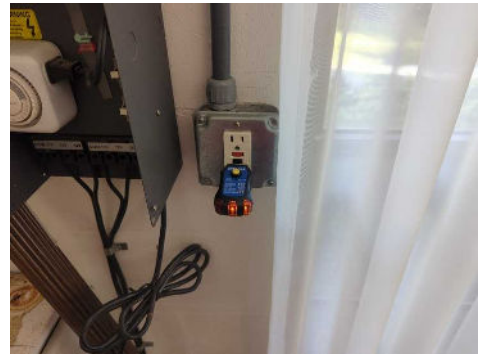
GFCI (Ground Fault Circuit Interrupter) outlet(s) was damaged at garage outlets.

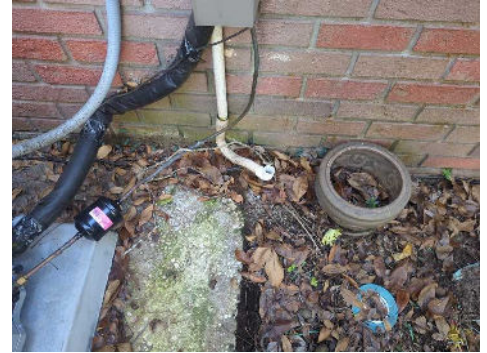
Condensate line should be routed away from foundation.

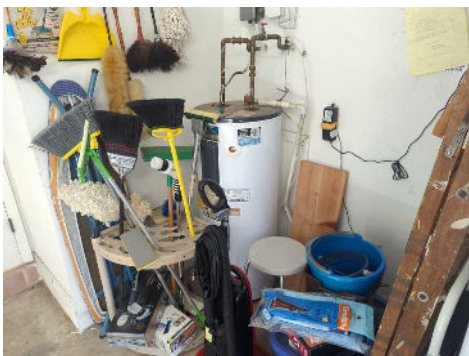
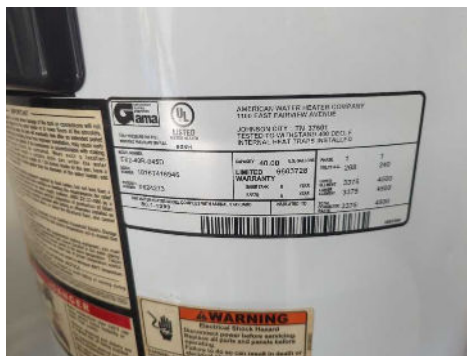
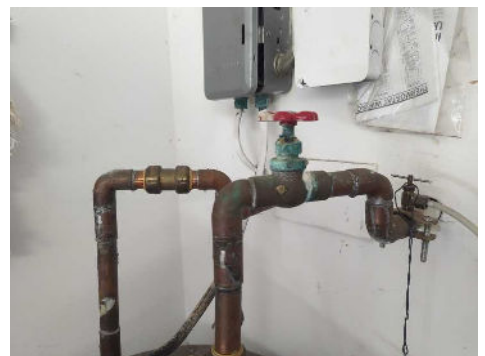
Corrosion was visible at the water heater.

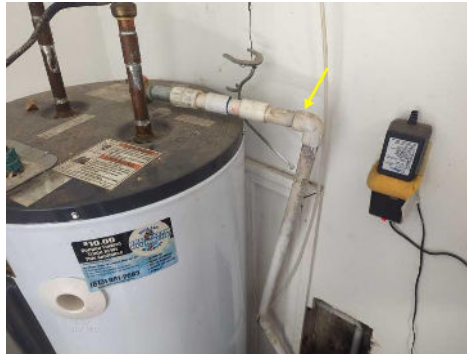
Temperature pressure relief valve (TPR Valve) piping was improper.

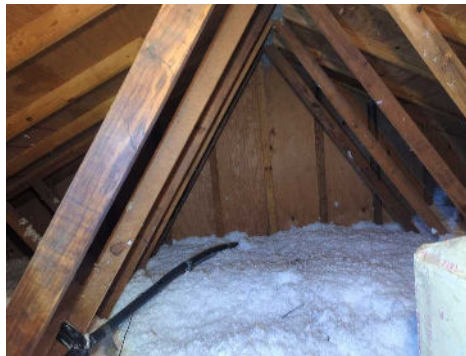
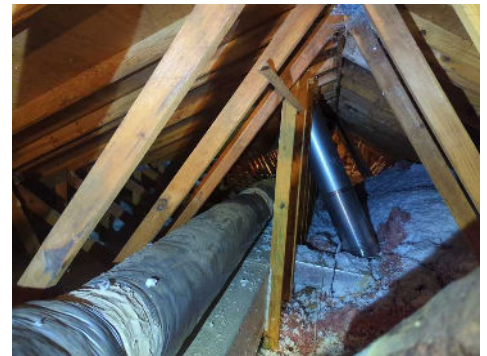
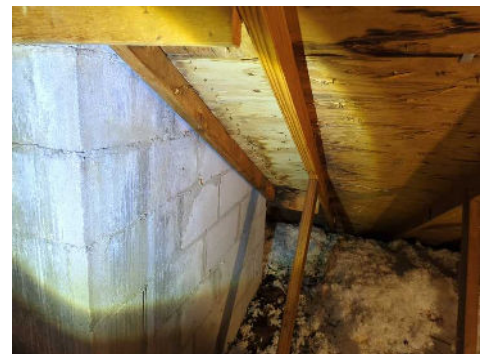
Insulation had been moved/disturbed, leaving low coverage areas.

Although dry at the time of the inspection, visible stain(s) indicated active leaks may be present. Unable to determine the underlying condition.

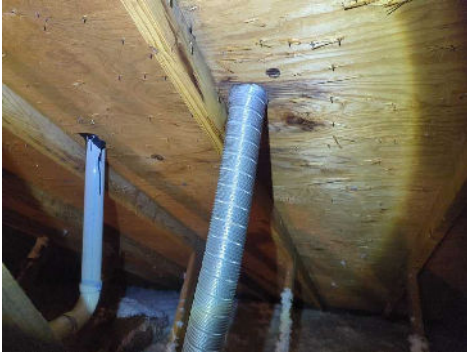
Although dry at the time of the inspection, visible stain(s) indicated active leaks may be present. Unable to determine the underlying condition.

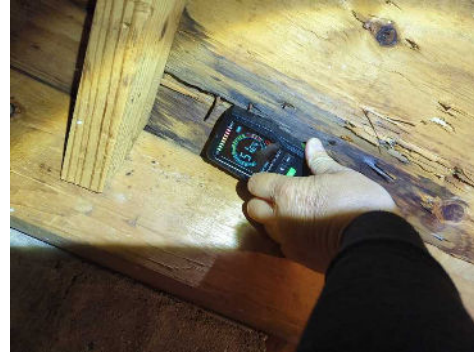
Moisture stain(s) were visible at the accessible areas of the attic. Stains tested wet at the time of inspection.

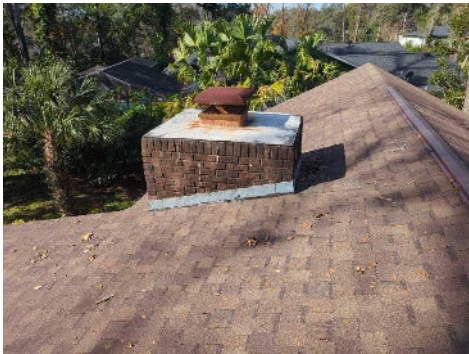
Rain cap was damaged.

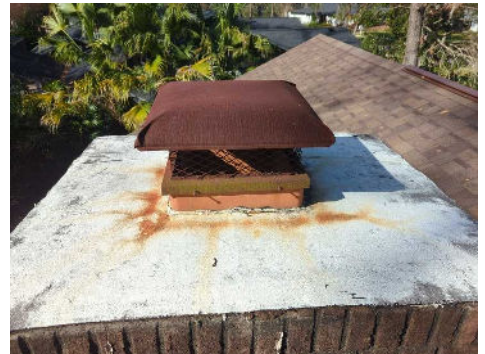
Spark screen was damaged/deteriorated.

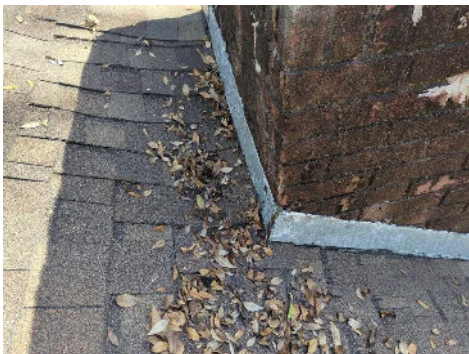
Flashing around chimney was damaged.

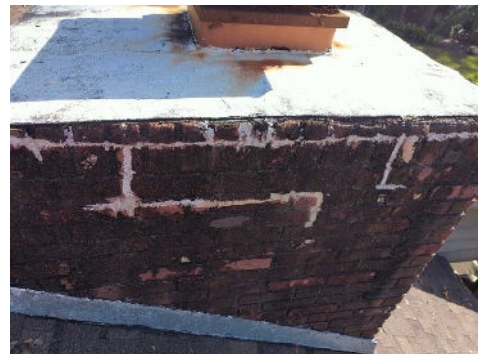
Brick/mortar at chimney was damaged.

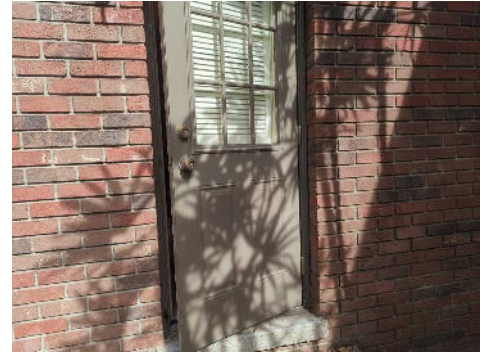
The secondary door(s) hardware was hard to operate.

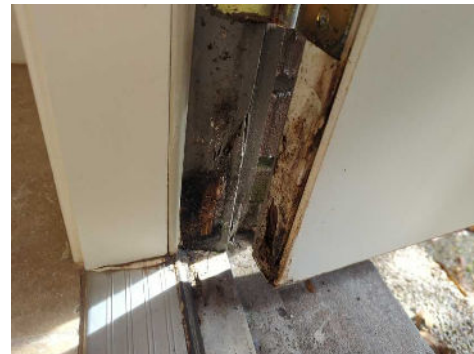
The secondary door(s) had visible moisture damage.

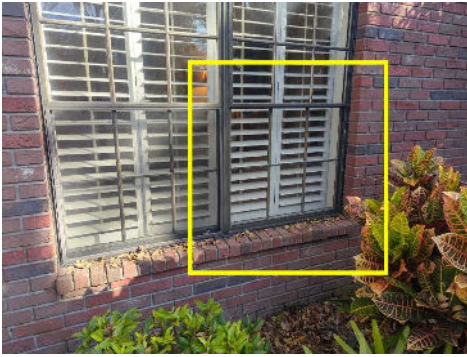
Screen(s) were missing/not installed.

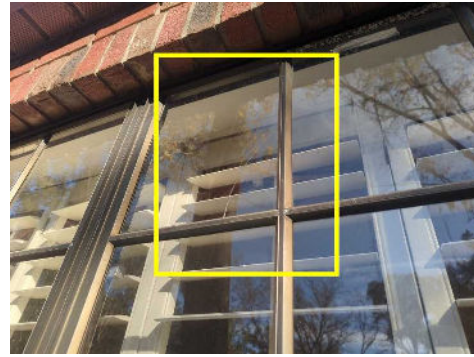
Cracked/damaged glass was present at primary bedroom.

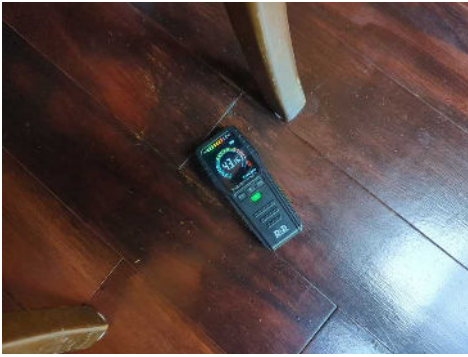
Flooring had visible moisture stains/damage. Stains/damage tested wet Unable to determine underlying condition at living and dining rooms.

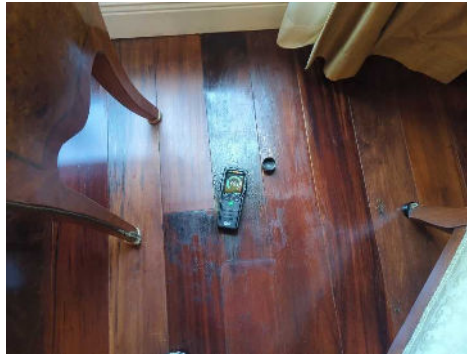
Flooring had visible moisture stains/damage. Stains/damage tested wet Unable to determine underlying condition at living and dining rooms.

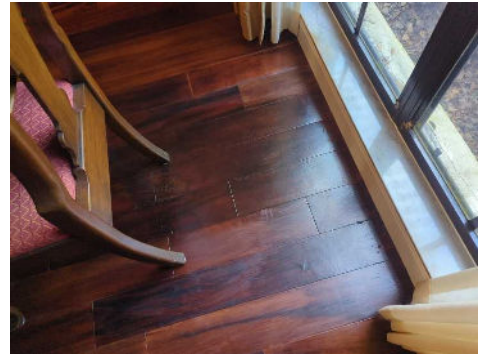
Flooring had visible moisture stains/damage. Stains/damage tested wet Unable to determine underlying condition at living and dining rooms.

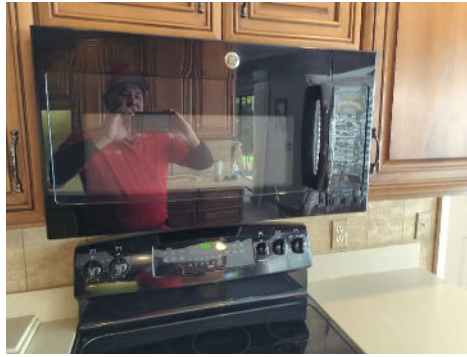
- Manufacturer: GE
- Microwave was near or exceeded the end of its useful life and may need replacement in the near future.

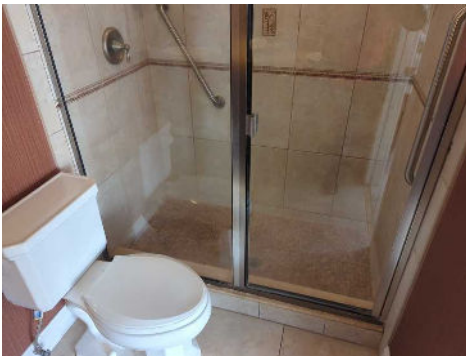
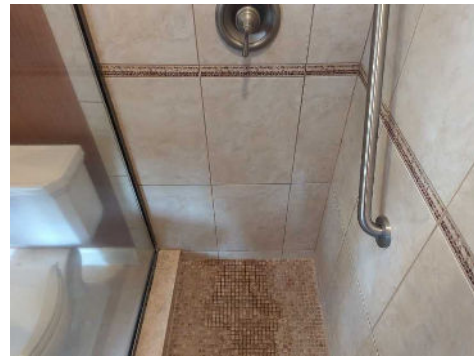
Water control valves were leaking at primary bathroom.

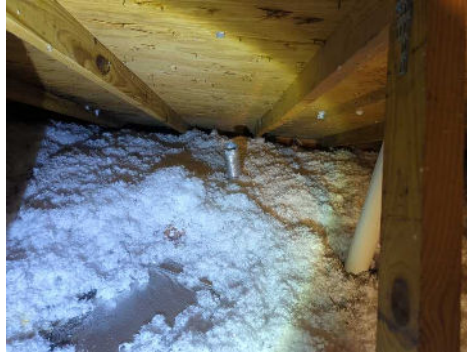
Exhaust fan(s) improperly vented into the attic at hallway bathroom.
