# NEW CONSTRUCTION PHASES

## PHASE 1: PRE-POUR INSPECTION

## PHASE 2: PRE-DRYWALL INSPECTION

## PHASE 3: FINAL INSPECTION

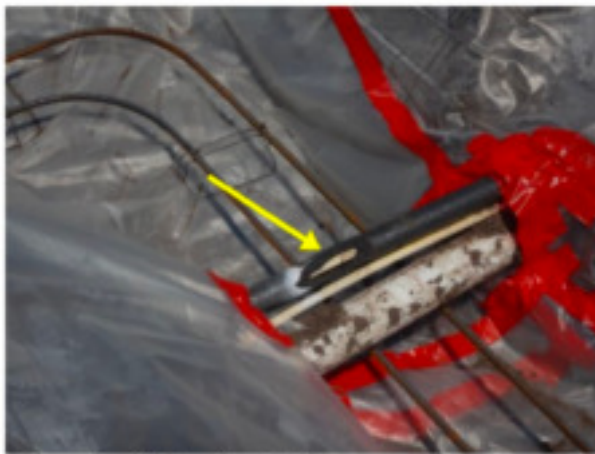
Supply piping insulation was damaged at utility room area.

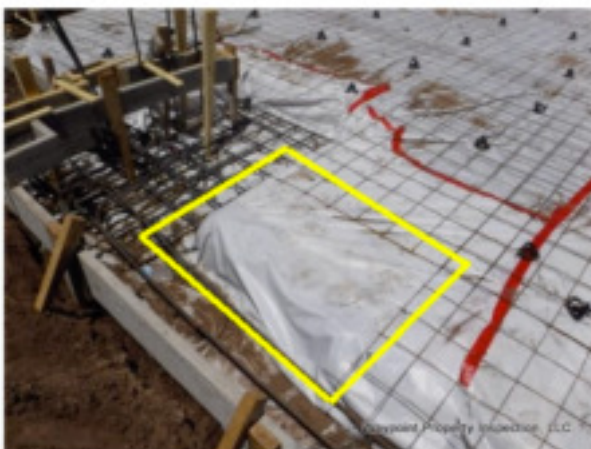
Structural concrete wire was missing near garage.

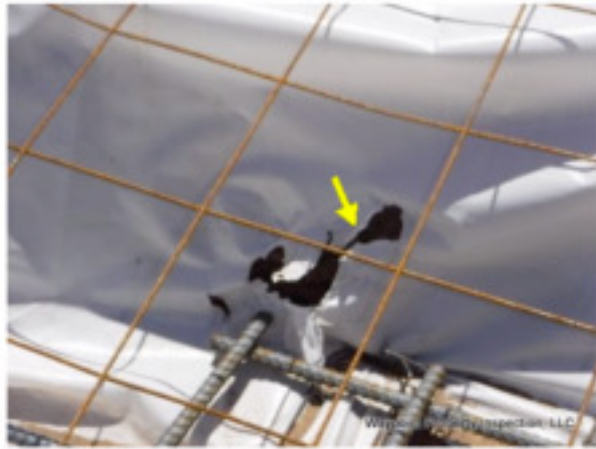
Minor holes were visible in visqueen vapor barrier.

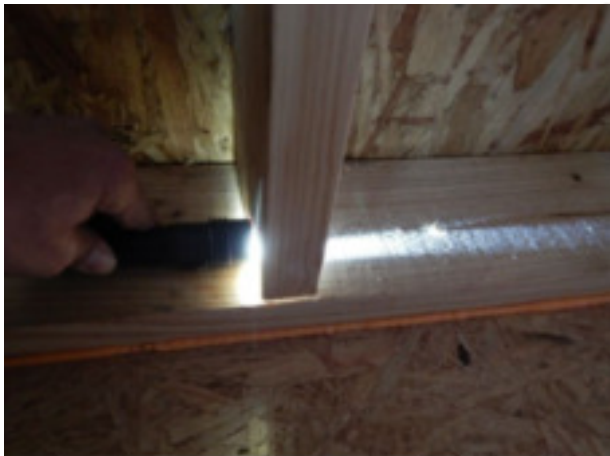
Framing was not properly installed at various areas.

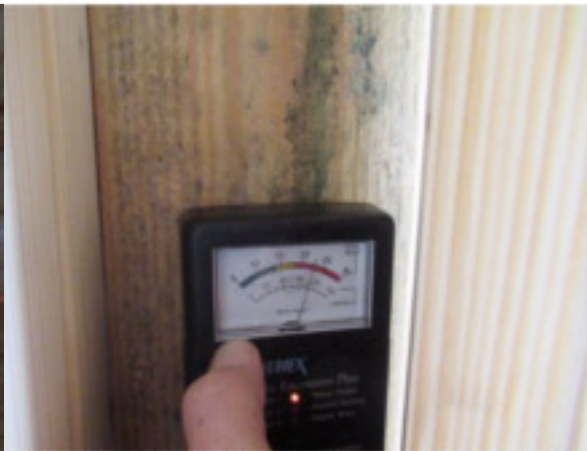
Moisture stains with microbial-like growth visible at several areas. Areas tested wet using a moisture meter.

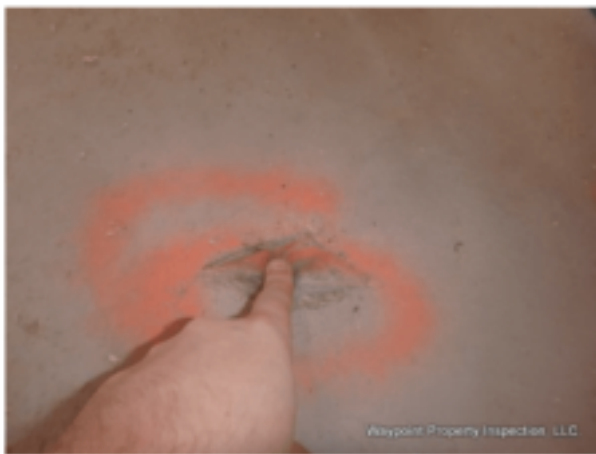
Exposed vapor barrier was present at kitchen in less than 1/4 inch of concrete.

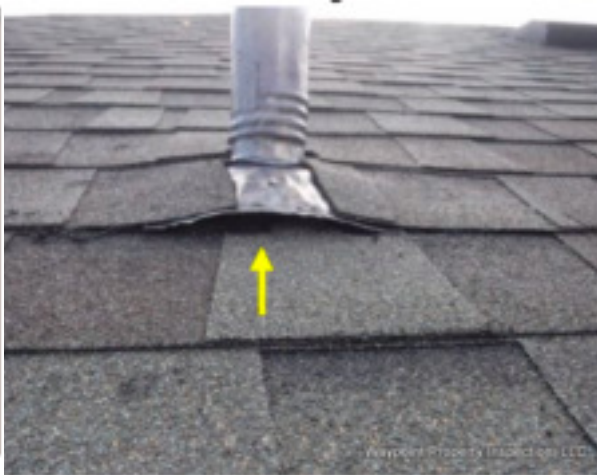
Loose roof covering was visible.

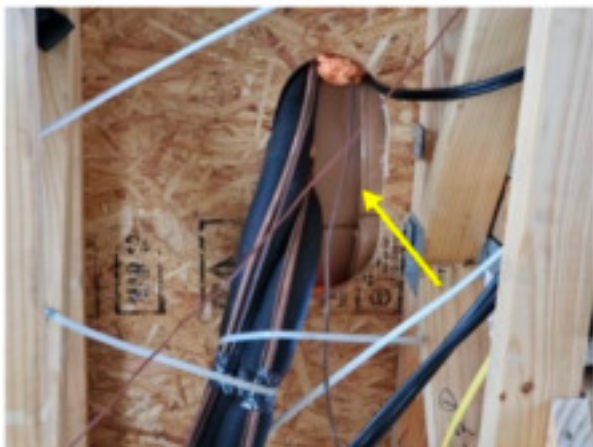
Cardboard was being used as a fire block.

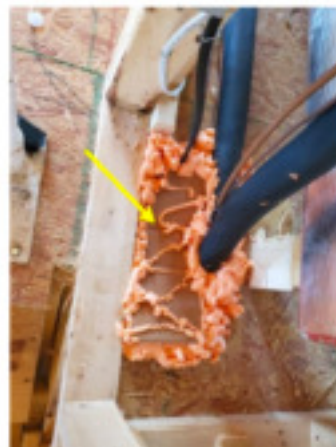
Cardboard was being used as a fire block.

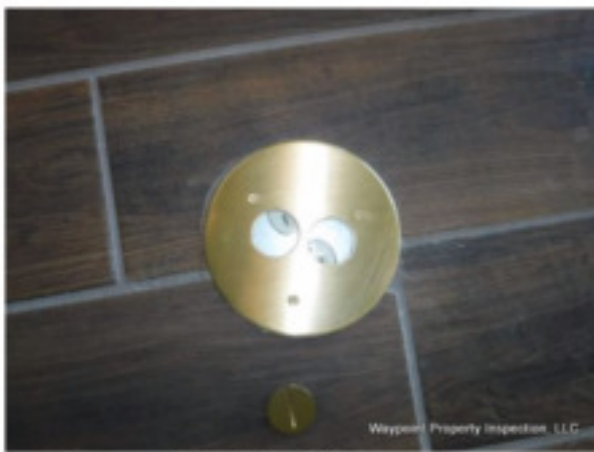
Cover plate at family room was not properly installed.

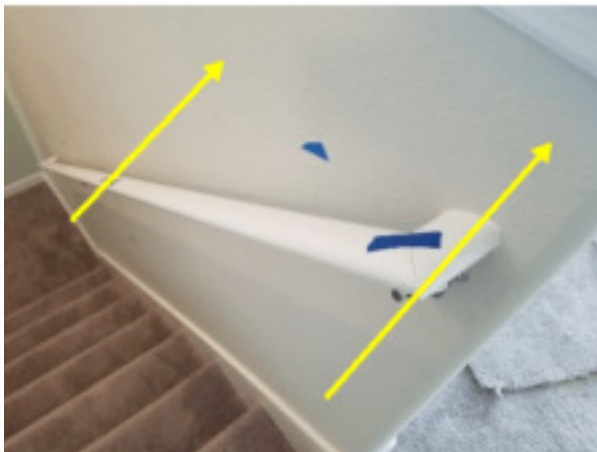
Top wall of staircase was loose.

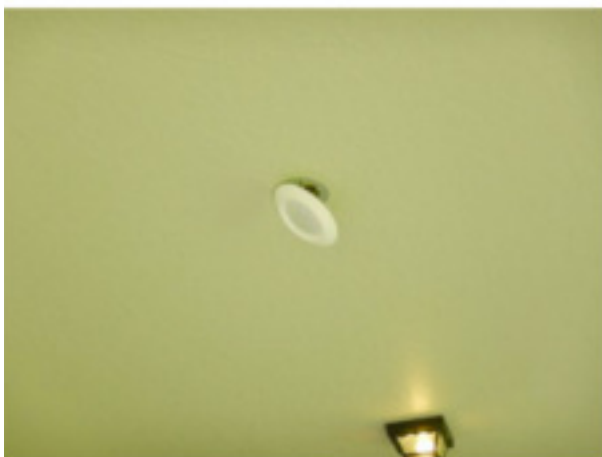
Light(s) were not properly secured at patio.

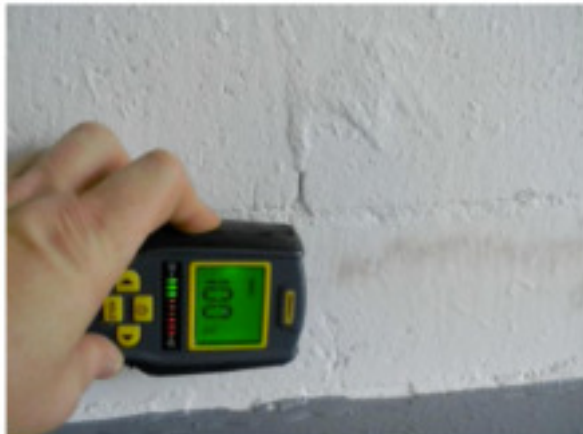
Moisture stains were visible. The stains tested wet using moisture meter.

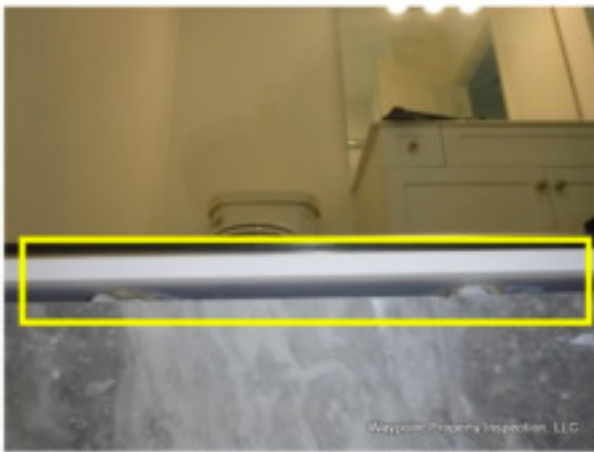
Grout was missing at En suite bathroom rear.

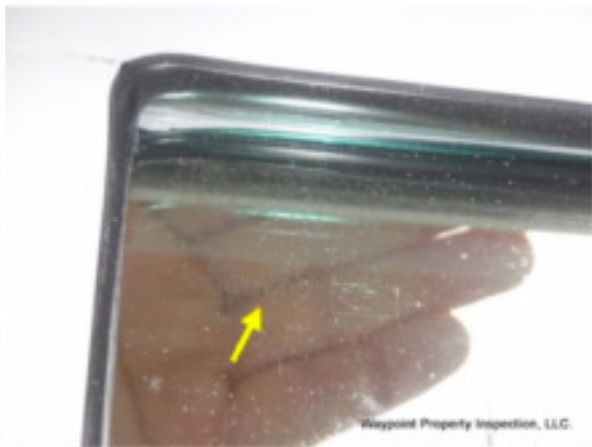
The sliding door(s) appeared to be installed upside down. Glass etching was reversed.

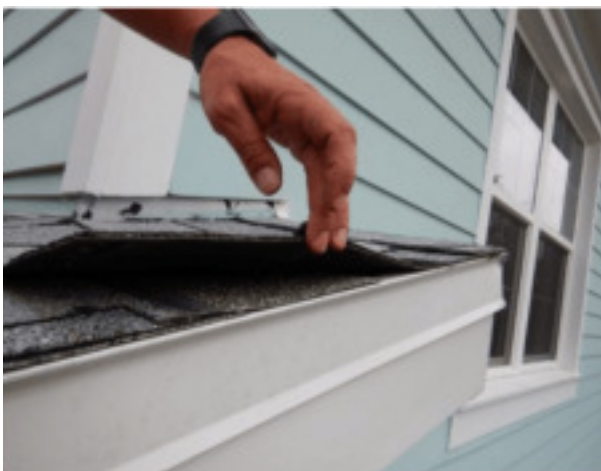
Loose shingles/covering were visible.

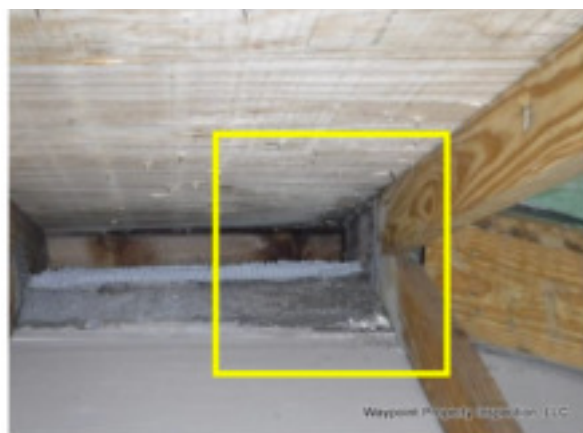
Moisture stain(s) were visible at the accessible areas of the garage attic. Stain was visible at garage ceiling.

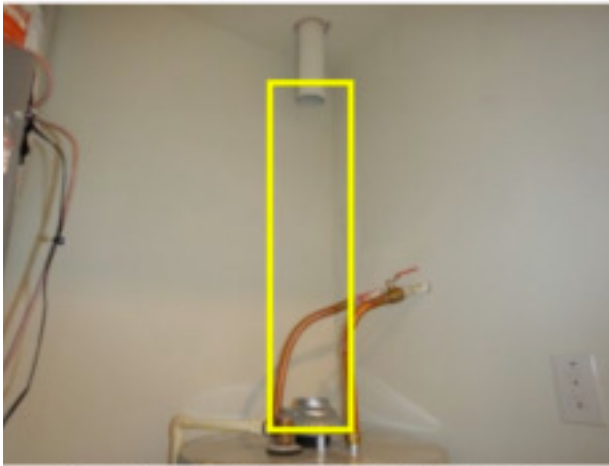
Vent flue piping was not installed.

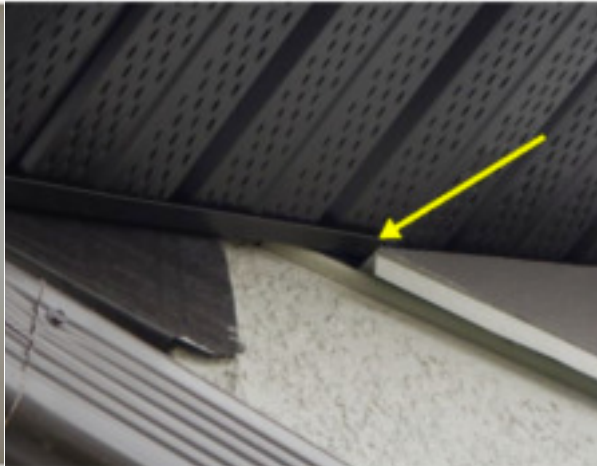
Trim pieces had visible gaps.

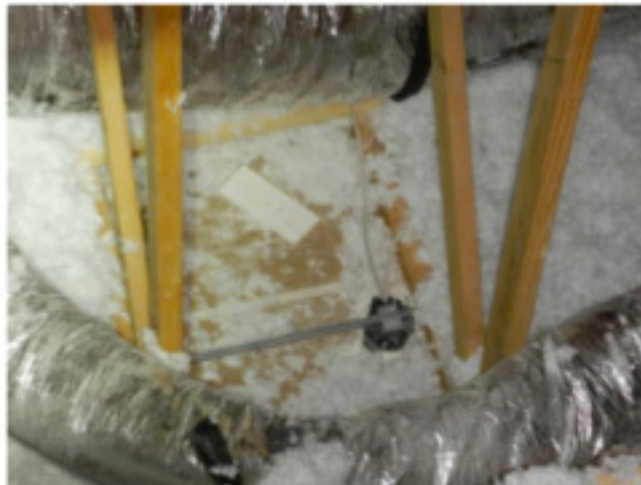
Insulation had been moved/disturbed, leaving low coverage areas.
