# Four Point Inspection Report

Inspector: David Vinas  
License #8427

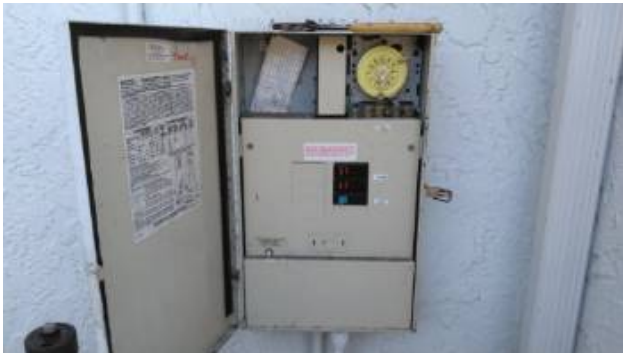
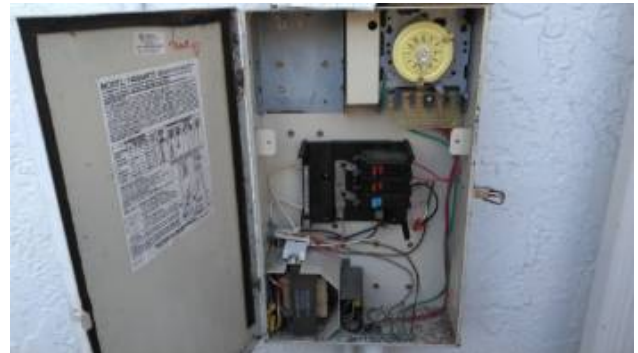
### 3. Sub-panel A Condition

Location: Pool equipment • Manufacturer: Cutler-Hammer

- Electrical panel was in good condition: Yes
- Age of Panel: original to home.

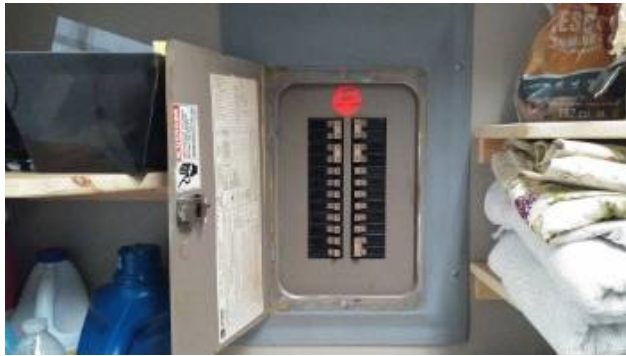
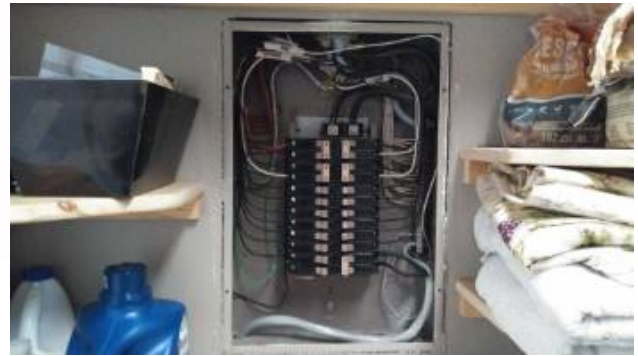
### 4. Sub-panel B Condition

Location: Interior utility room • Manufacturer: Cutler-Hammer

- Electrical panel was in good condition: Yes
- Age of Panel: 20 - 25 yrs.

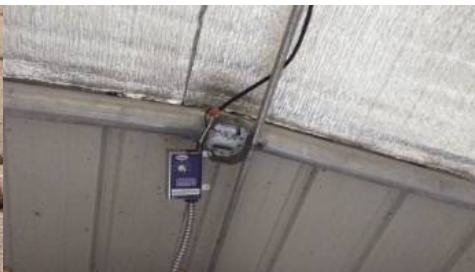
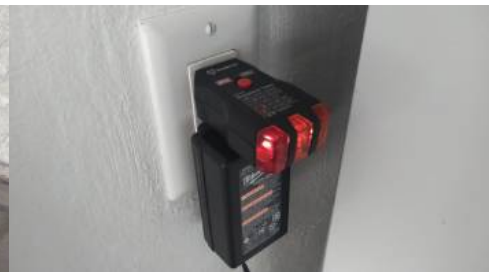
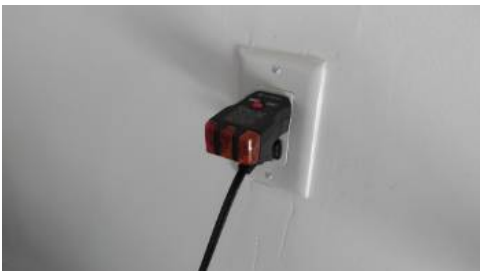
- Current occupants belongings and furnishings prevented accessing and testing all of the outlets and switches.
- Outlet(s) were not operational at the porch.
- Outlet(s) tested as having reverse polarity at garage.
- Outlet(s) tested not operational at garage.
- Exposed wiring was not properly protected at detached garage work shop.
- Extension cord was improperly used as hard/permanent wiring at garage.
- Outlet(s) tested not properly grounded at master bathroom.

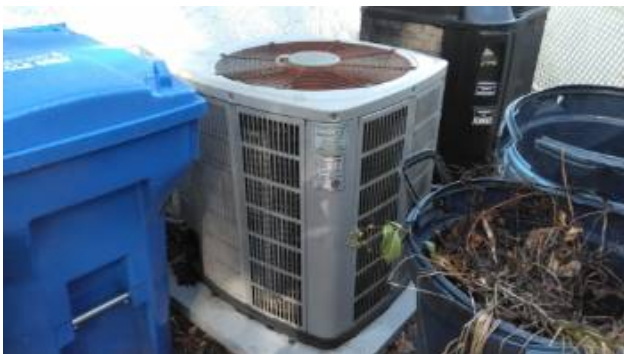
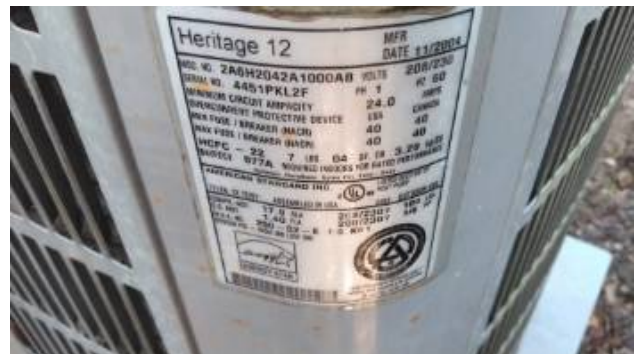
### 1. Cooling System 1

- Manufacturer: Heritage
- Age of unit: 2004
- Size in Tonnage: 3.5.
- Location: right side
- Air Conditioner

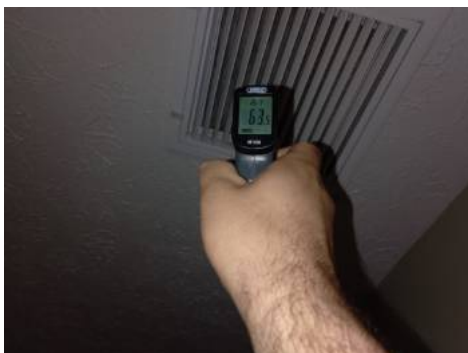
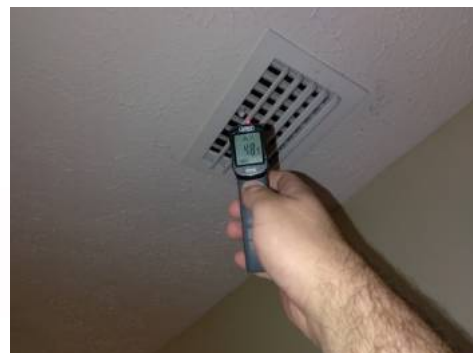
### 2. Cooling System 1 Condition

- Cooling system operated: Yes.

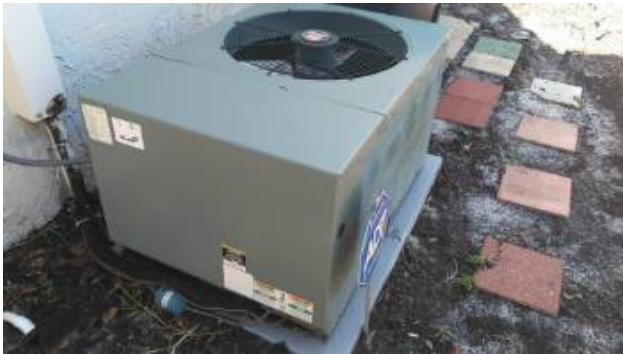
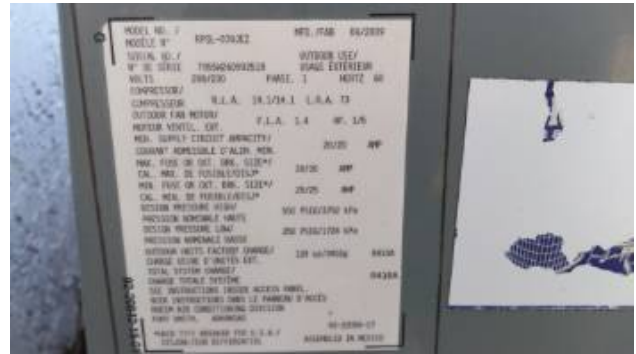
### 3. Cooling System 2

- Manufacturer: Rheem
- Age of unit: 2009
- Size in Tonnage: 2.5.
- Location: left side
- Air Conditioner

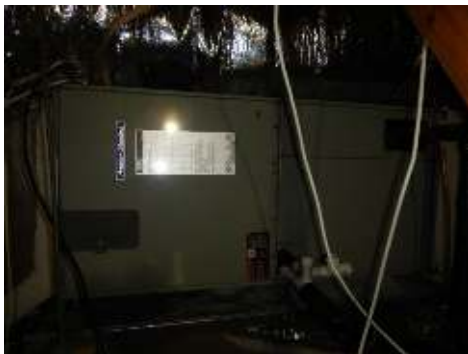
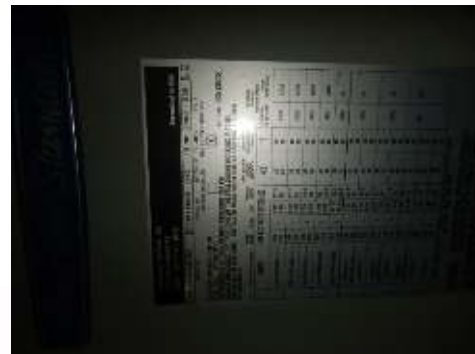
### 1. Heating System 1

- Manufacturer: American Standard
- Age of unit: 2005
- Size in Tonnage: 3.5.
- Electric Furnace
- Attic

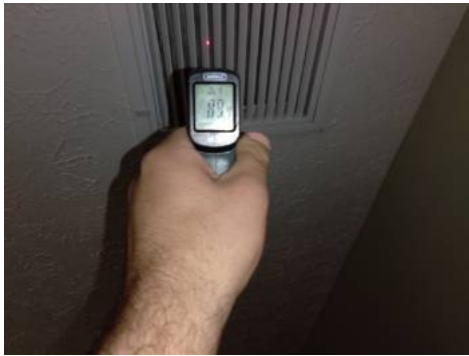
Return air temperature

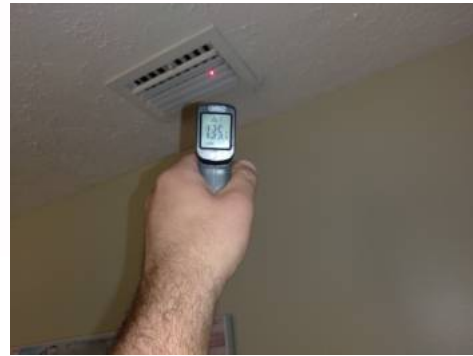
Supply air temperature

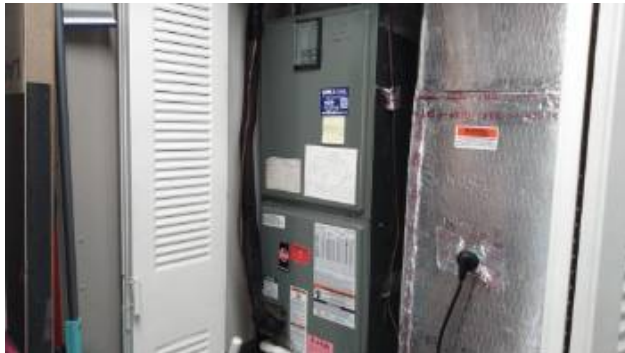
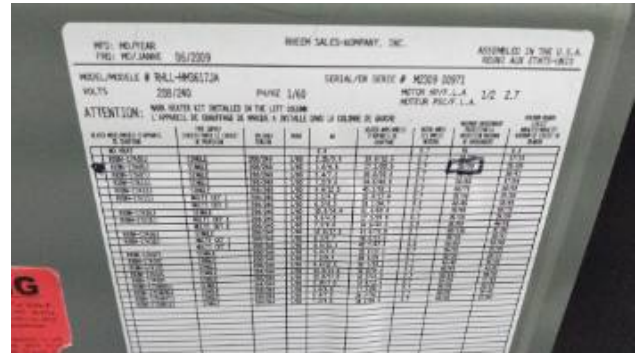
### 3. Heating System 2

- Manufacturer: Rheem
- Age of unit: 2009
- Size in Tonnage: 3.0.
- Electric Furnace
- Interior Closet

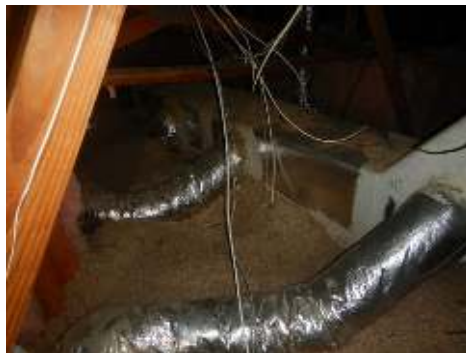
### 5. Distribution Condition

Type: Flexible and rigid insulated ducts • Ducts were not fully visible

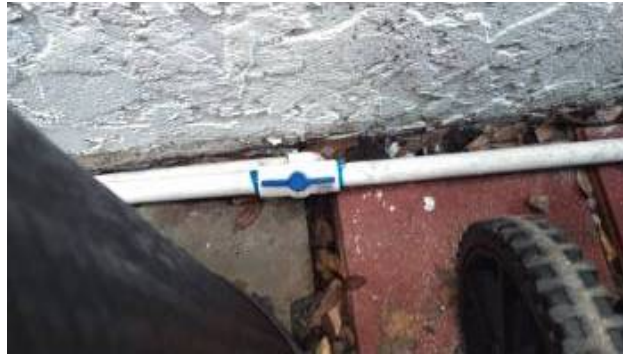
### 1. Main Line Condition

Location: Location: right side

Materials: PVC/CPVC piping

- Visible main line was in good condition: Yes
- Age of main line: 1 - 5 yrs.

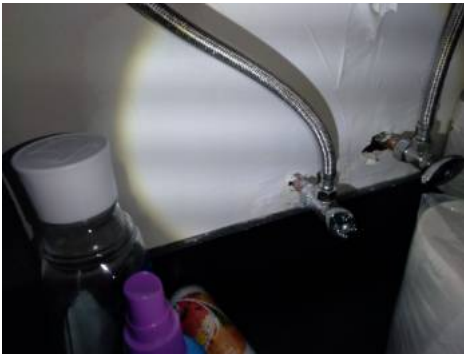
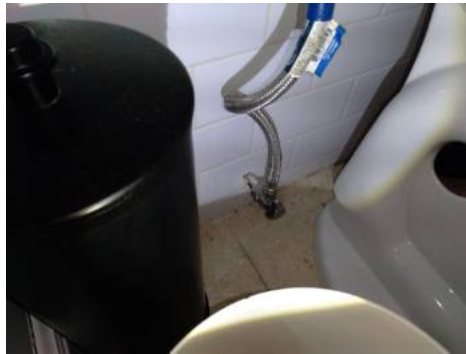
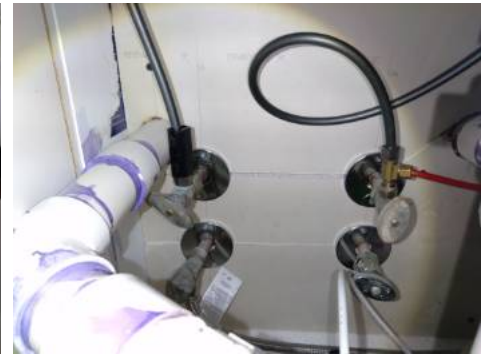
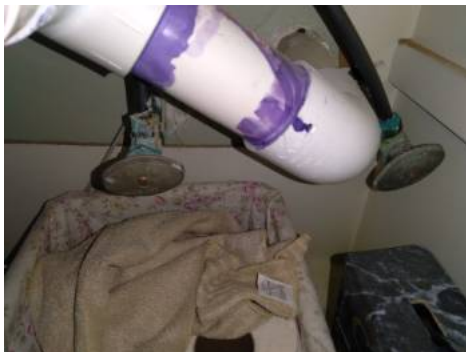
### 2. Supply Lines Condition

Materials: PVC/CPVC piping • Copper piping • Galvanized piping • Supply piping was partially replumbed.

- Visible supply piping were in good condition: Yes
- Age of supply lines: 1 - 5 yrs.

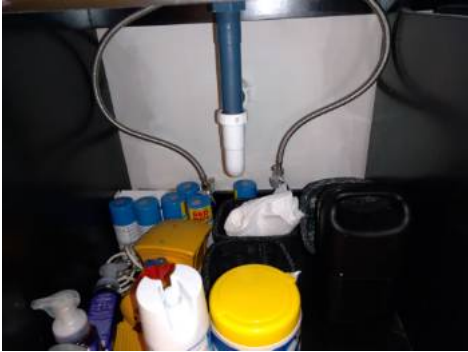
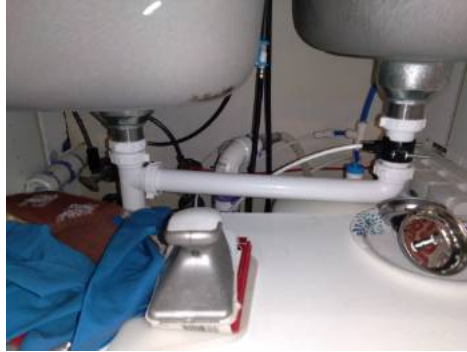
### 3. Drain/Waste/Vent Lines Condition

Materials: PVC/CPVC piping

- Visible drain lines were in good condition: Yes
- Age of drain lines: original to home.
- Traps were improper/not present at master bathroom.

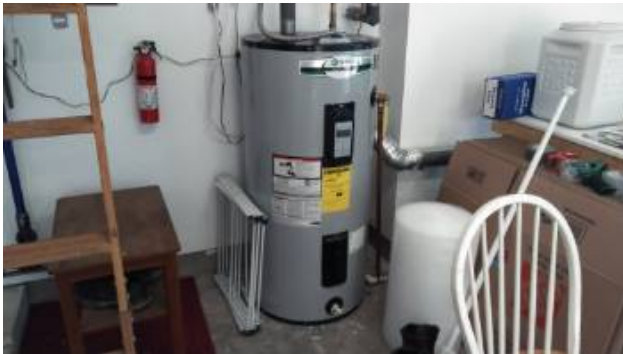
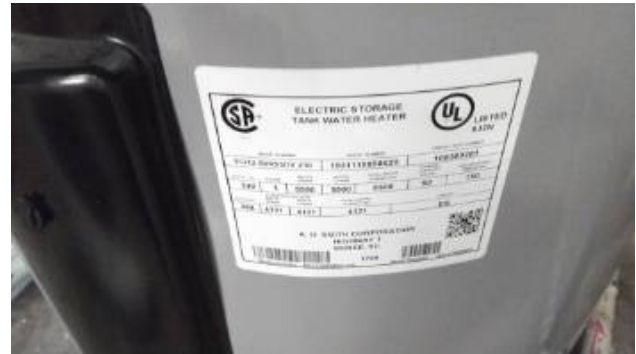
### 4. Water Heater 1

- Manufacturer: A.O. Smith
- Age of unit: 2019
- Water heater type: electric
- Size of water heater: 50 Gallons.
- Garage

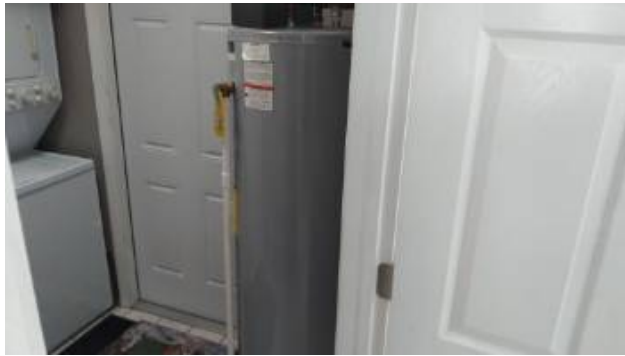
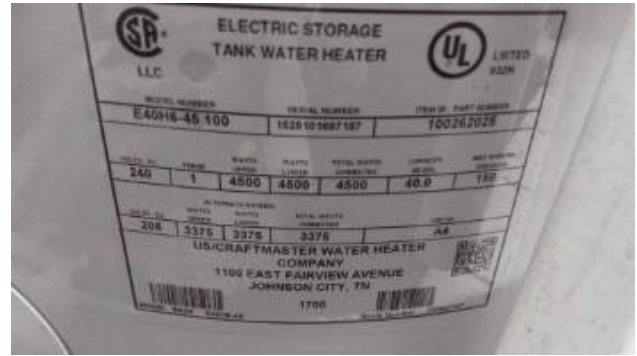
### 6. Water Heater 2

- Manufacturer: Whirlpool
- Age of unit: 2015
- Water heater type: electric
- Size of water heater: 40 Gallons.
- Interior closet

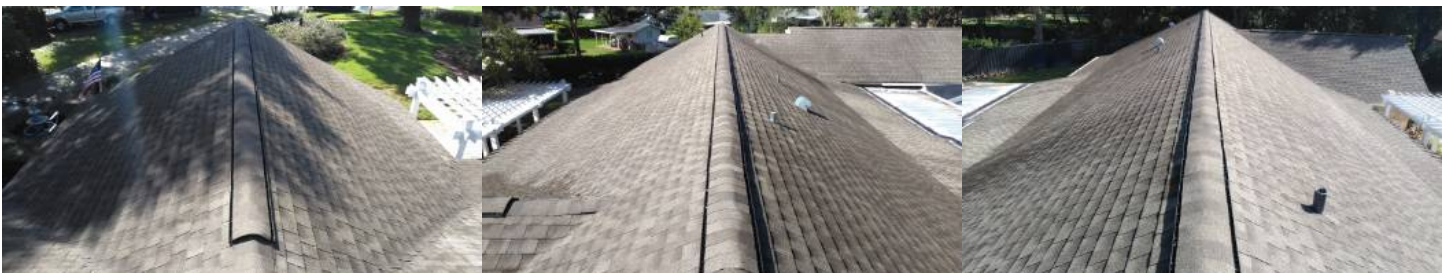
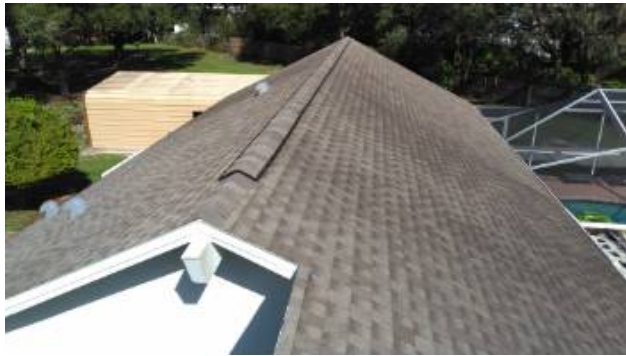
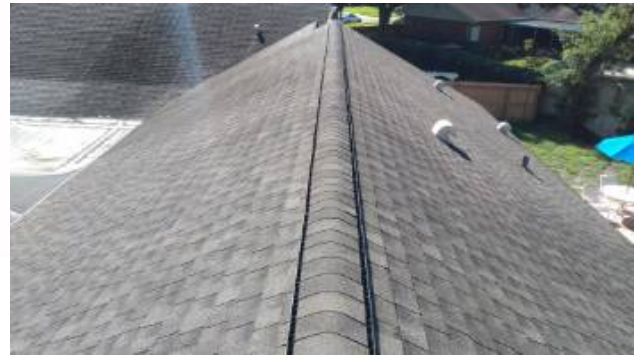
### 1. Main Roof Condition

Shape: Gable style

Materials: Asphalt architectural shingle

- Estimated age of the roof covering: 6 - 8 yrs.
- Estimated remaining life of the roof covering: 14 yrs.

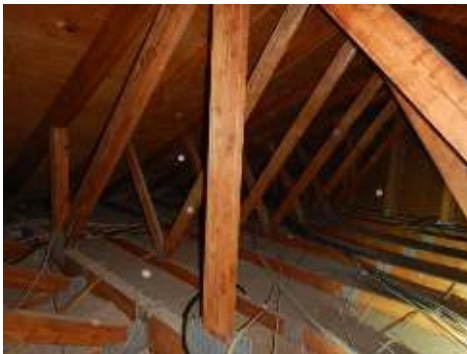
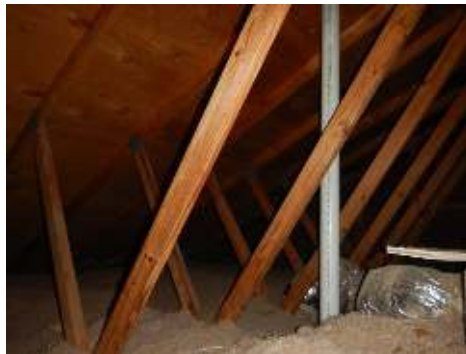
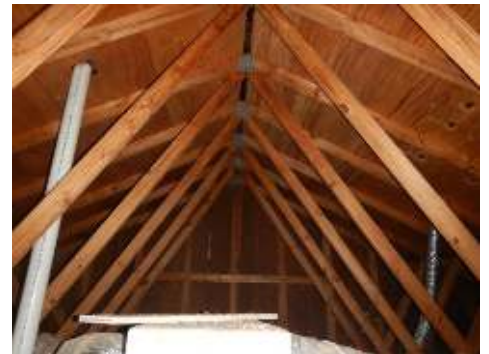
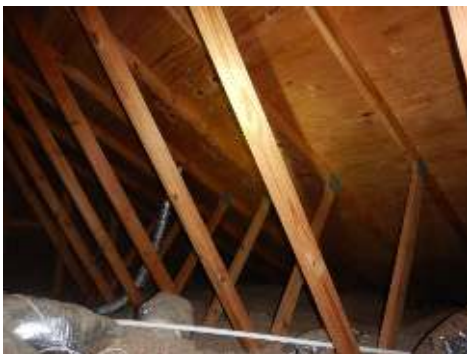
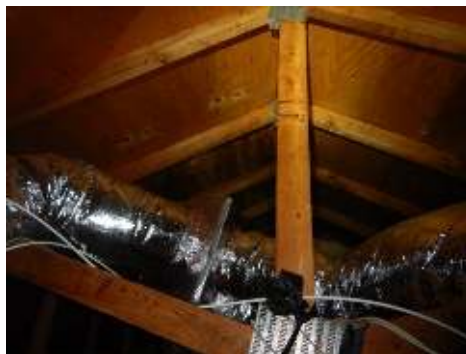
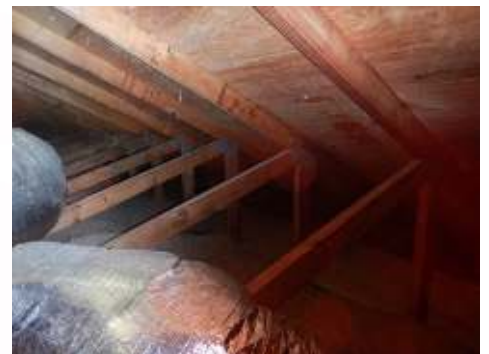
## 3. Attic Condition

Materials: Roof engineered trusses • Roof framing: 2x4 • Roof framing: 2x6 • Ceiling framing: 2x4 • Blanket/batt fiberglass insulation • Recycled material insulation
