# WAYPOINT

## INSPECTIONREPORT

1234 Easy Street Tampa, FL 33619

**4-Point Inspection Form**Insured/Applicant Name: James Smith Application / Policy #: \_\_\_\_\_Address Inspected: 1234 Easy StreetActual Year Built: 1998 Date Inspected: XXXXXX**Minimum Photo Requirements:**

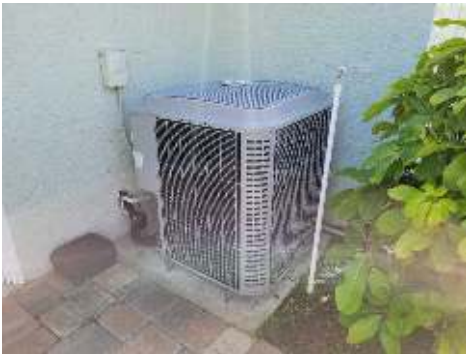
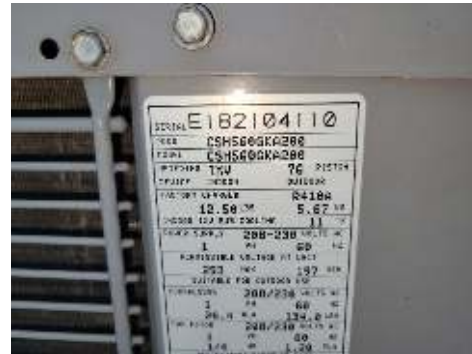
## 1. Cooling System 1

- Location: left side
- Manufacturer: International Comfort Products
- Age of unit: 2018
- Size in Tonnage: 5.0
- Heat Pump

- Cooling system operated: Yes.

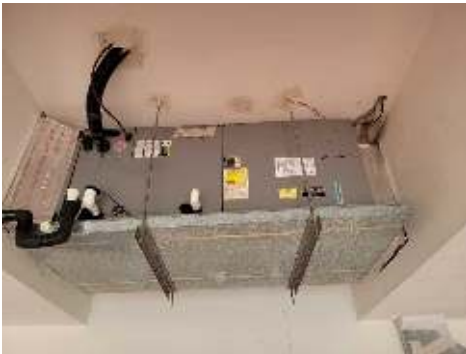
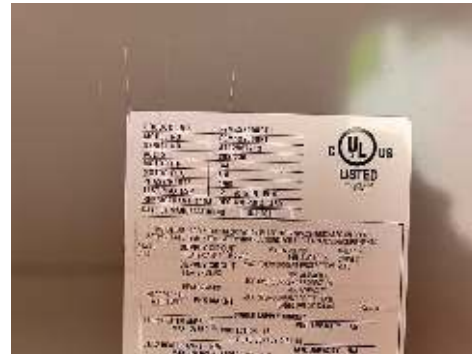
## 2. Heating System 1 Condition

- Location: garage
- Manufacturer: Comfortmakers
- Age of unit: 2011
- Size in Tonnage: 5.0
- Electric Furnace

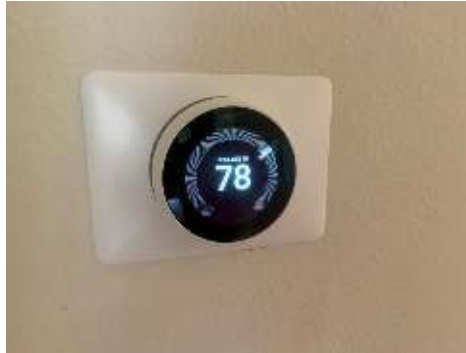
## 4. Thermostat(s) Condition

Location: Hallway

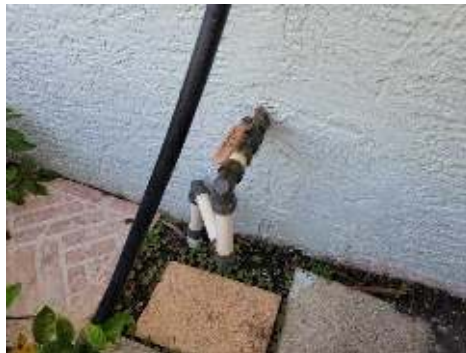
- Visible main line was in good condition: Yes
- Age of main line: original to home

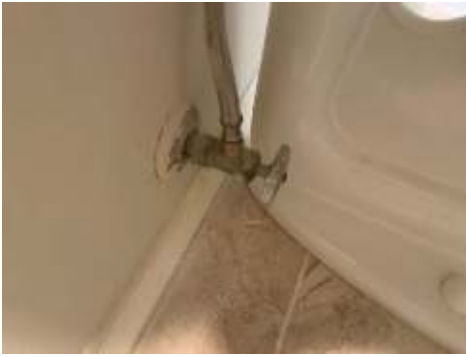
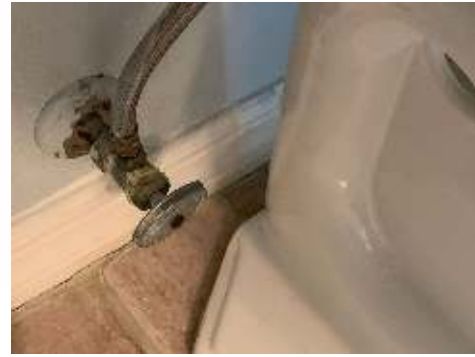
### 2. Supply Lines Condition

Materials: Copper piping • Supply piping was original.

- Visible supply piping were in good condition: Yes
- Age of supply lines: original to home

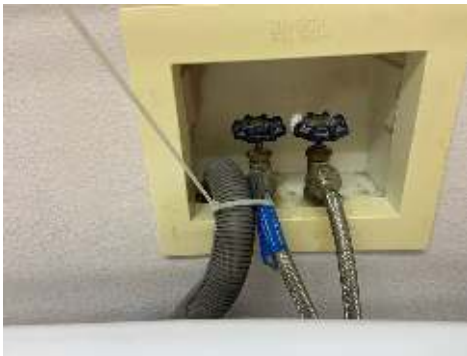
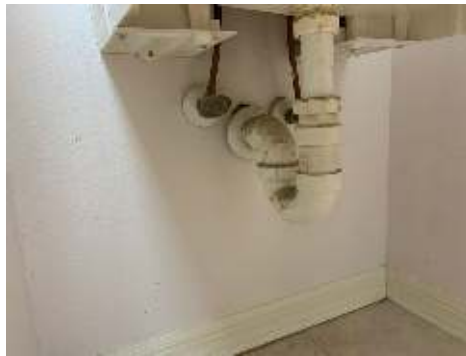
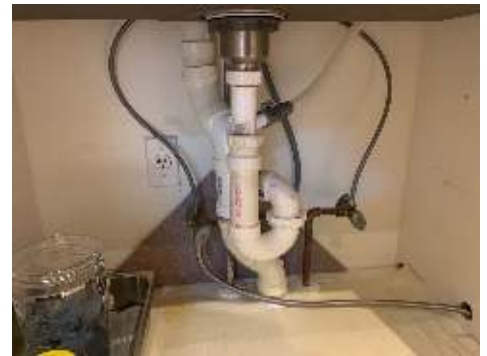
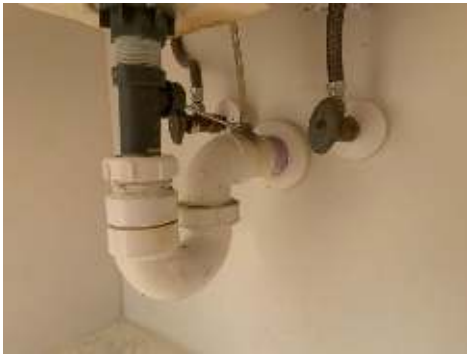
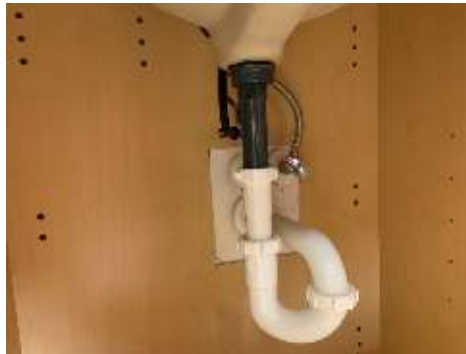
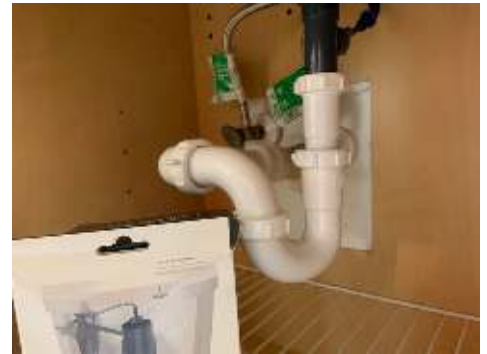
### 3. Drain/Waste/Vent Lines Condition

Materials: PVC/CPVC piping

- Visible drain lines were in good condition: Yes
- Age of drain lines: original to home
