INSPECTION REPORT

0000 New Home Ct

Plant City, FL

Pre-Drywall Phase Inspection Description

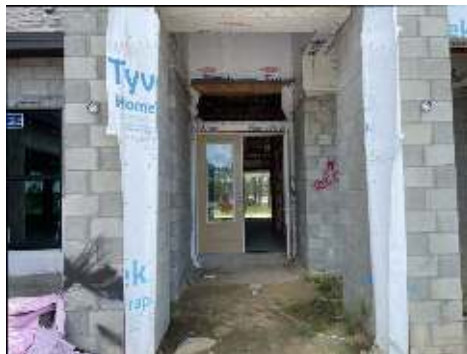
3. Porch

- Porch appeared to be in serviceable condition.
- Porch cover framing appeared to be in serviceable condition.

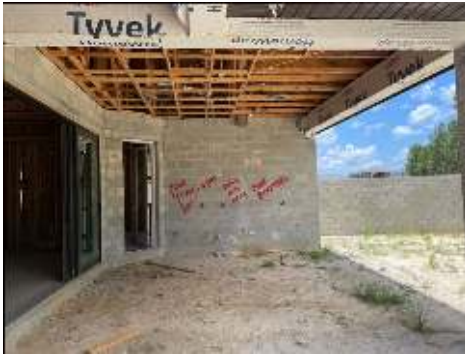
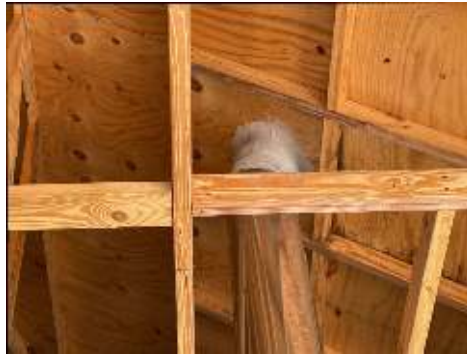
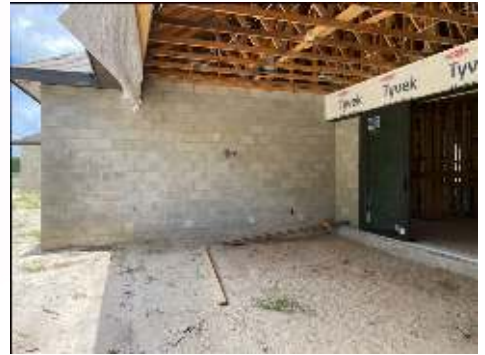
4. Patio

- Patio appears to be in serviceable condition.
- Patio surface was not installed.

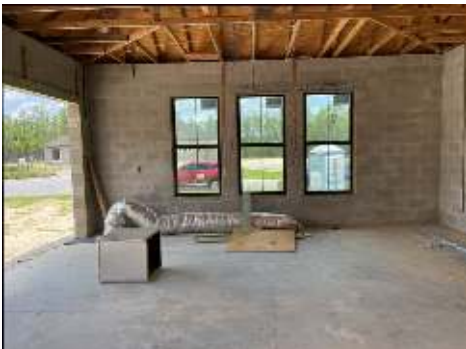
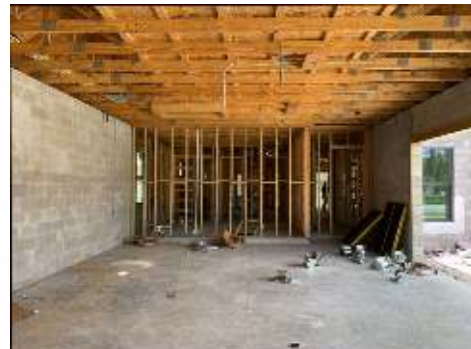
1. Observations

- Exterior garage walls appeared to be properly constructed.
- Garage structure was in serviceable condition.

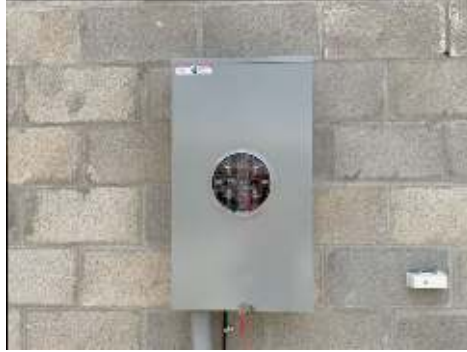
- Panel box appeared to be in serviceable condition.
- Panel box cover appeared to be in serviceable condition.

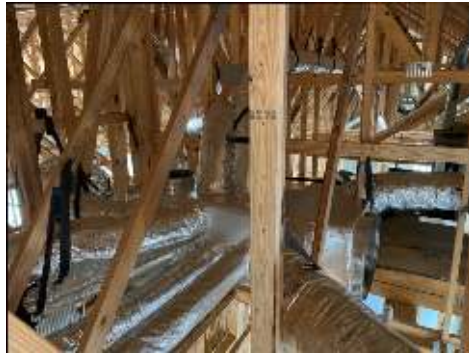
3. Heating System 2

Heating system 1 and 2 were in the process of being installed.

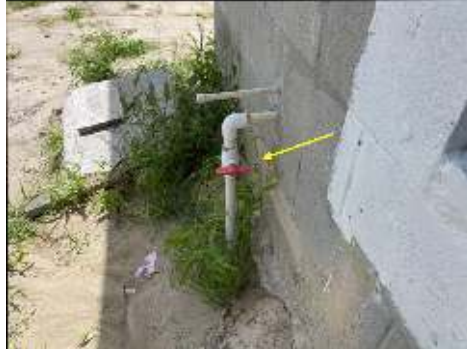
- Main water line appeared to be in serviceable condition.

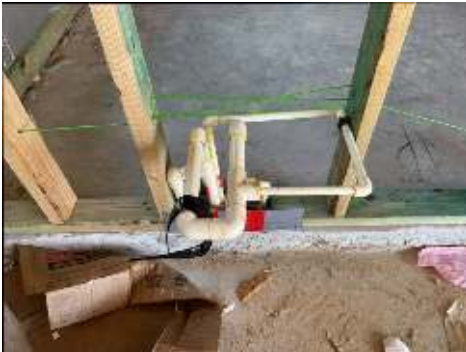
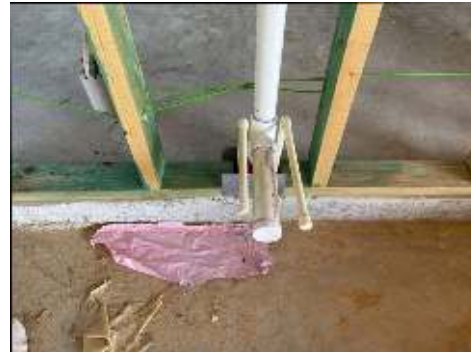
2. Supply Lines

- Supply piping appeared to be in serviceable condition.

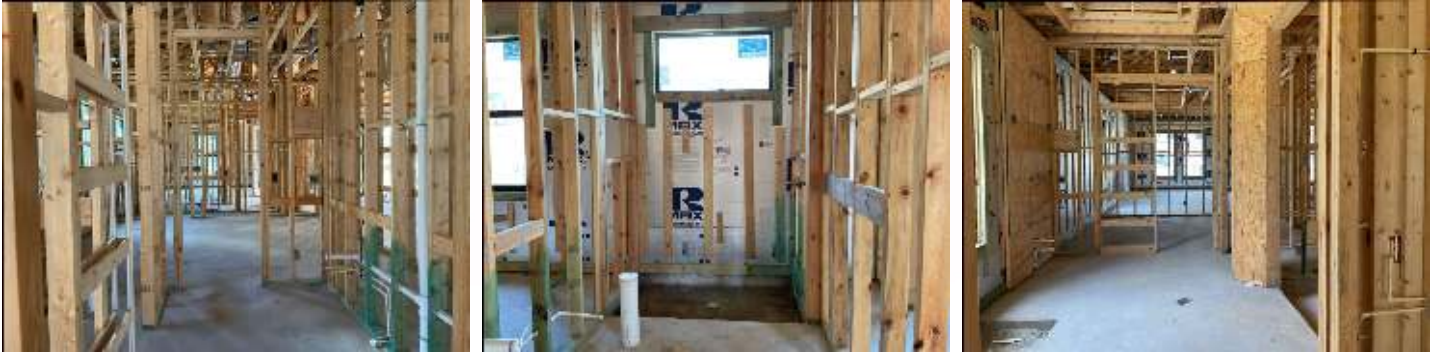
- Master bathroom.
- Bathroom #2
- Bathroom #3

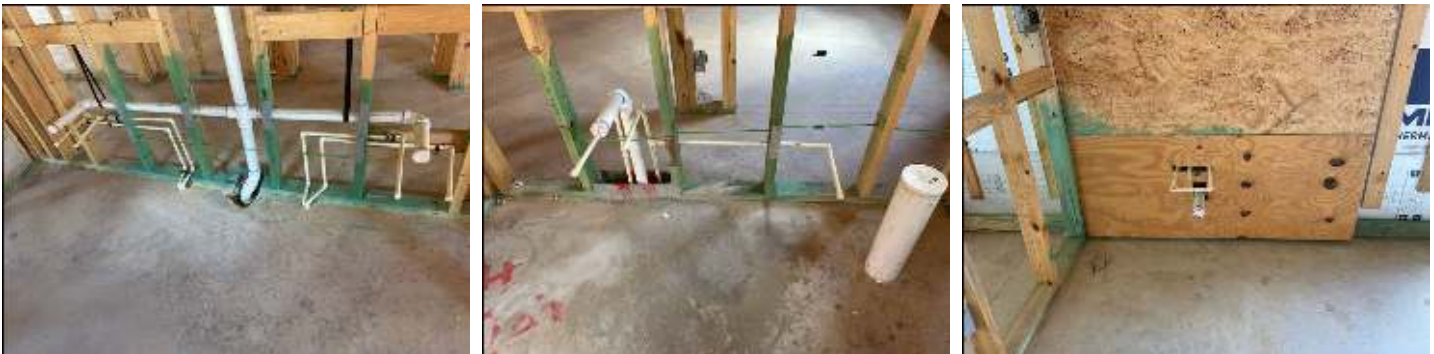
2. Sink Condition

- Sink supply plumbing appeared to be in serviceable condition.
- Sink drain plumbing appeared to be in serviceable condition.

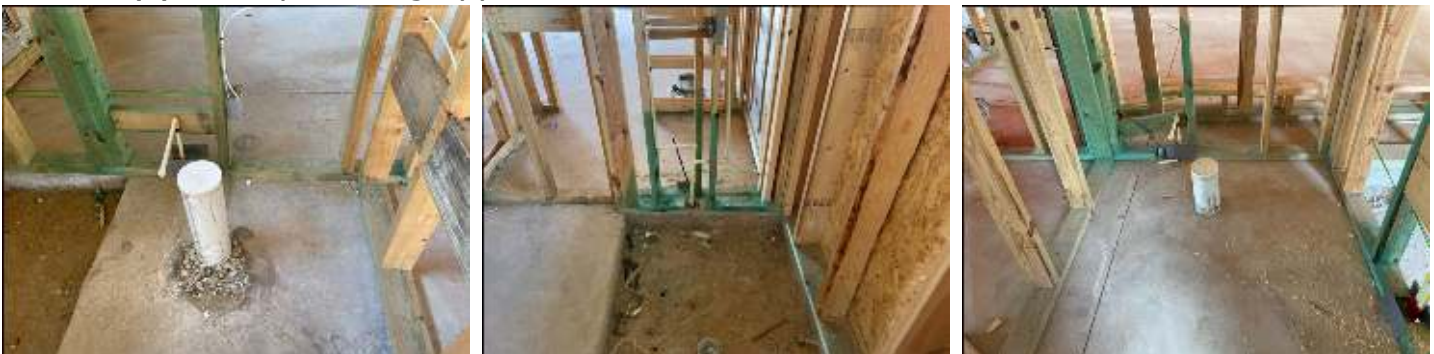
3. Toilet Condition

- Toilet(s) supply plumbing appeared to be in serviceable condition.
- Toilet(s) drain plumbing appeared to be in serviceable condition.

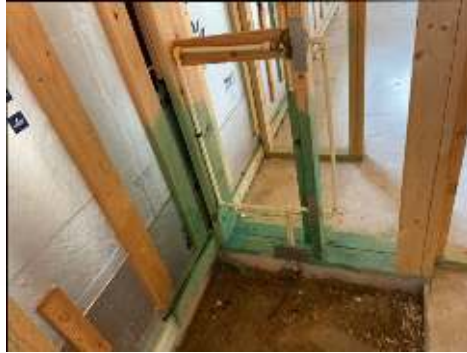
4. Bathtub Condition

- Bathtub(s) appeared to be in serviceable condition.
- Bathtub supply plumbing appears to be in serviceable condition.
- Bathtub drain plumbing appears to be in serviceable condition.

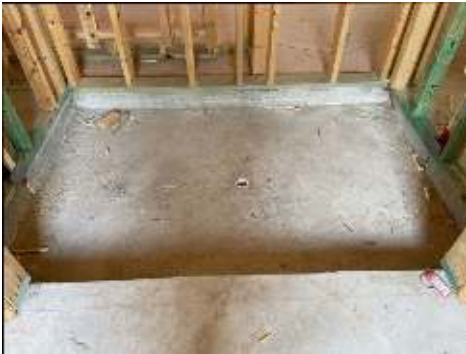
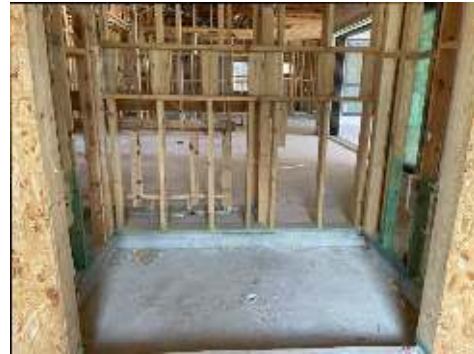
5. Shower Condition

- Shower(s) appeared to be in serviceable condition.
- Shower(s) supply plumbing appeared to be in serviceable condition.
- Shower(s) drain plumbing appeared to be in serviceable condition.
