Inspection Date: 6/9/2022

# INSPECTIONREPORT

00000 New Home St St. Pete, FL 33616

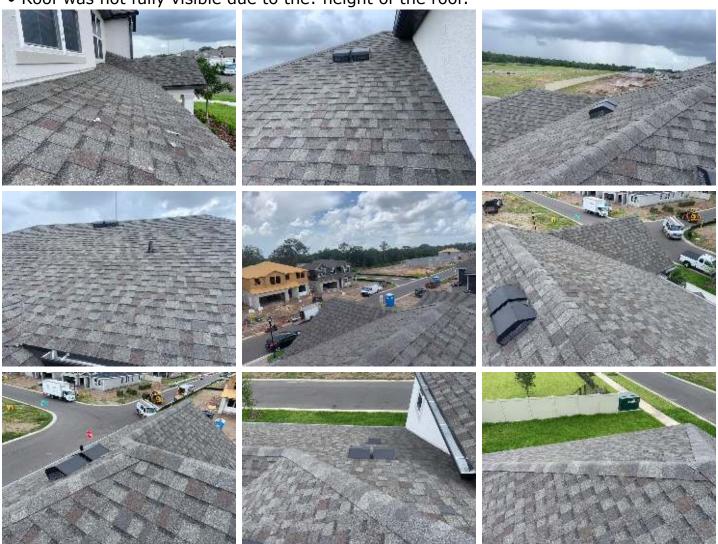
• Roof was viewed from a ladder, from the ground with binoculars, walked

• Roof was not fully visible due to the: height of the roof.
