# COMMERCIAL INSPECTION REPORT

Inspector: [REDACTED]  
License [REDACTED]  
Tampa, FL  
Phone: 813 486 8551  
Email: [info@waypointinspection.com](mailto:info@waypointinspection.com)  
[www.waypointwest.com](http://www.waypointwest.com)

## Summary of Findings

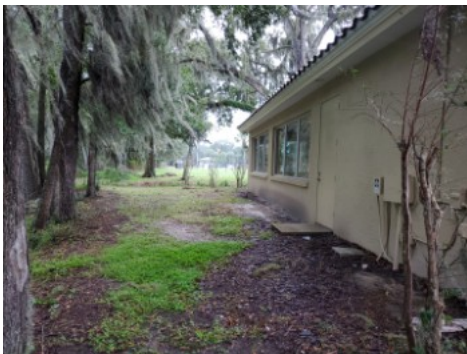
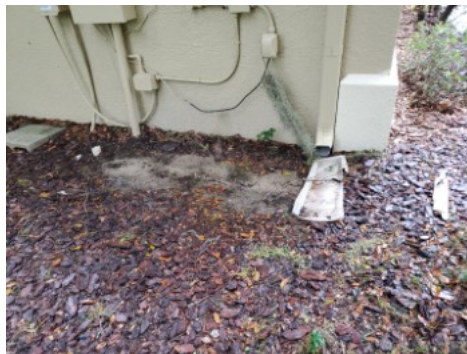
Visible signs of erosion were present.  
Suggest installing gutters for proper drainage.

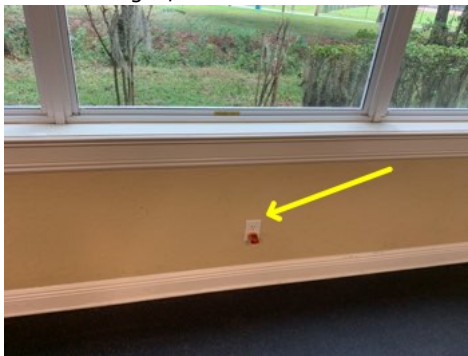
Outlet(s) were not operational.

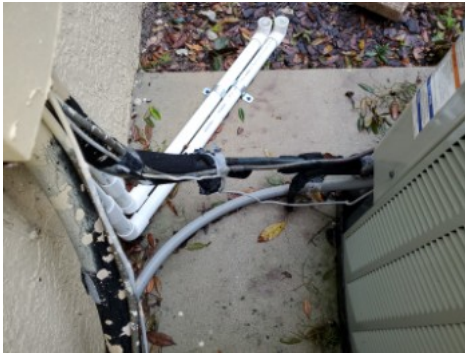
The insulation on refrigerant line was deteriorated.

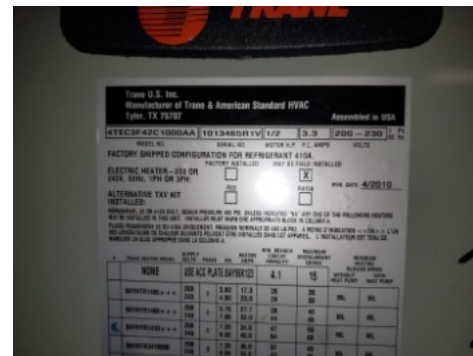
- Heating system operated: No
- Heating coils should be serviced and cleaned on a regular basis.
- Heating system did not operate.

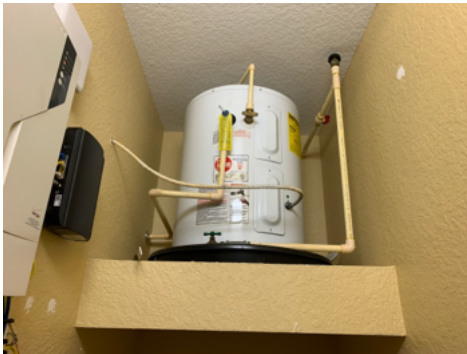
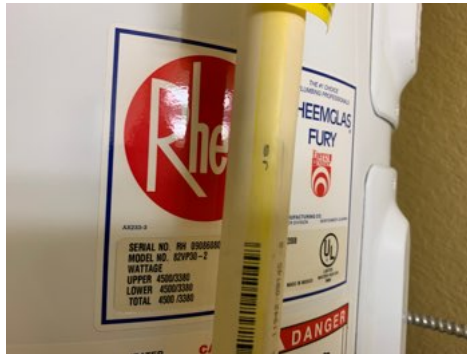
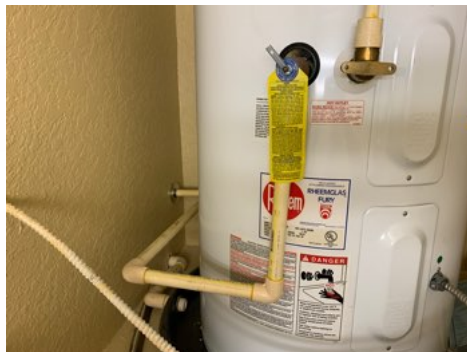
### 5. Water Heater 1 Condition

- Water heater was in good condition: Yes
- Water heater was near or exceeded the end of its useful life (10-12 yrs.) and may need replacement in the near future.

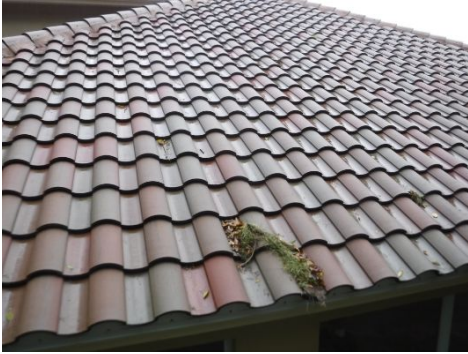
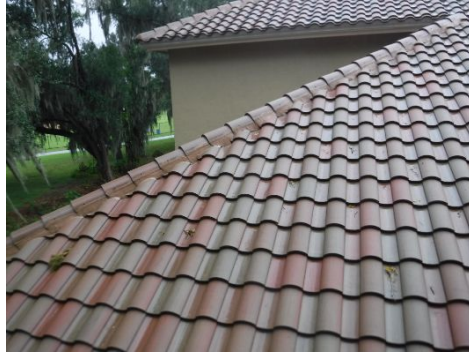
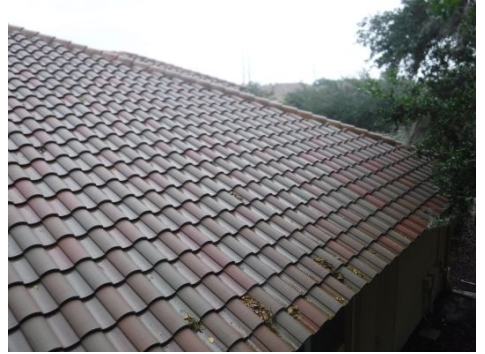
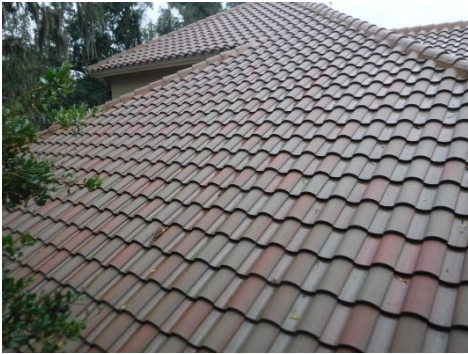
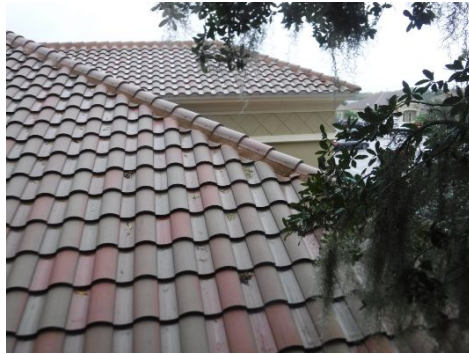
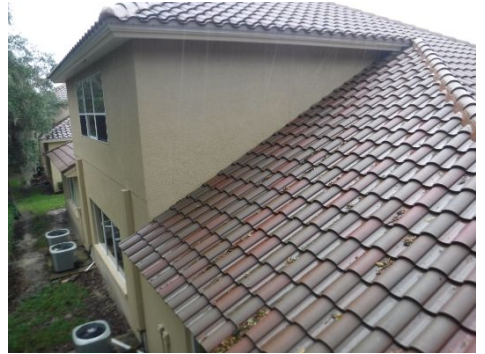
- Estimated age of the roof covering: 8 - 10 yrs.
- Roof was viewed with a Spectroscope.

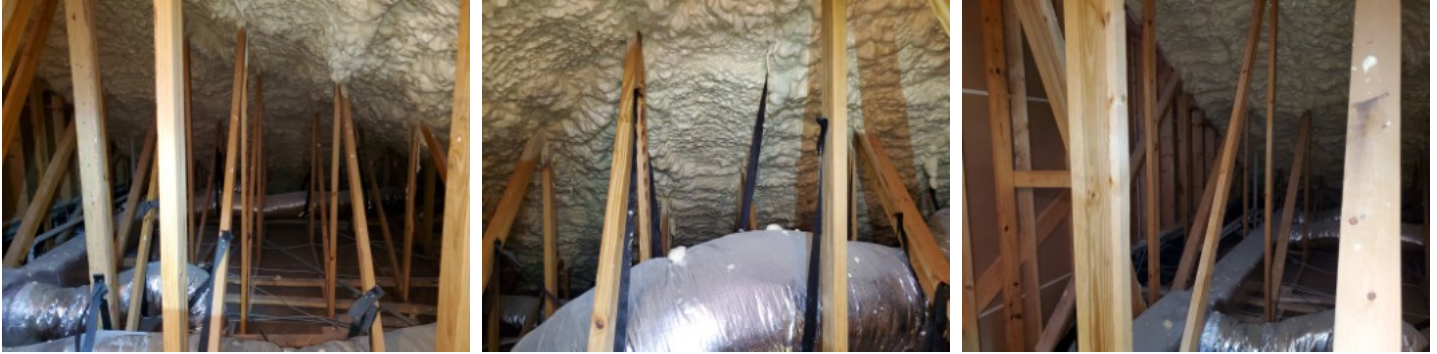
- Attic was not fully visible due to insulation, ductwork and height of structure.
- Attic was not fully accessible due to the current occupant's belongings

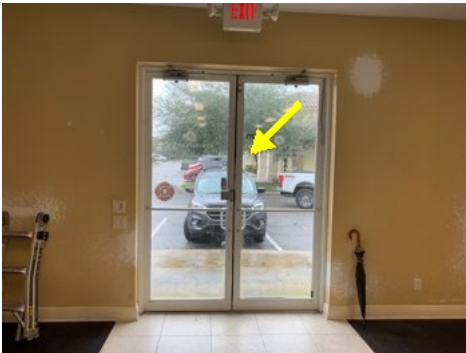
Weather-stripping did not properly seal the front door. Gap was visible.

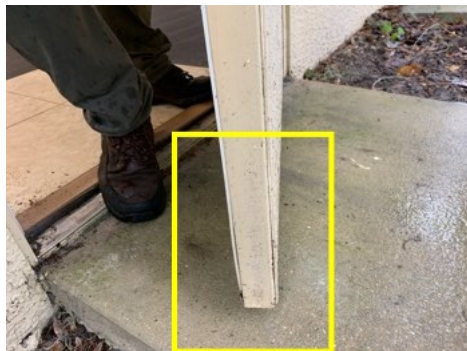
Moisture damage was visible at the secondary door(s).

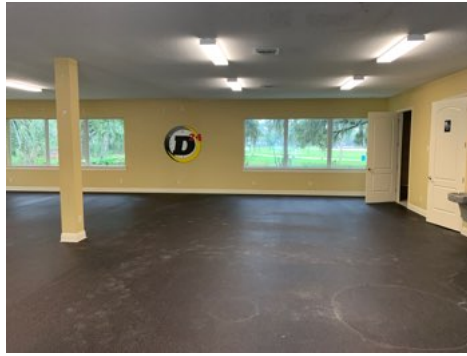
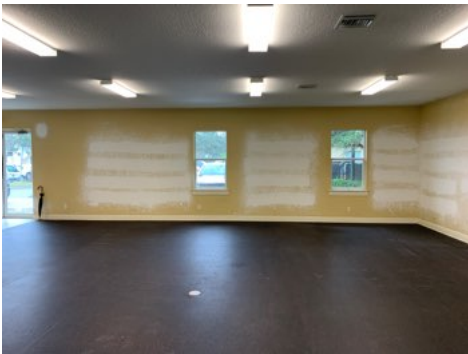
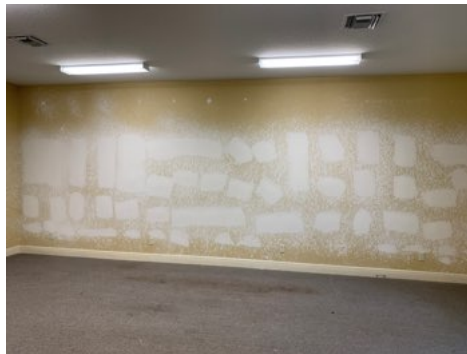
- Minor damage was visible.

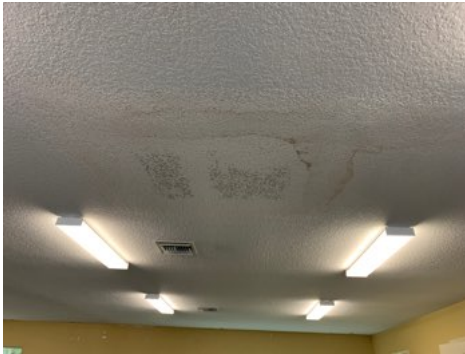
Although dry at the time of the inspection, the visible stain(s) indicated active leaks may be present.

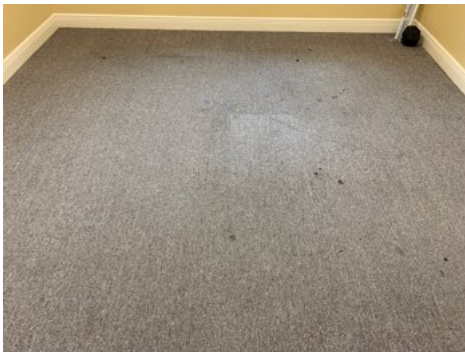
Carpet was deteriorated.

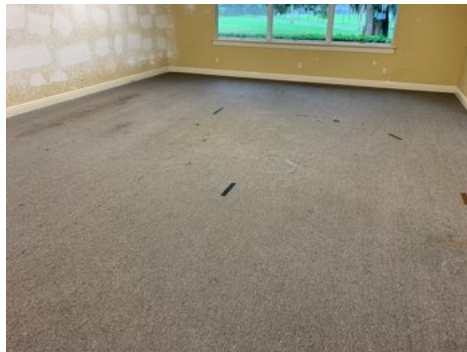
Carpet was deteriorated.

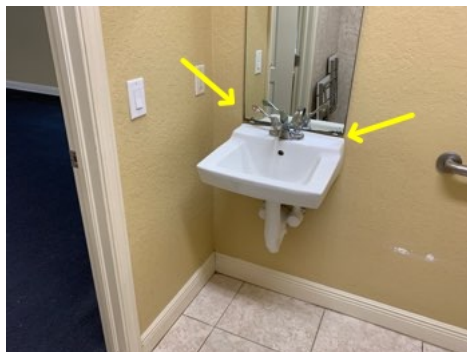
Sink was not properly secured to wall at women's bathroom left.

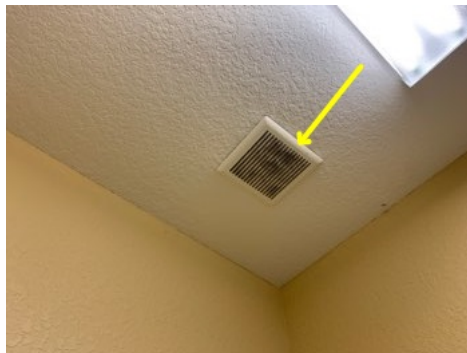
Exhaust fan made excessive noise at bathroom right side.
