**WAYPOINT**  
Property Inspection, LLC

# INSPECTIONREPORT

Type of Structure: Restaurant • One story structure

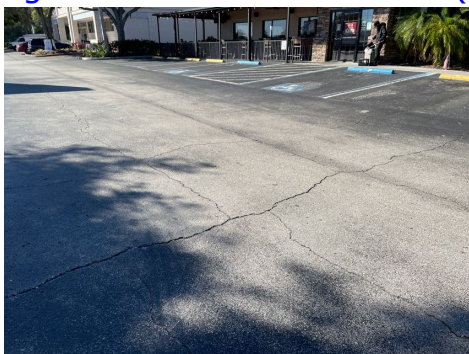
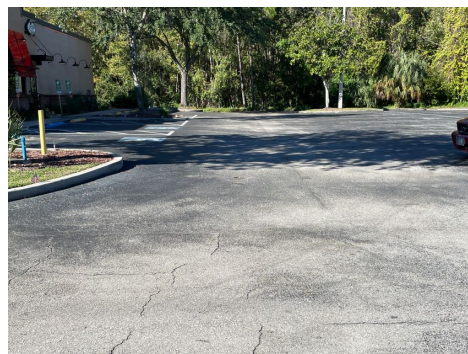
### 1. Parking Lot/Walkway Condition

- Parking Lot had settlement crack(s)

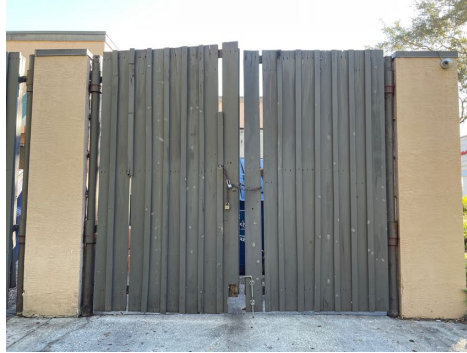
Gate(s) were damaged.

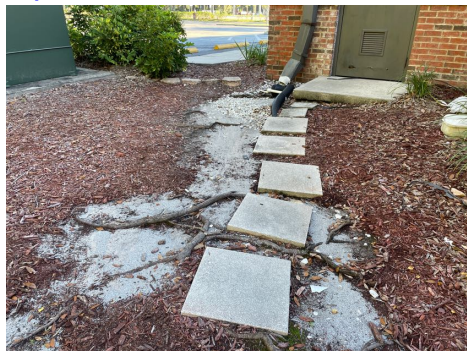
### 1. Grading Condition

- Visible signs of erosion were present.

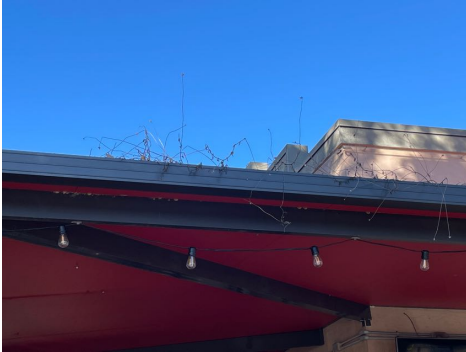
Gutters were filled with debris and the drains were blocked.

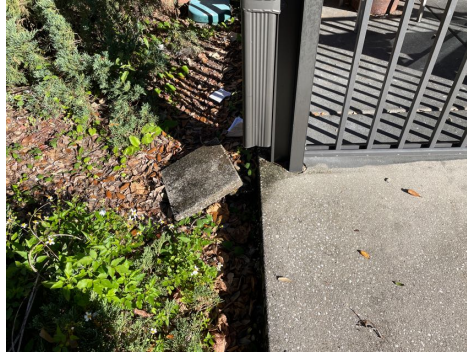
Downspout(s) were missing/not installed.

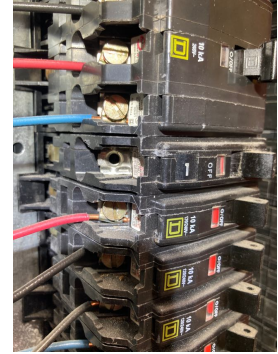
Defective breaker(s) were present.

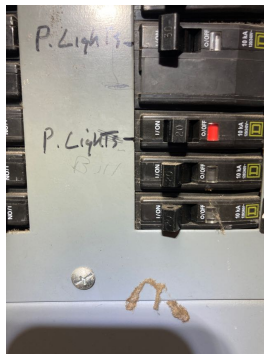
Breaker was tripped, unable to determine cause.

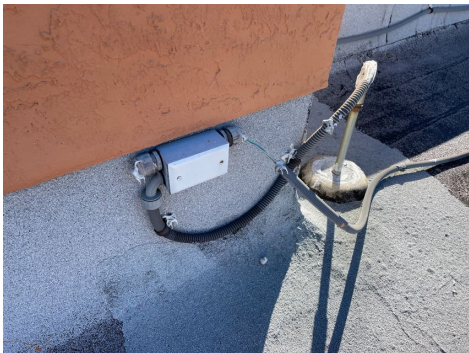
Exposed wiring was not properly protected at various areas of the roof.

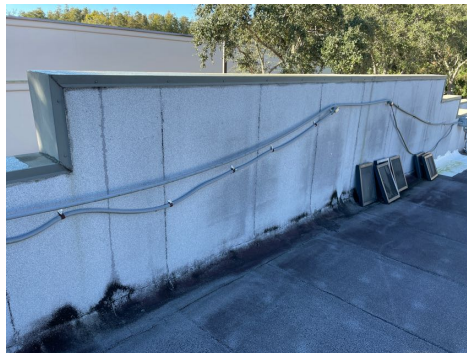
Conduit was not properly secured at multiple locations of the roof.

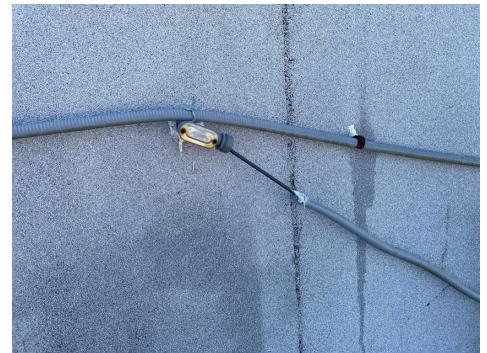
Exposed wiring was not properly protected at various areas of the roof.

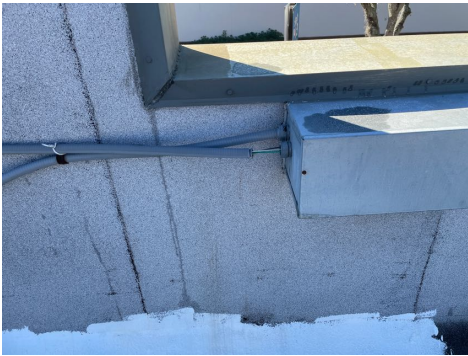
Exposed wiring was not properly protected at various areas of the roof.

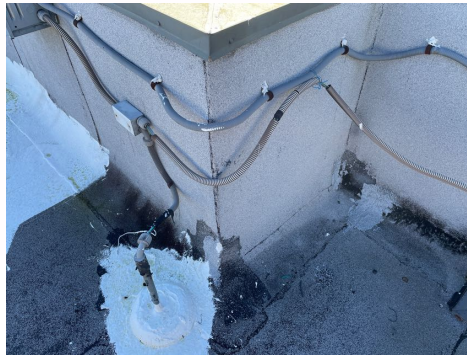
Exposed wiring was not properly protected at various areas of the roof.

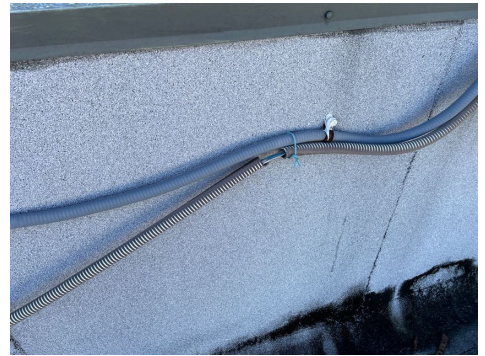
Exposed wiring was not properly protected at various areas of the roof.

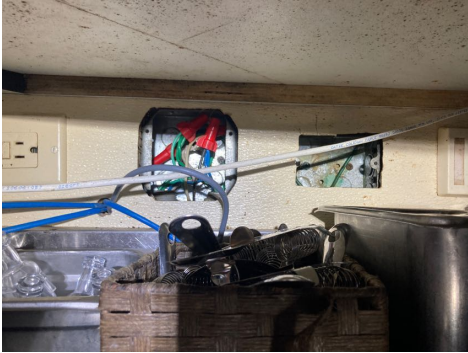
Cover plate(s) were not installed.

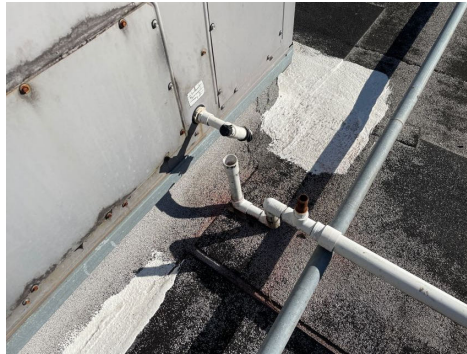
Condensate was disconnected.

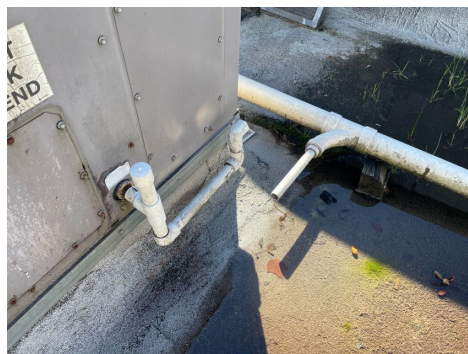
Condensate line was disconnected.

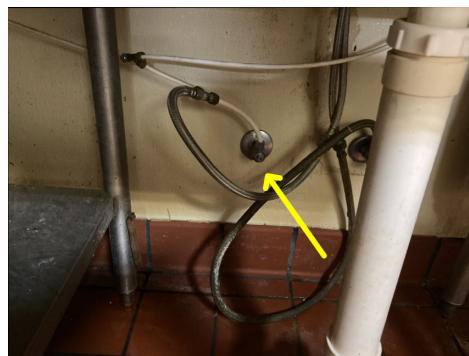
Minor corrosion was visible at the supply lines.

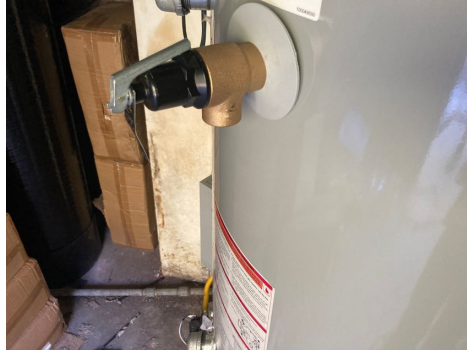
TPR piping was missing.

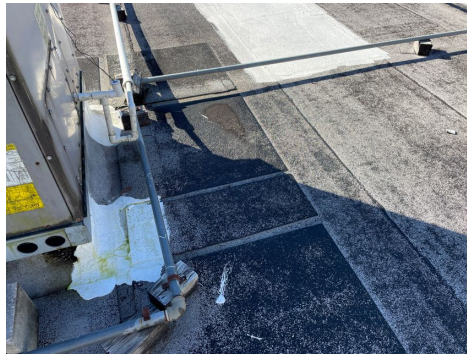
Improper drainage was visible at the rear section of roofing.

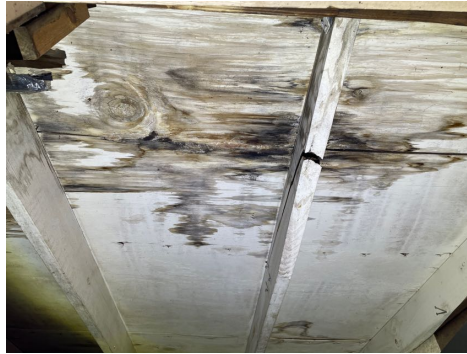
Damaged/deteriorated roof covering was visible.

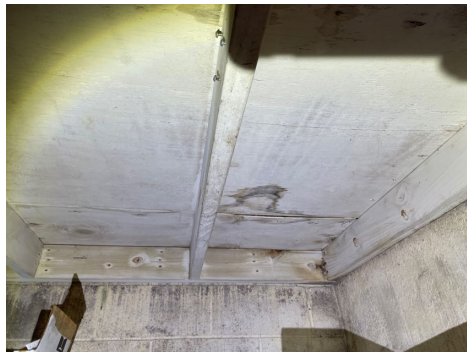
Based on the condition of the roof, a full evaluation should be completed by a qualified roofer.

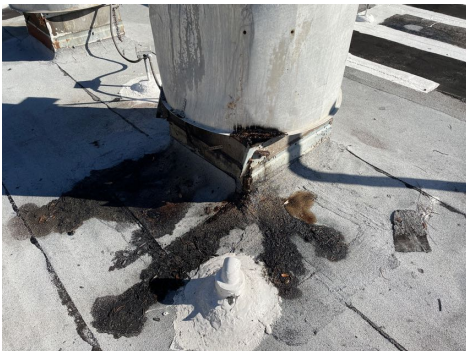
Exhaust hood with grease catch appear to be leaking.

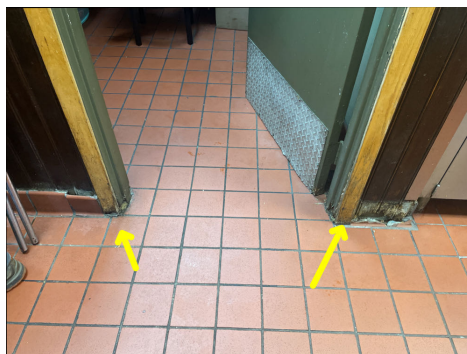
- Door jamb was damaged.

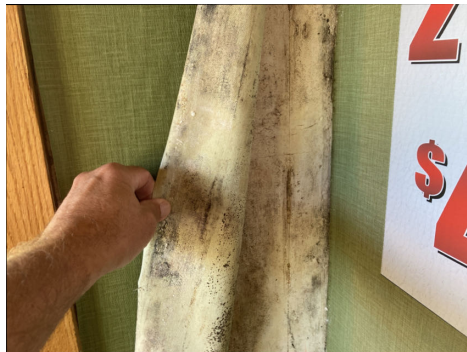
- Although dry at the time of the inspection, the visible stain(s) indicated active leaks may be present.

Although dry at the time of the inspection, the visible stain(s) indicated active leaks may be present.

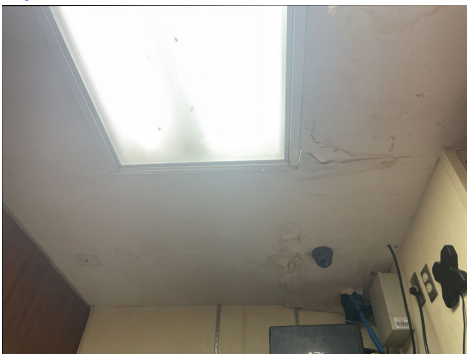
- Although dry at the time of the inspection, the visible stain(s) indicated active leaks may be present.

Although dry at the time of the inspection, the visible stain(s) indicated active leaks may be present.

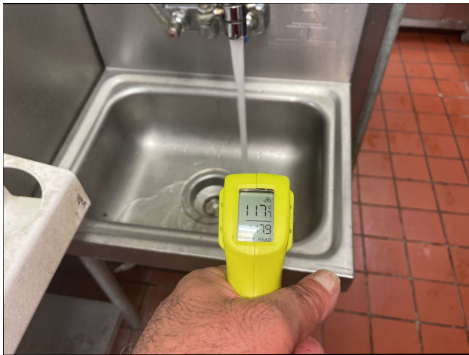
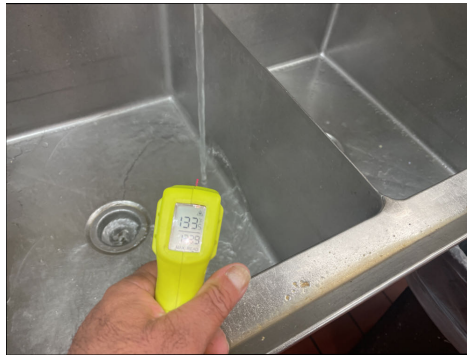
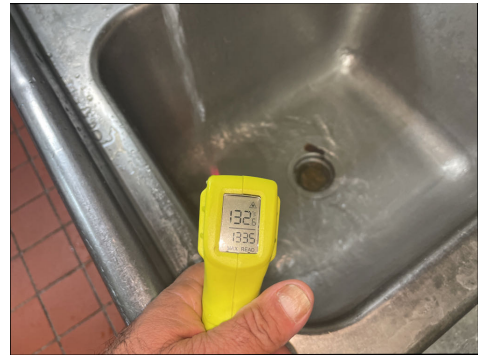
- Drain line was leaking at kitchen sink.

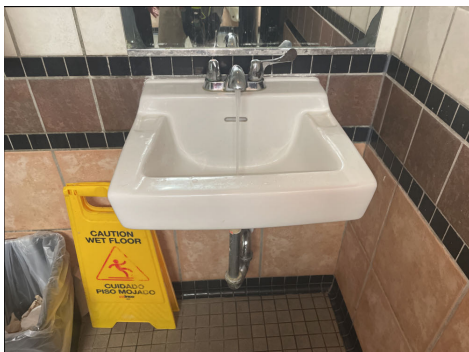
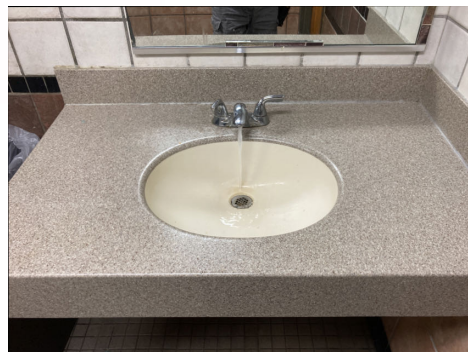
- Hot water was not detected at all the bathrooms., mens bathroom.

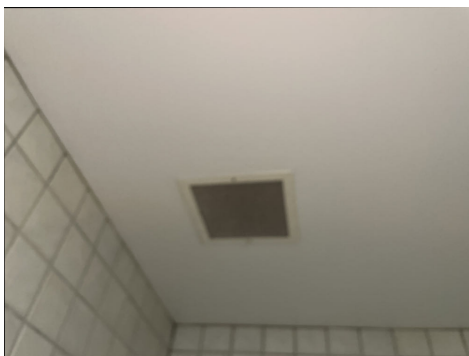
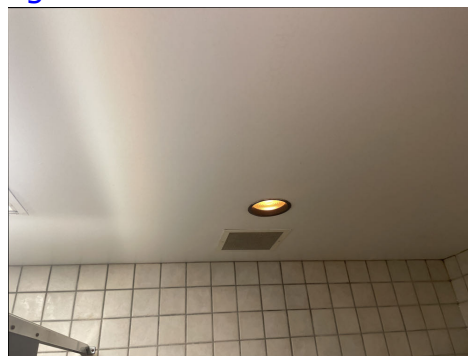
- Exhaust fans and covers should be cleaned on a regular basis.
