WAYPOINT

INSPECTIONREPORT

Bradenton, 34207

Inspection Date: 11/30/2023

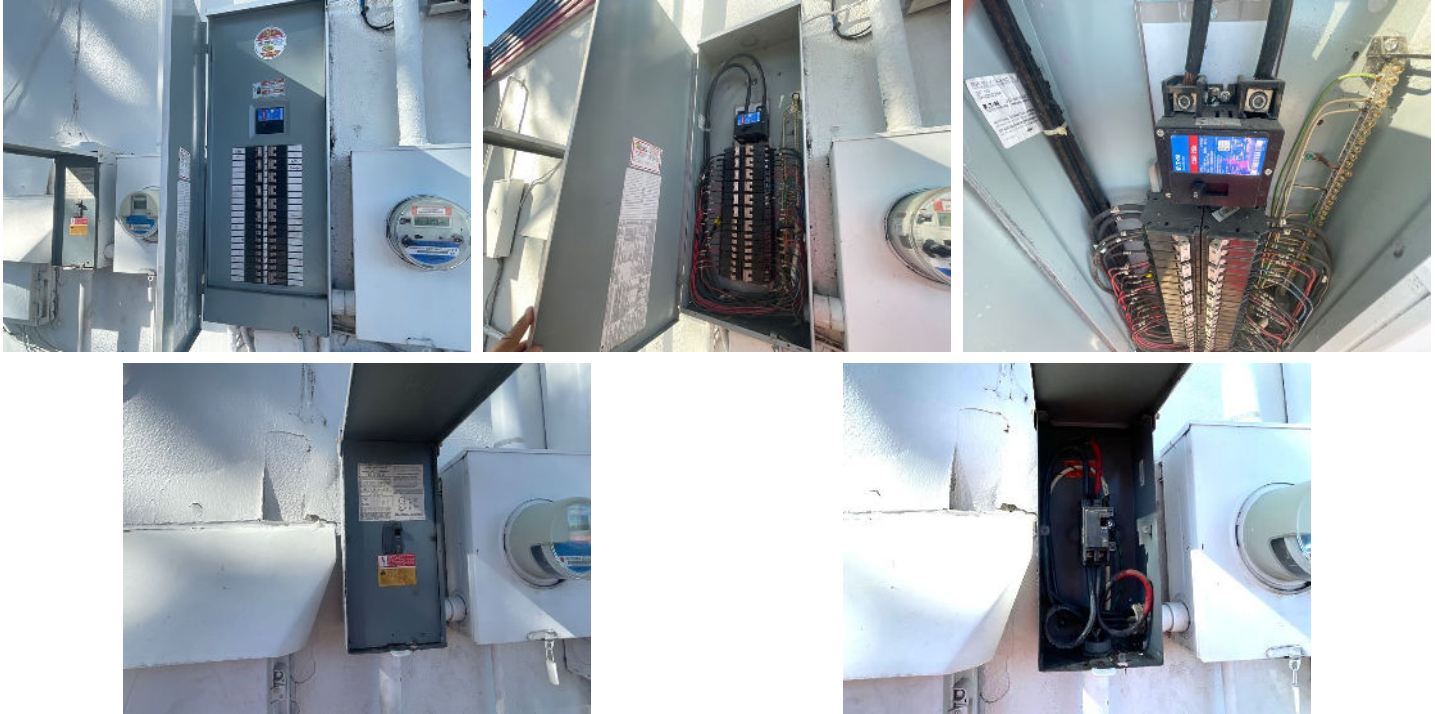
2. Main Panel Condition

- Electrical panel was in good condition: Yes.

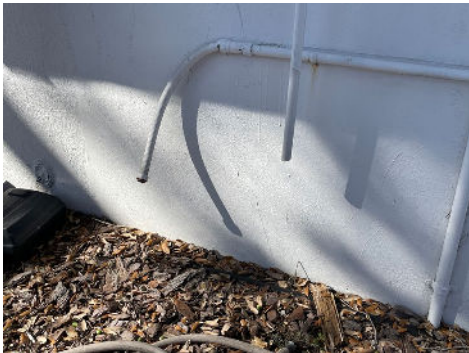
Exposed wiring was not properly protected at multiple locations.

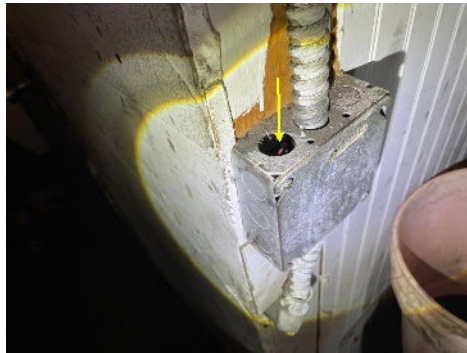
Exposed wiring was not properly protected at multiple locations.
Garage

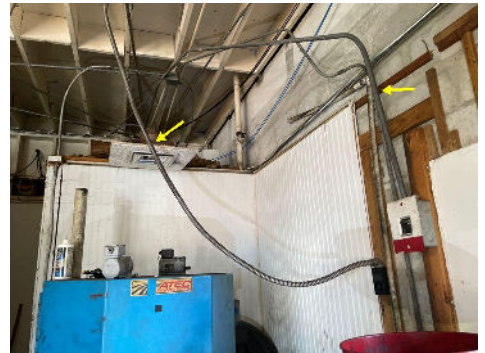
Exposed wiring was not properly protected at multiple locations.
Not properly secured.

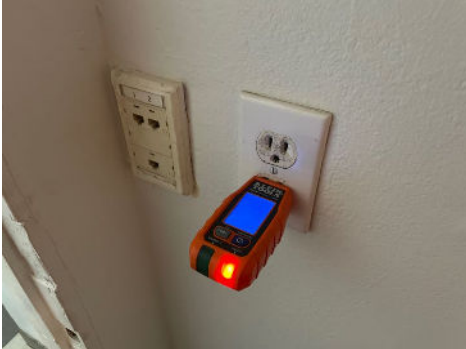
Outlet(s) tested not grounded at interior.

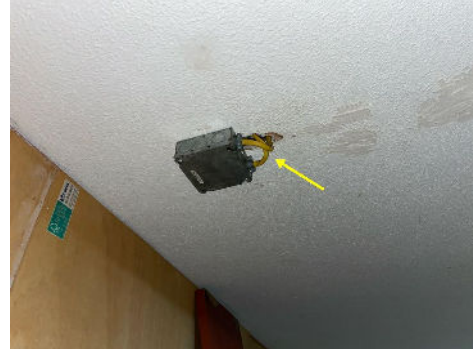
Exposed wiring was not properly protected at multiple locations.

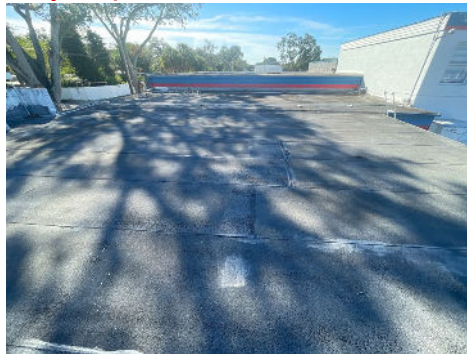
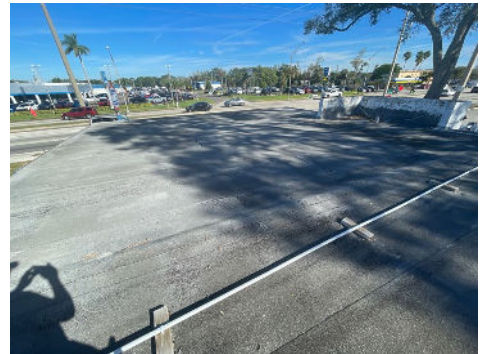
Missing roof material(s) were visible at multiple locations. An evaluation and repair should be completed by a qualified licensed roofer.
