INSPECTION REPORT

SAMPLE REPORT - 123 Main Street Orlando, FL 54321

Age: 2013 Heated Sq Ft: 8292

Inspection Date: 10/19/2023

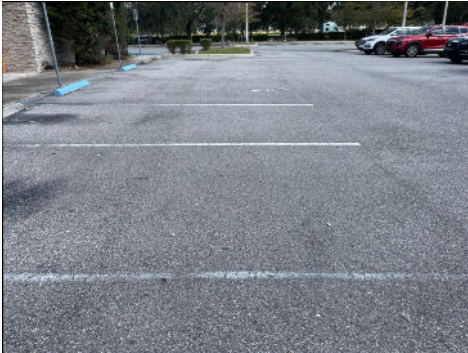
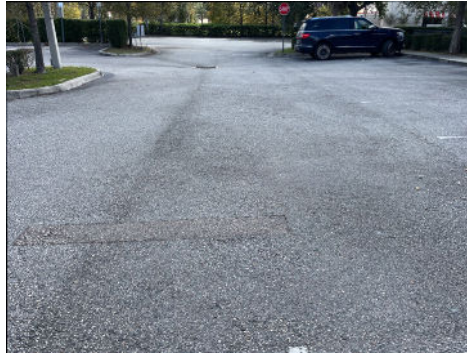
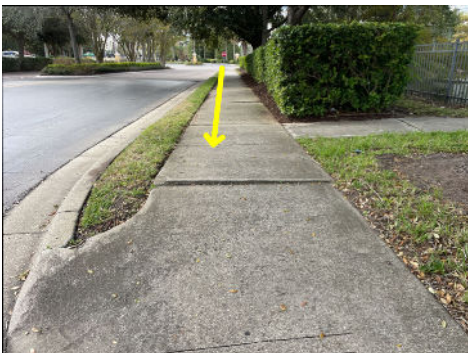
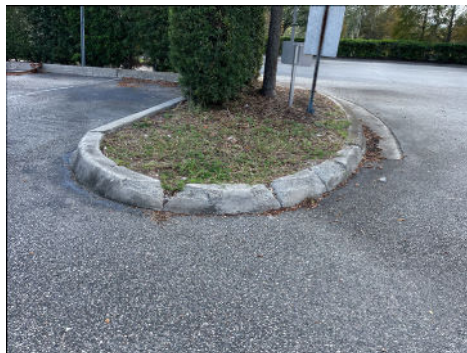
1. Parking Lot/Walkway Condition

- surface was worn.
- Walkway surface was uneven.
- Curb was damaged

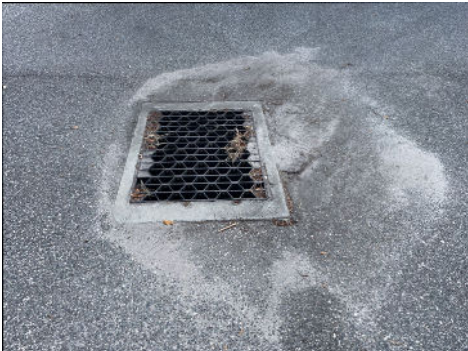
Walkway surface was uneven.

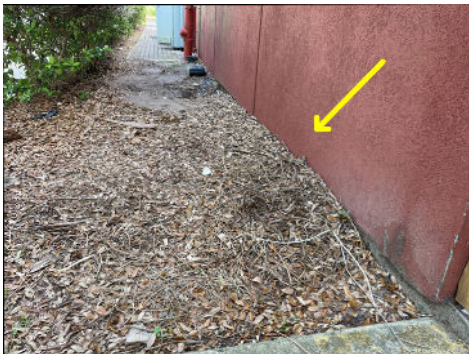
Soil and grading was high at the foundation. The affected areas should be regraded to enable proper draining and prevent potential moisture intrusion and damage to the house.

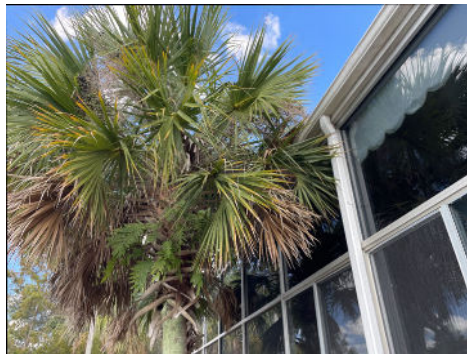
Vegetation/Shrubs/Trees appeared to be planted too close to foundation and structure of the house.

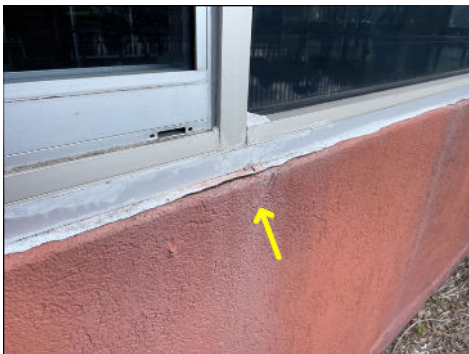
Gaps/holes was visible at various locations.

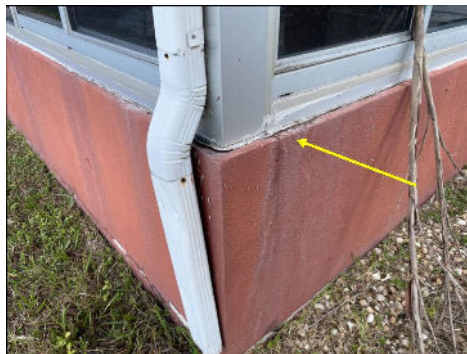
Gaps/holes was visible at various locations.

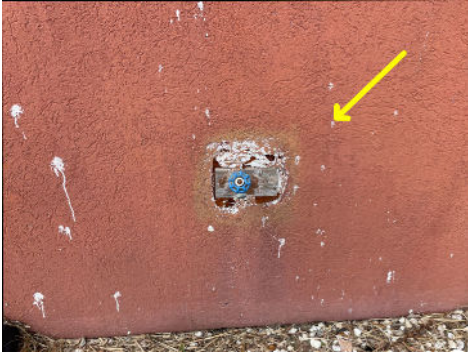
Exterior wall was damaged at various locations.

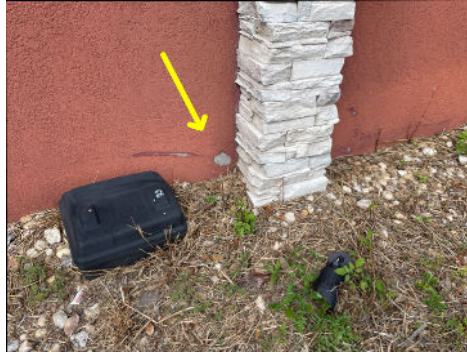
Exterior wall was damaged at various locations.

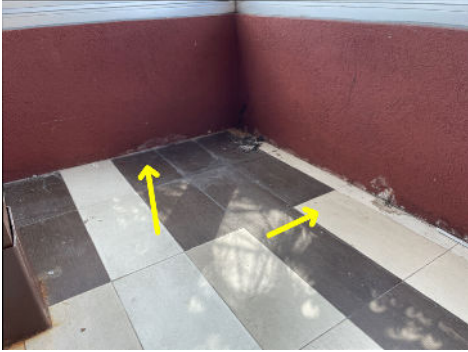
Gaps/holes was visible at various locations.

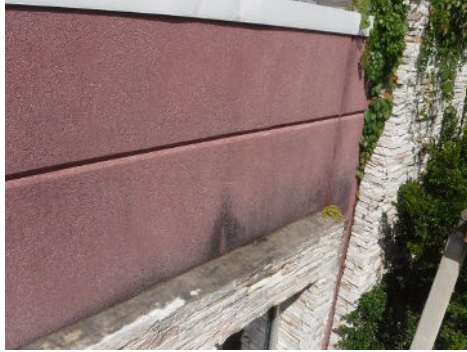
Front rock veneer top cap was missing proper flashing. Deterioration was visible.

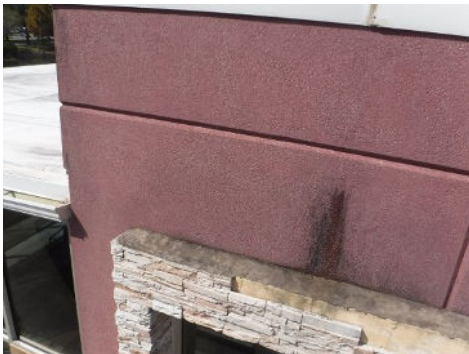
Front rock veneer top cap was missing proper flashing. Deterioration was visible.

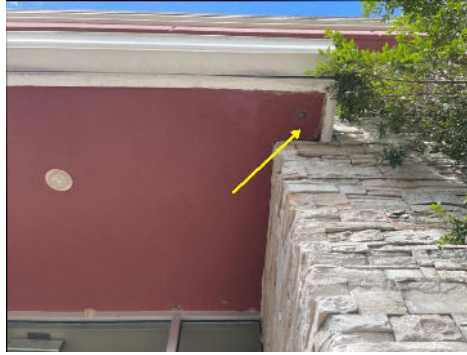
Trim pieces had visible damage at multiple locations.

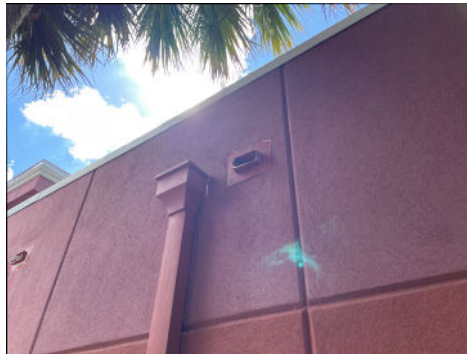
3. Gutters & Downspouts Condition

- Gutter seams were leaking.
- Splash blocks should be installed for proper drainage.
- Extensions should be installed to channel drainage away from the foundation.

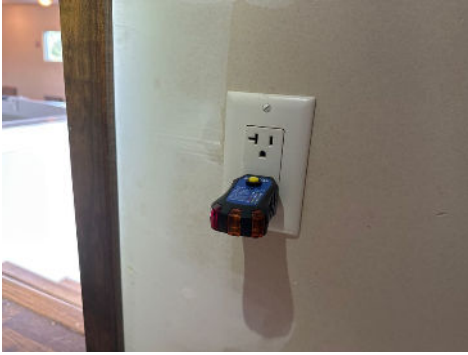
Outlet(s) were not operational at multiple locations.

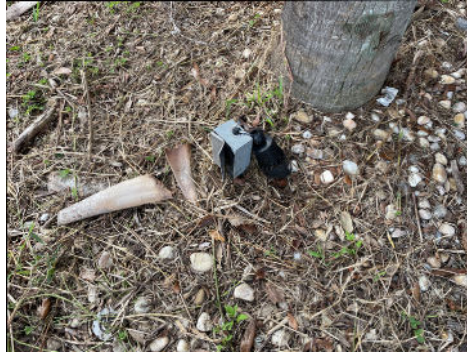
Exposed wiring was not properly protected at exterior.

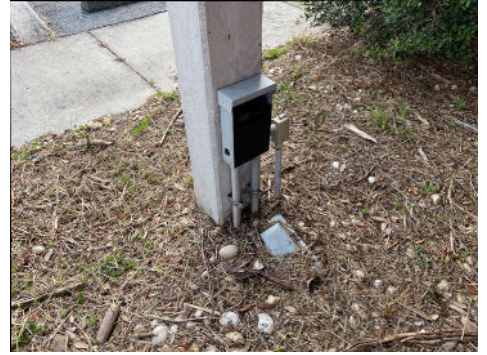
Exposed wiring was not properly protected at exterior.

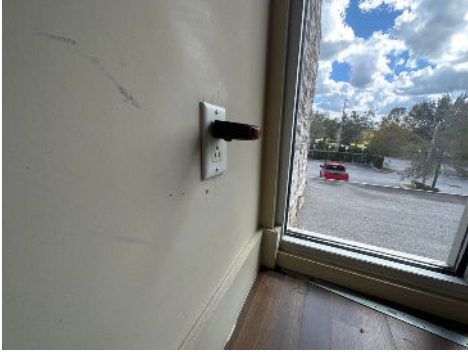
Outlet(s) were not operational at multiple locations.

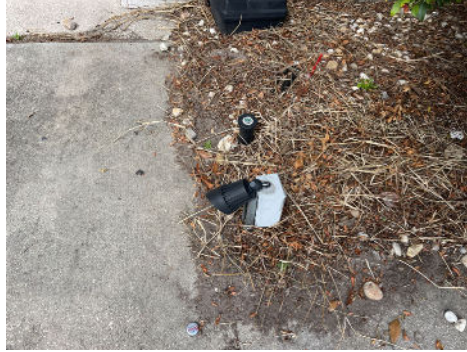
Exposed wiring was not properly protected at exterior.

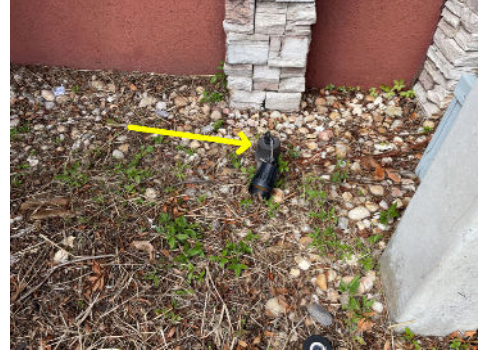
Exposed wiring was not properly protected at exterior.

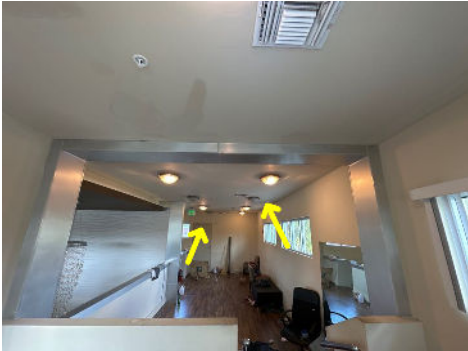
Light(s) were tested and not operational at multiple locations.

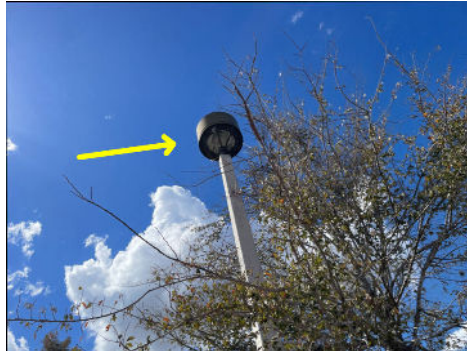
Light(s) were tested and not operational at multiple locations.

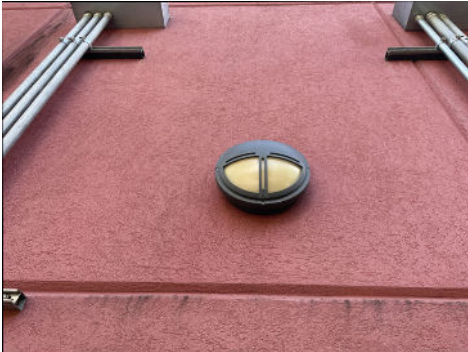
Light(s) were tested and not operational at multiple locations.

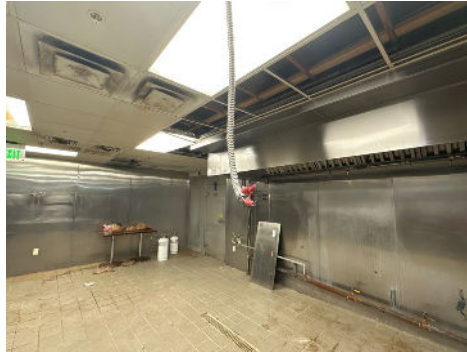
Exposed wiring was not properly protected at Kitchen

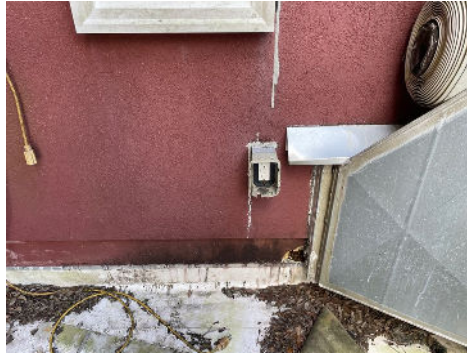
Weatherproof covers were damaged/missing at exterior outlet(s).

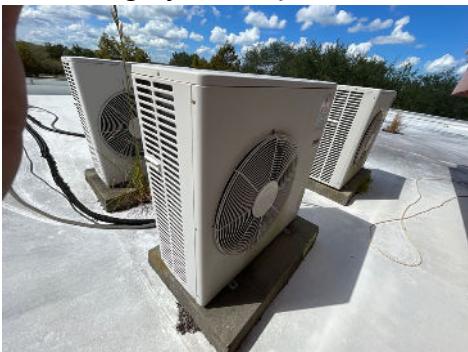
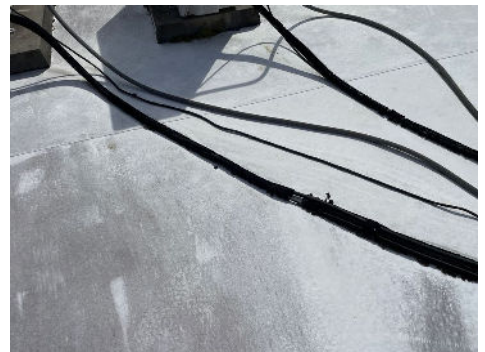
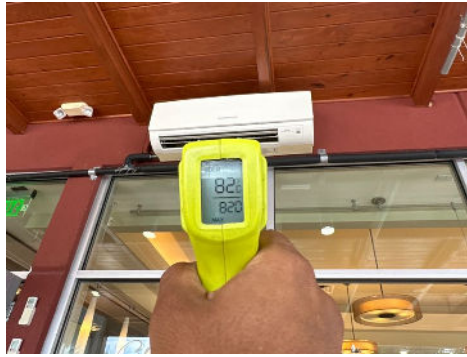
5. Cooling System 5 Condition

- Cooling system operated: No.

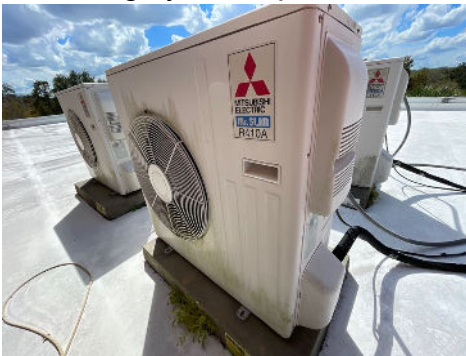
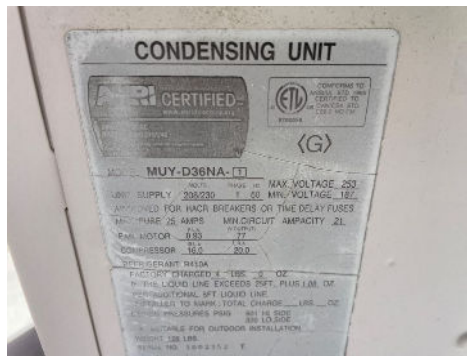
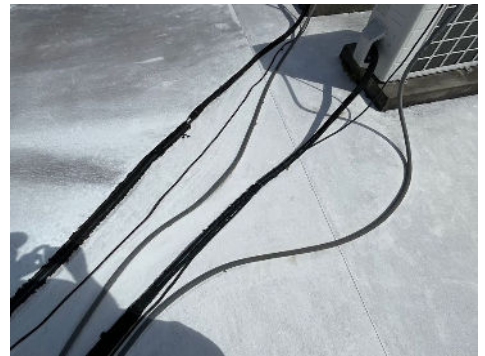
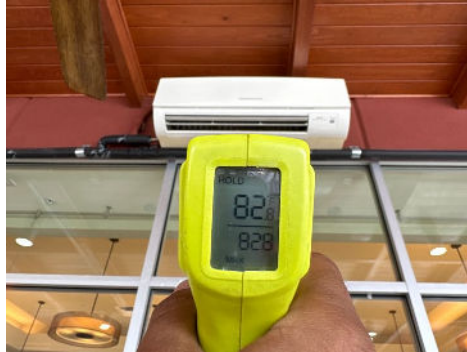
6. Cooling System 6 Condition

- Cooling system operated: No.

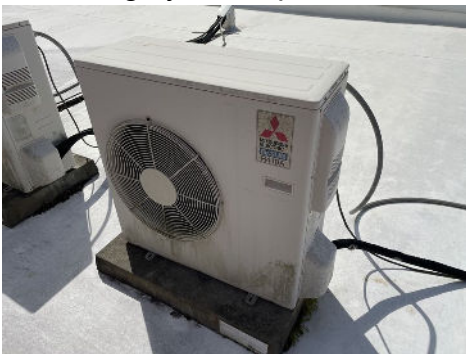
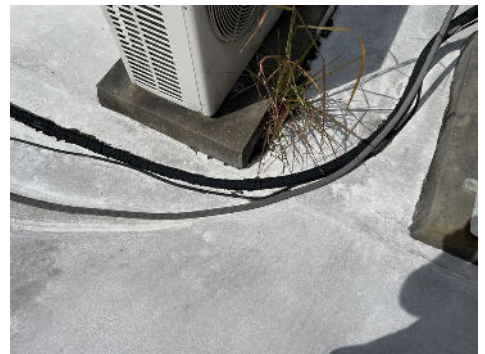
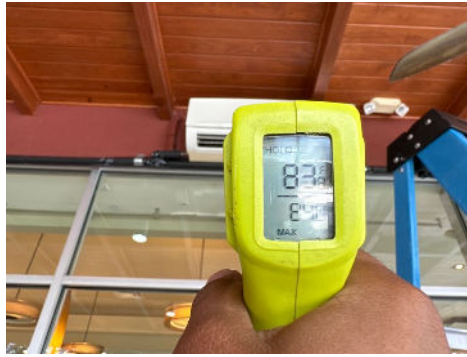
7. Cooling System 7 Condition

- Cooling system operated: No.

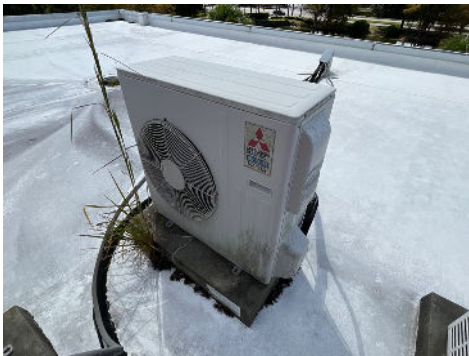
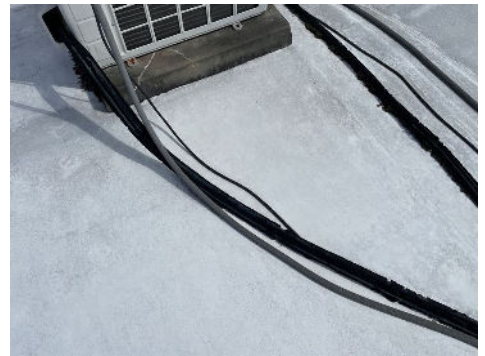
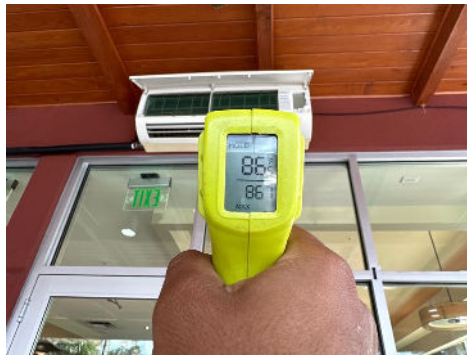
8. Cooling System 8 Condition

- Cooling system operated: No.
- Insulation on refrigerant line was damaged .

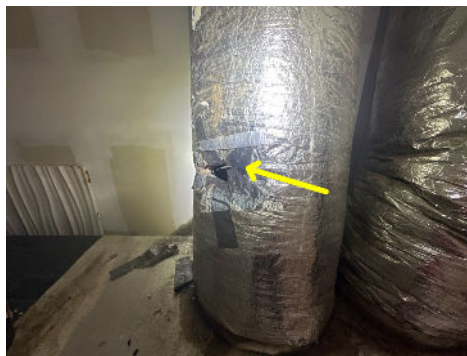
Air leaks were detected at the visible connections.

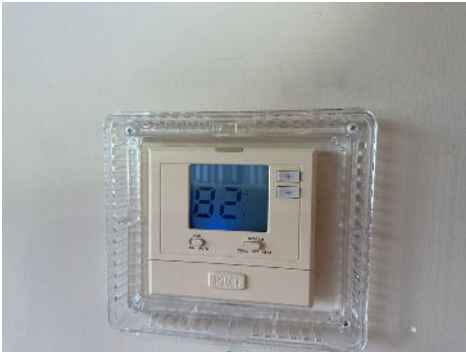
Thermostat(s) was damaged.

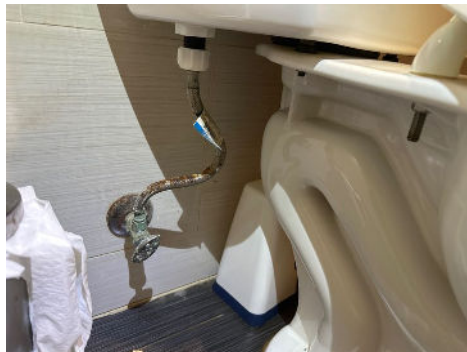
Leaks were visible at the supply valves at kitchen.

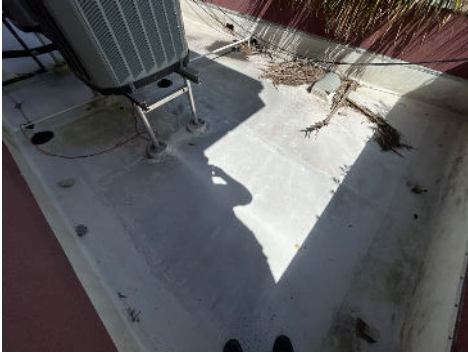
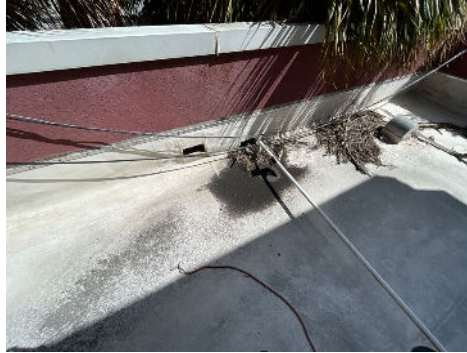
Evidence of water pooling was visible.

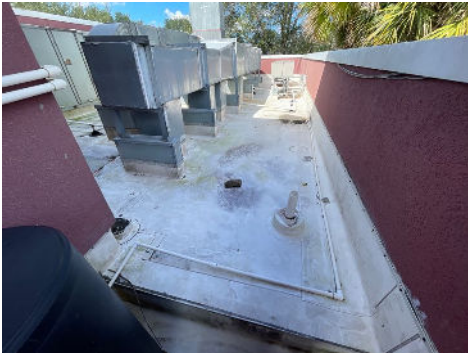
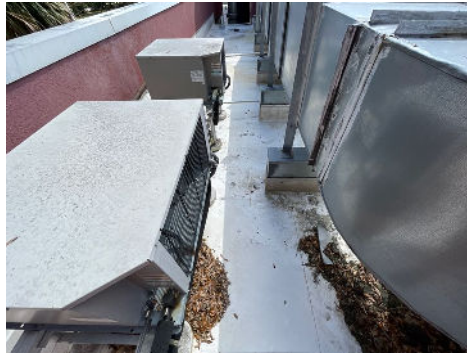
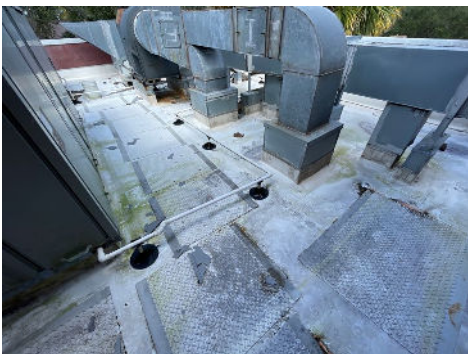
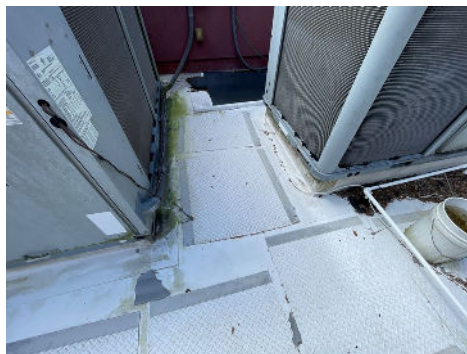
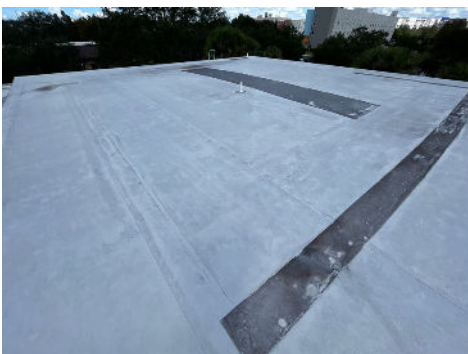
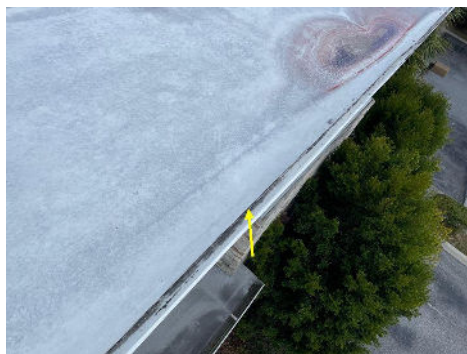
Damaged/Loose roofing material(s) were visible.

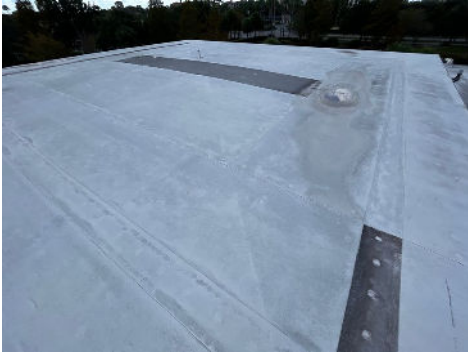
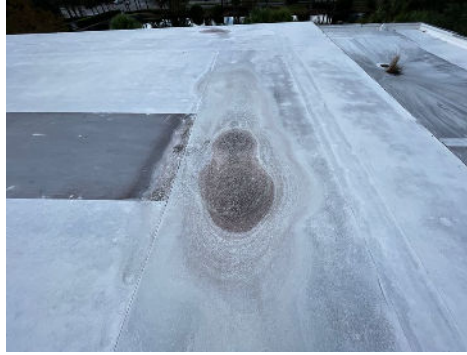
Evidence of water pooling was visible.

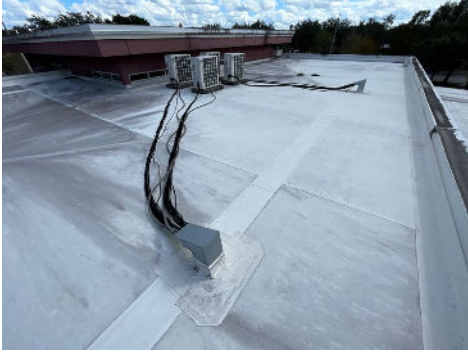
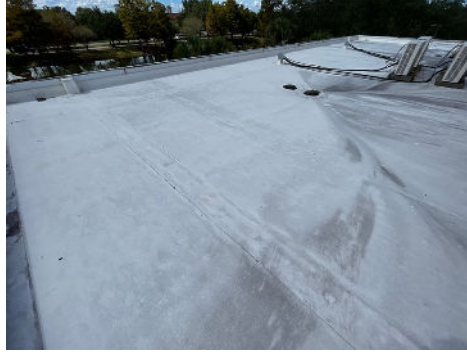
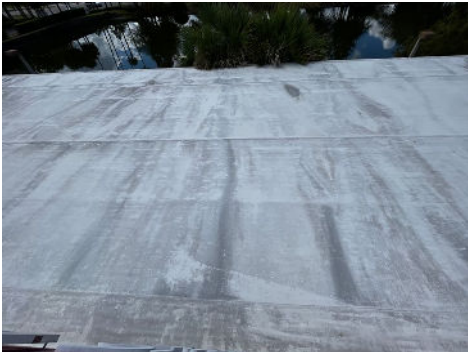
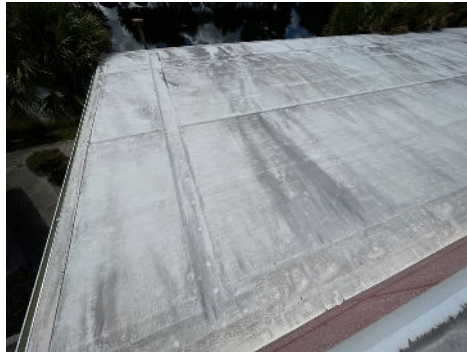
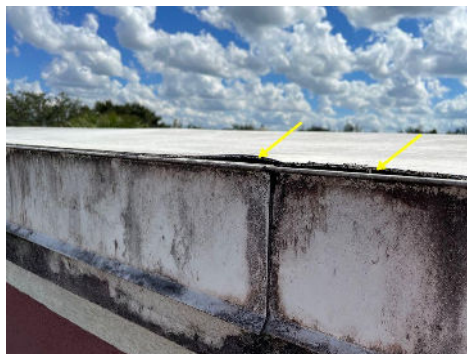
Damaged/Loose roofing material(s) were visible.

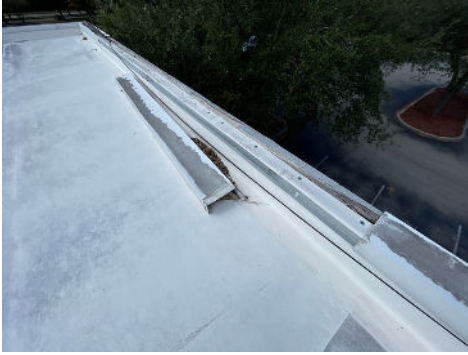
Top cap flashing was damaged. Moisture stains and damage were visible at the wood structure below.

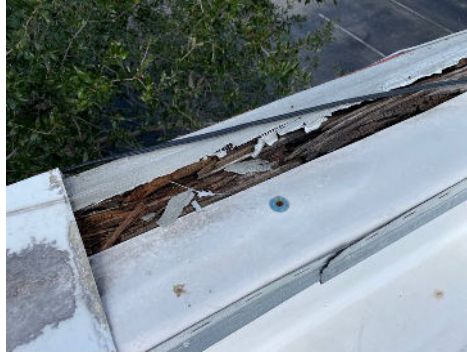
Top cap flashing was damaged. Moisture stains and damage were visible at the wood structure below.

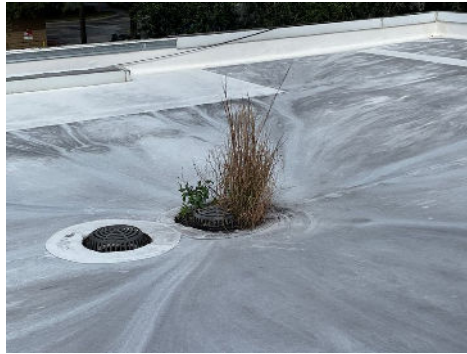
Roof drains should be cleared of all debris and vegetation.

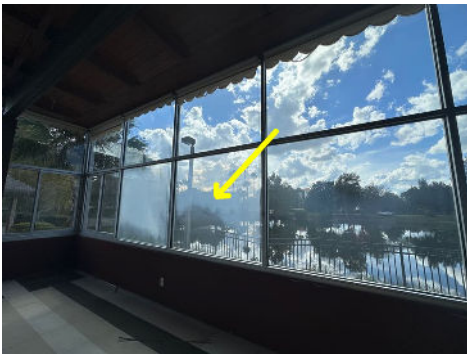
Window pane was not fully sealed in multiple locations.

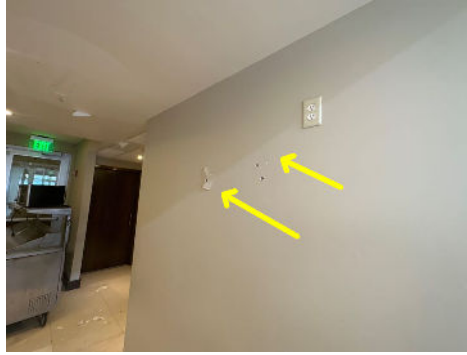
Damaged wall(s) were visible at multiple locations.

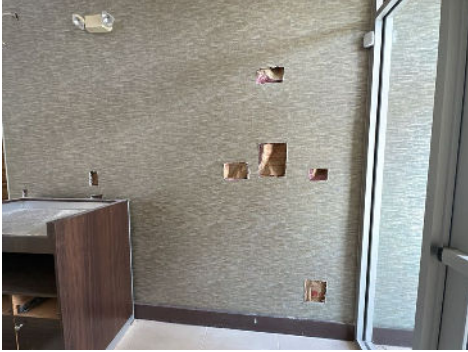
Damaged wall(s) were visible at multiple locations.

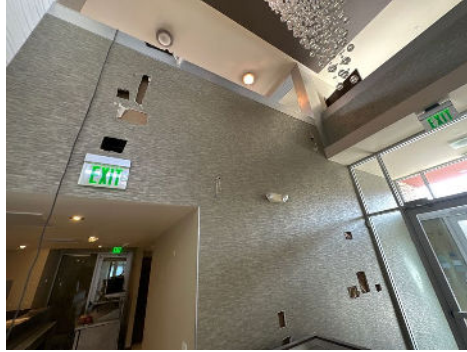
Damaged wall(s) were visible at multiple locations.

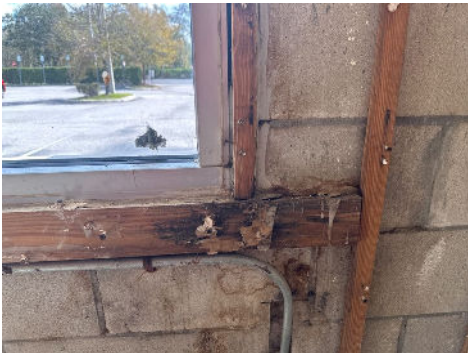
WDO-Like damage was visible at multiple locations.

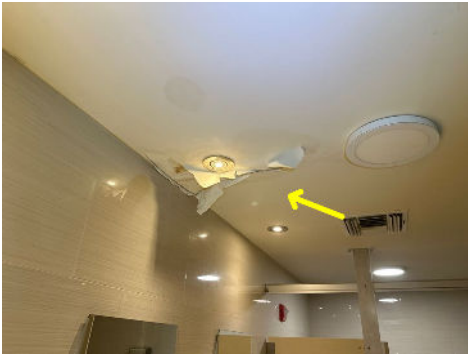
Damage was visible at multiple locations.

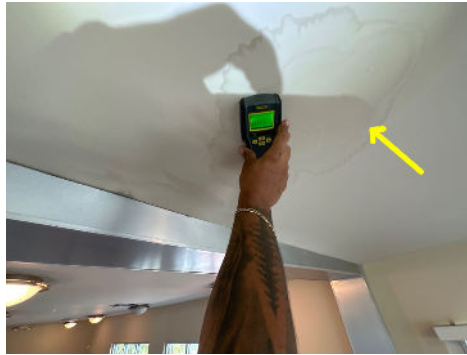
Although dry at the time of the inspection, the visible stain(s) indicated active leaks may be present at multiple locations.

Page 26 Item: 4	Ceilings Condition	• Damaged/separating seams were visible multiple locations. • Although dry at the time of the inspection, the visible stain(s) indicated active leaks may be present at multiple locations.
-----------------	--------------------	--

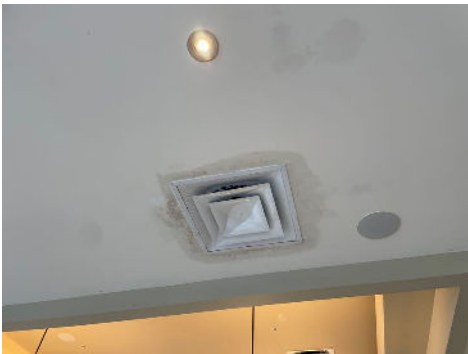
Damage was visible at multiple locations.

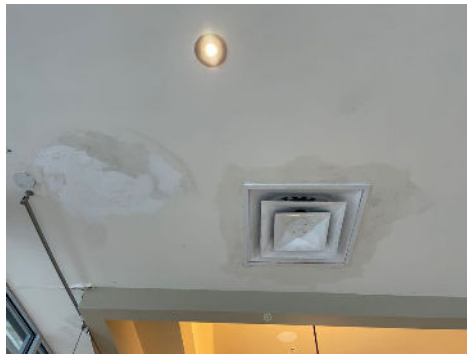
Damage was visible at multiple locations.

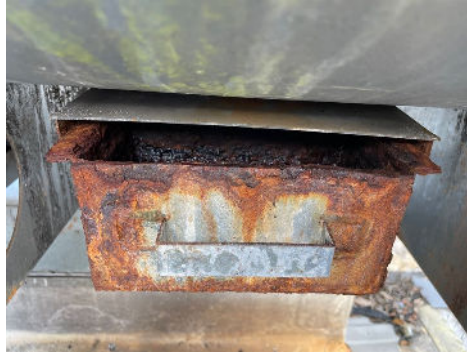
Grease catch was deteriorated and should be serviced on a regular basis.

Page 27 Item: 1	Ventilation Condition	• Grease catch was deteriorated and should be serviced on a regular basis.
-----------------	--------------------------	--

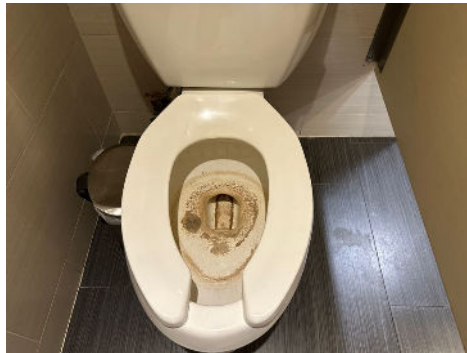
Moisture was visible at the base of the toilet at All bathrooms.

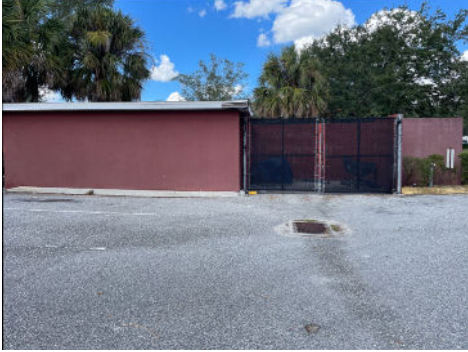
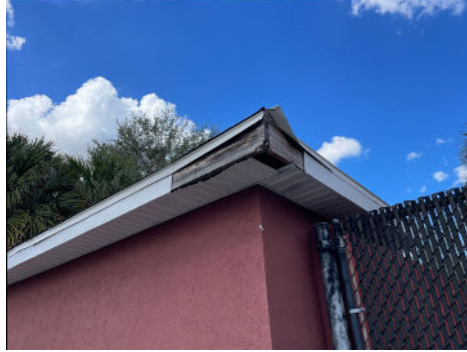
Damage was visible at various locations.

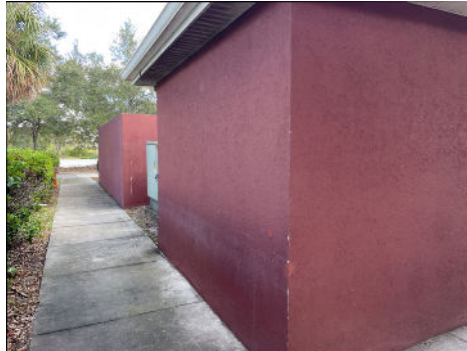
- Damage was visible at various locations.

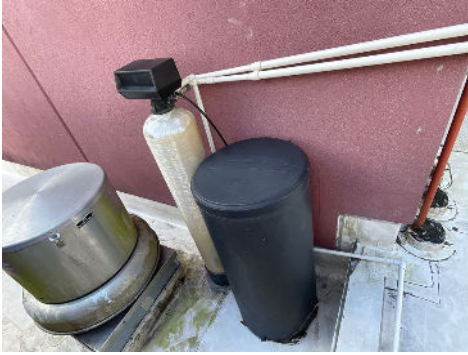
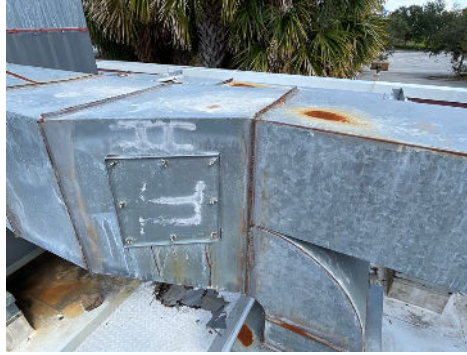
Kitchen ventilation system was present. Vent ducts at the roof were deteriorated/damaged.

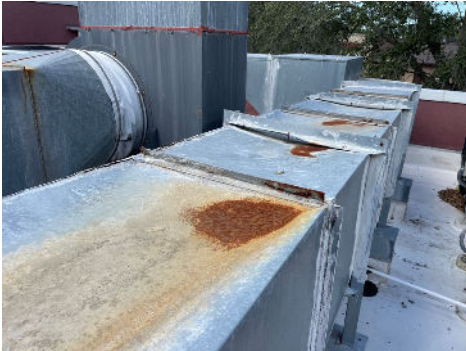
Kitchen ventilation system was present. Vent ducts at the roof were deteriorated/damaged.
