**WAYPOINT**  
Property Inspection, LLC

Prepared for: Pre-drywall Inspection **SAMPLE**

# INSPECTIONREPORT

**SAMPLE** Pre-drywall Inspection  
Jupiter, FL  
32588

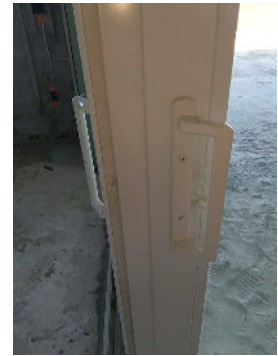
Sliding door was difficult to lock.

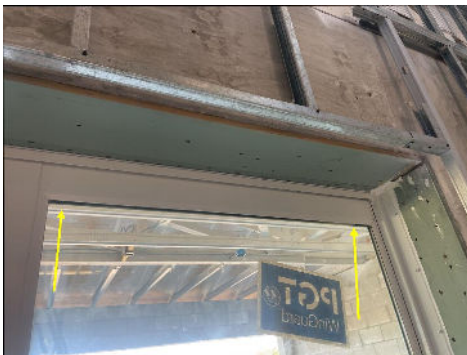
Door needed to be leveled. Should be checked at final inspection.

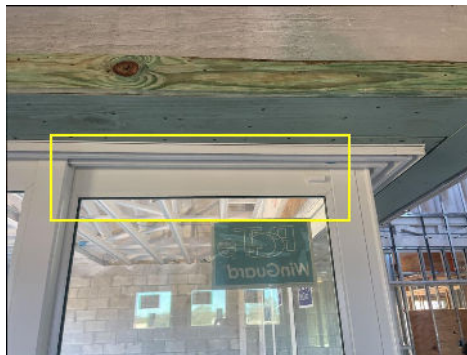
Door needed to be leveled. Should be checked at final inspection.

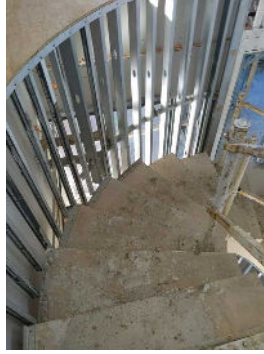
Stairway appeared to be safe. Unsure if support boards was missing inside closet area. Recommend a further evaluation.

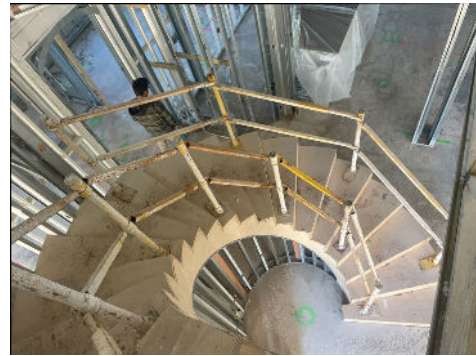
Rails were not installed at the time of inspection.

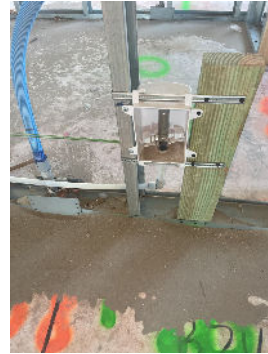
Refrigerator rough plumbing appears serviceable.

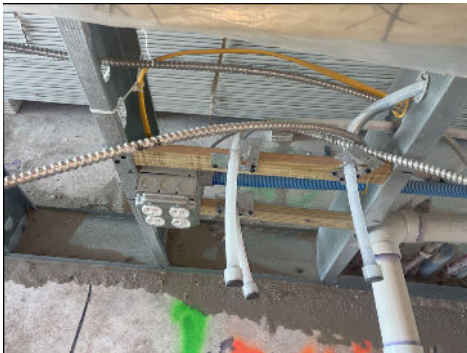
GFCI outlets rough wiring appeared serviceable.

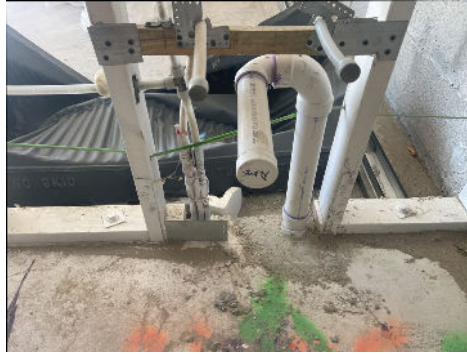
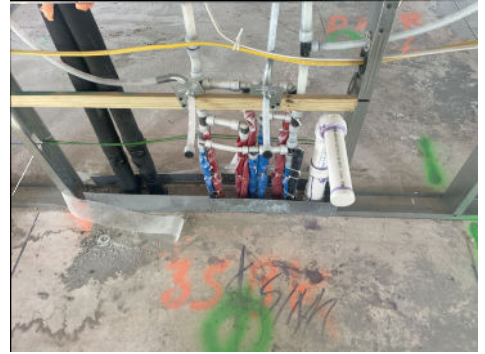
Bathroom #2

- Sink supply plumbing appeared to be in serviceable condition.
- Sink drain plumbing appeared to be in serviceable condition.

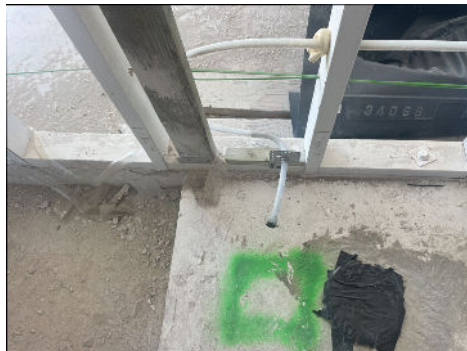
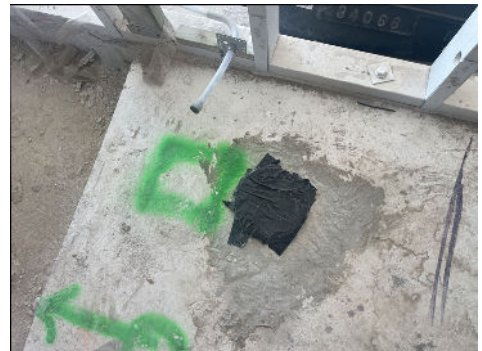
Bathroom #2

- Toilet(s) supply plumbing appeared to be in serviceable condition.
- Toilet(s) drain plumbing appeared to be in serviceable condition.

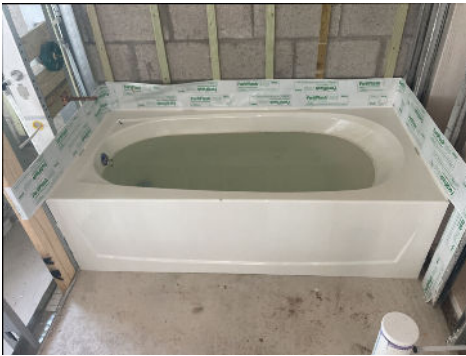
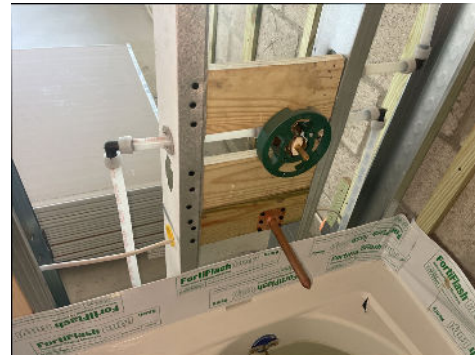
Bathroom #5

- Bathtub(s) appeared to be in serviceable condition.
- Bathtub supply plumbing appears to be in serviceable condition.
- Bathtub drain plumbing appears to be in serviceable condition.

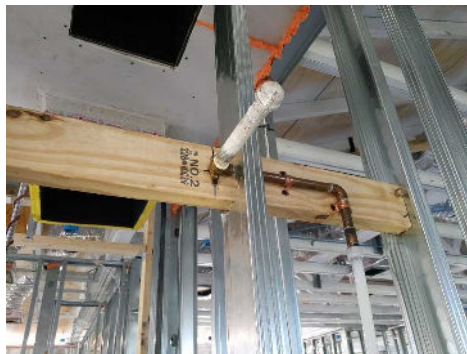
Shower(s) drain plumbing appeared to be in serviceable condition.

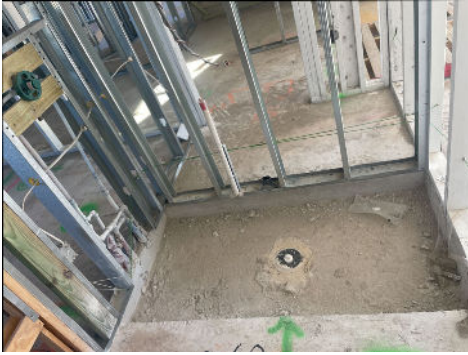
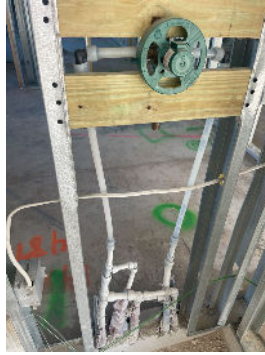
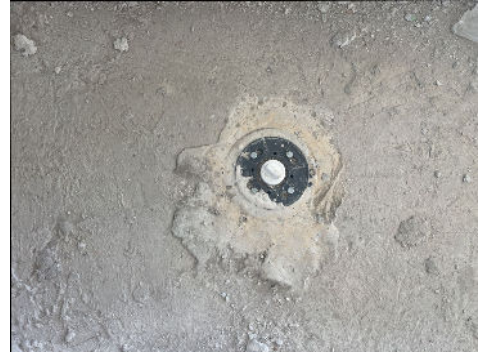
Bathroom #2

- Shower(s) supply plumbing appeared to be in serviceable condition.
- Shower(s) drain plumbing appeared to be in serviceable condition.
- Shower(s) appeared to be in serviceable condition.
- Shower wall needed to be secured. Should be checked at final inspection.

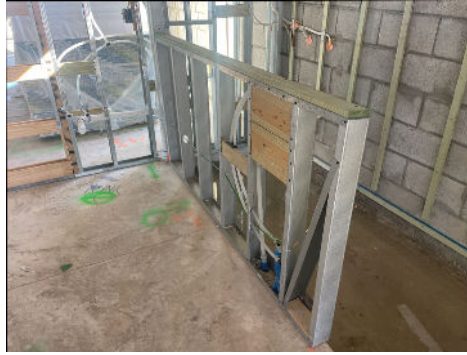
Shower wall needed to be secured. Should be checked at final inspection.

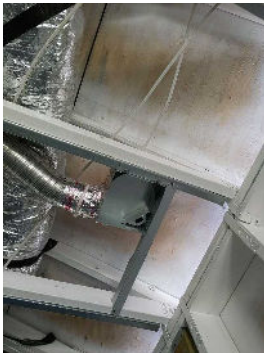
Bathroom #2

Ventilation fan housing and vent piping appeared to be in serviceable condition.

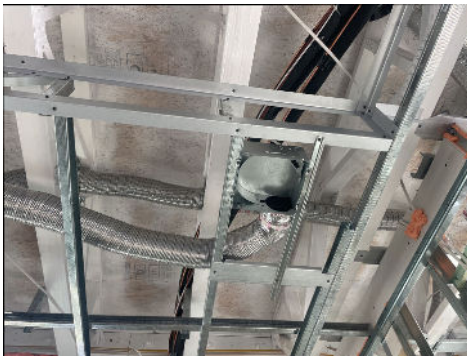
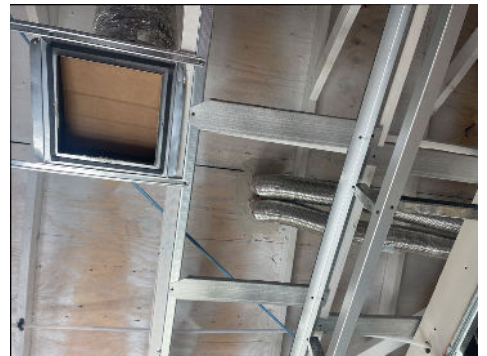
Master

- Ventilation fan housing and vent piping appeared to be in serviceable condition.

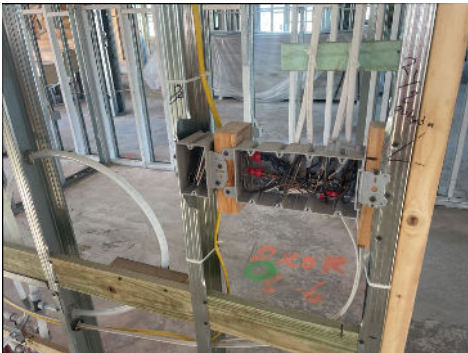
Master

- GFCI wiring appeared to be in serviceable condition.

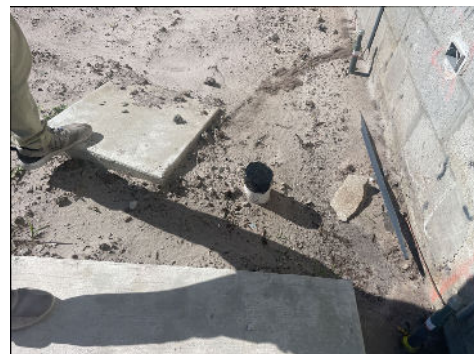
Clean out drain(s) were visible

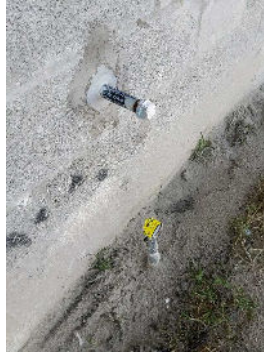
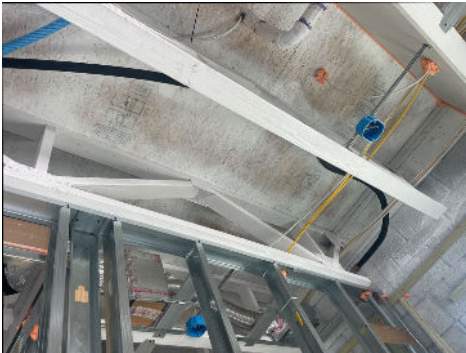
Rough plumbing for the fuel system appeared serviceable.

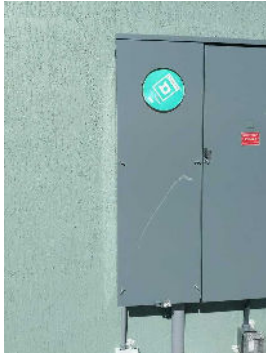
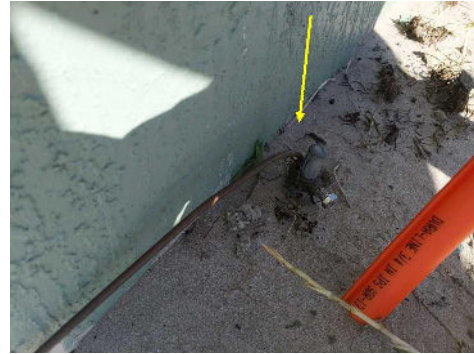
Rod grounding

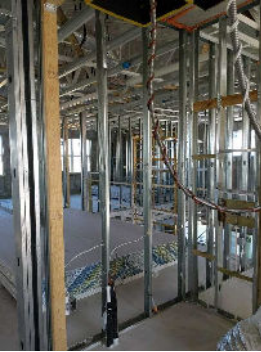
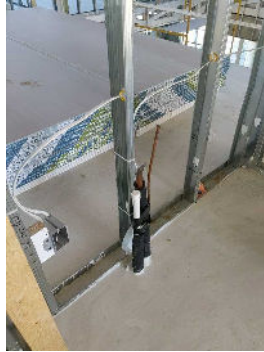
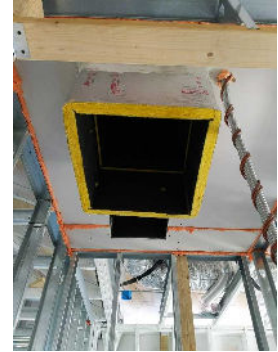
## 9. Heating System 3 Condition

- Heating system platform appeared serviceable.
- Rough plumbed refrigerant and condensate lines appeared serviceable.
- Insulation on refrigerant and condensate line were installed.

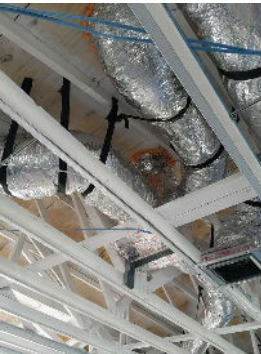
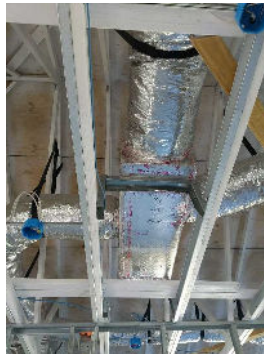
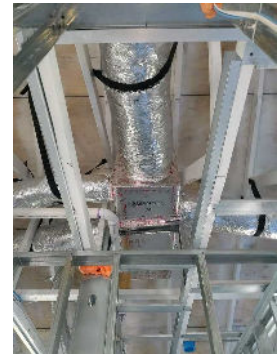
## 10. Distribution

- Visible ducts appeared to be in serviceable condition.

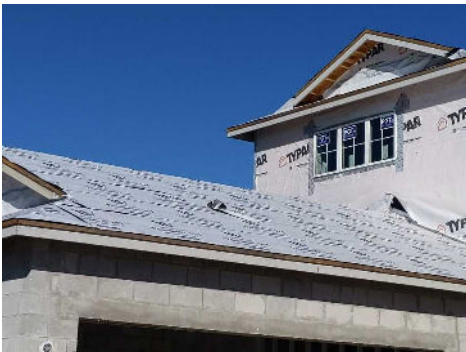
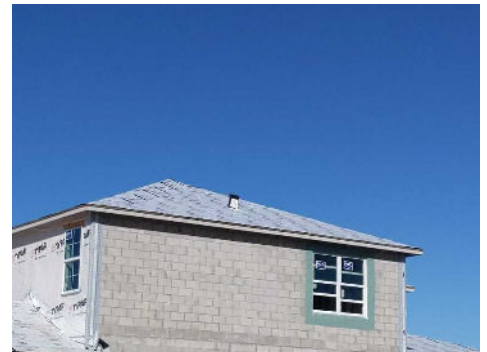
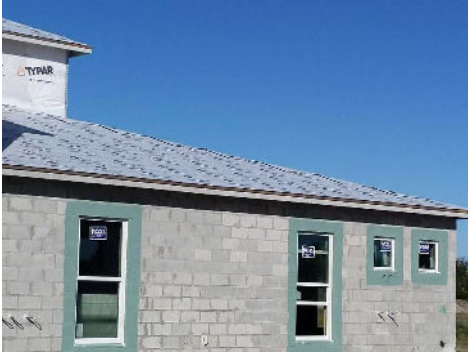
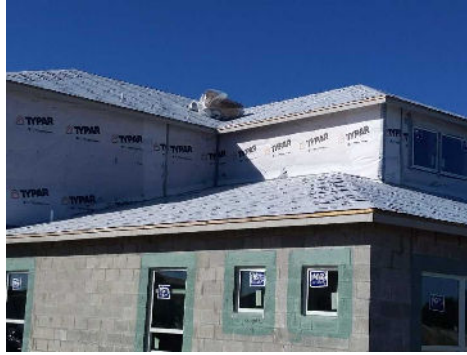
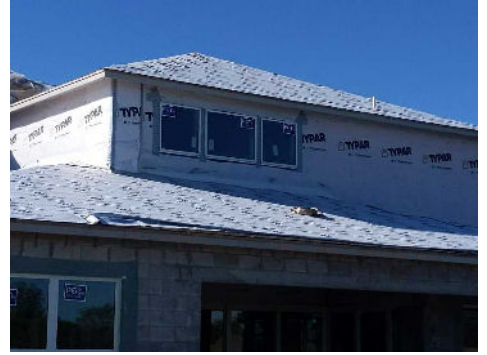
## 1. Main Roof

- Roof was not completely installed.
