# WAYPOINT

## INSPECTIONREPORT

Age: 1986 Heated Sq Ft: 39515

Inspection Date: 9/4/2023

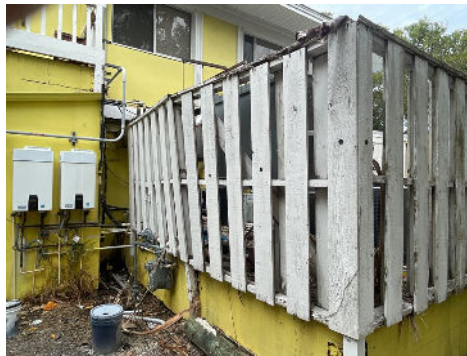
Fence were damaged.

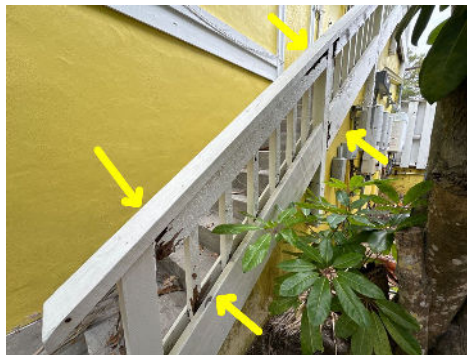
Rails were damaged.

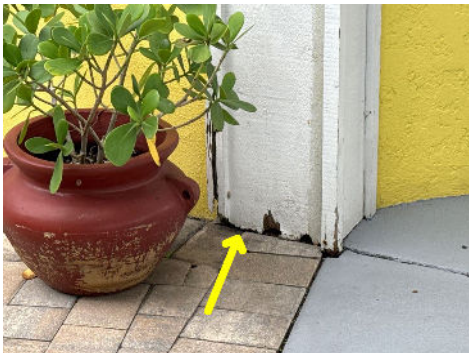
Trim pieces had visible damage at multiple locations.

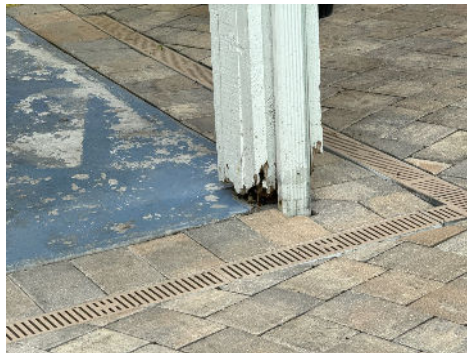
Trim pieces had visible damage at multiple locations.

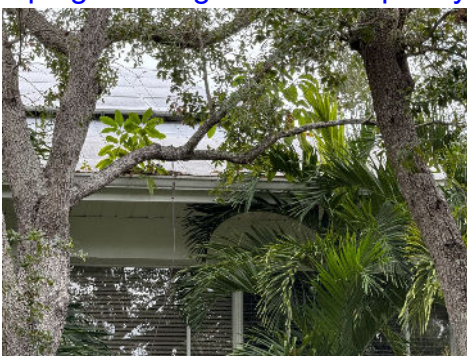
Gutters were filled with debris and the drains were blocked.

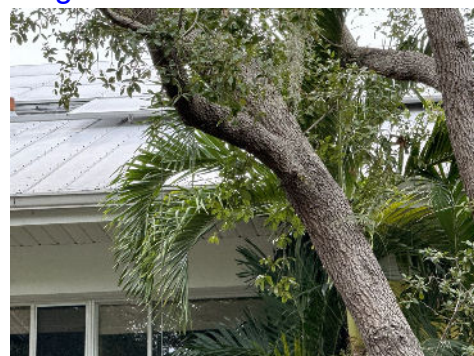
Landscaping and vegetation was poorly maintained and overgrown.

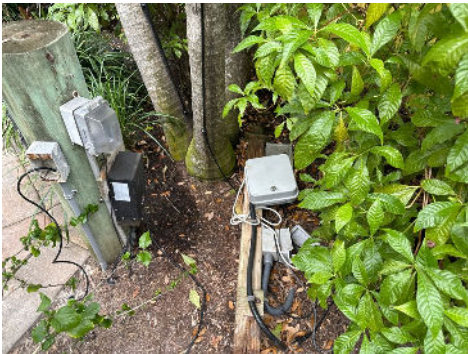
Sprinkler control box was damaged.

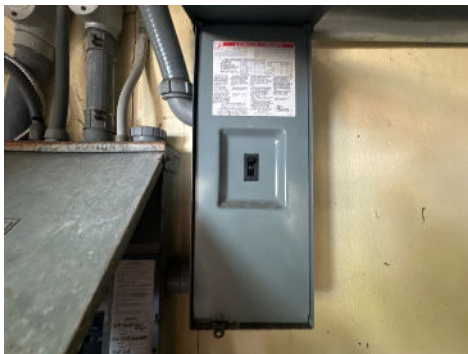
Electrical Main Panel 1 was in good condition: No. **Neutral conductor was not identified/taped white.**

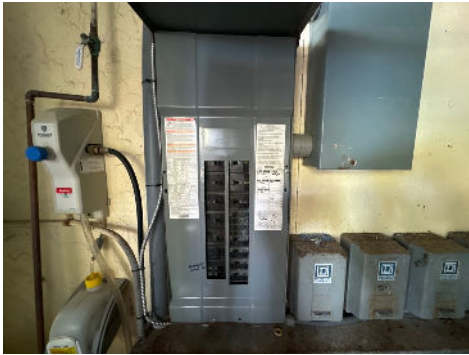
Double Tap connection was visible.

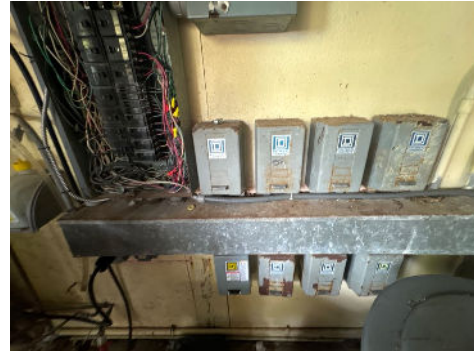
Disconnects were not labeled.

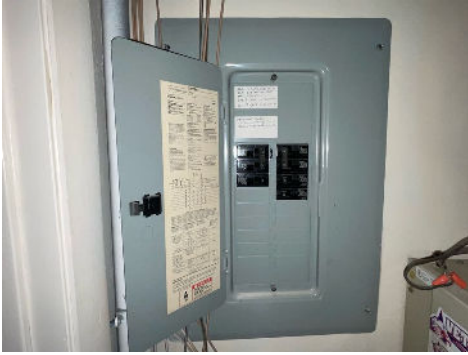
## 5. Sub-Panel C Condition

- Electrical panel was in good condition: No.
- **Fasteners should be rated for panel type to prevent damage to wiring.**

Fasteners should be rated for panel type to prevent damage to wiring.

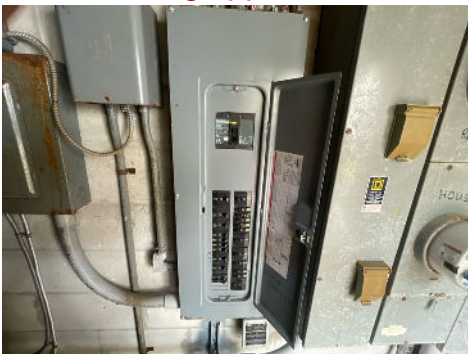
## 7. Sub-Panel E Condition

- Electrical panel was in good condition: No.
- Neutral and ground wires improperly shared the same buss bar.
- Defective breaker(s) were present.
- Panel wiring appeared to be corroded/discolored.

Neutral and ground wires improperly shared the same buss bar.

Panel wiring appeared to be corroded/discolored.

Defective breaker(s) were present. Rust/corrosion present.

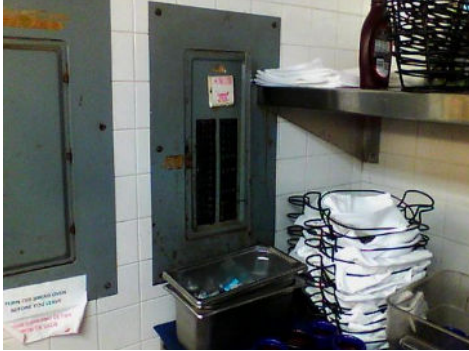
## 10. Sub-Panel H Condition

- Electrical panel was in good condition: Yes.
- Panel was not accessible for inspection. Panel was blocked.
- Area around the panel box should be kept clear in front (30") and side to side (36") for accessibility.

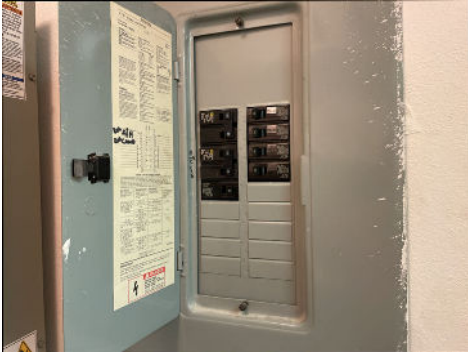
## 12. Sub-Panel J Condition

- Electrical panel was in good condition: No.
- Breakers did not have a brand matching the brand of the panel box.

Breakers did not have a brand matching the brand of the panel box.

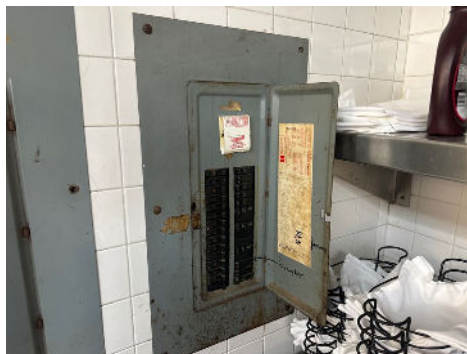
### 14. Sub-Panel L Condition

- Electrical panel was in good condition: No.
- Panel was not accessible for inspection. Panel was blocked.
- Breakers had grease contamination. Fire hazard.

Breakers had grease contamination. Fire hazard.

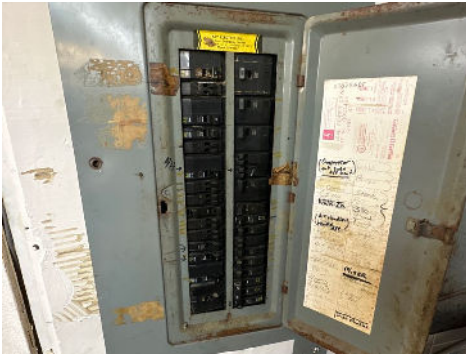
## 15. Sub-Panel M Condition

- Electrical panel was in good condition: No.
- Breakers had grease contamination. Fire hazard.

Breakers had grease contamination. Fire hazard.

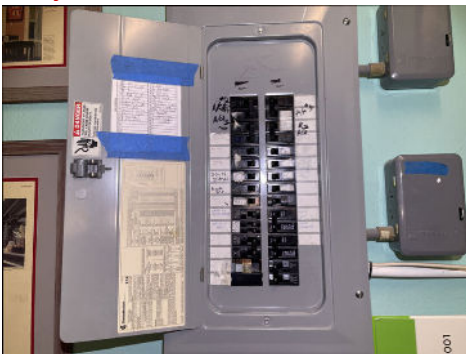
## 16. Sub-Panel N Condition

- Electrical panel was in good condition: No.
- Unprotected opening(s) were present.
- Challenger service panels and breakers were present. These panels are outdated and should be evaluated by licensed electrician.

Challenger service panels and breakers were present. These panels are outdated and should be evaluated by licensed electrician.

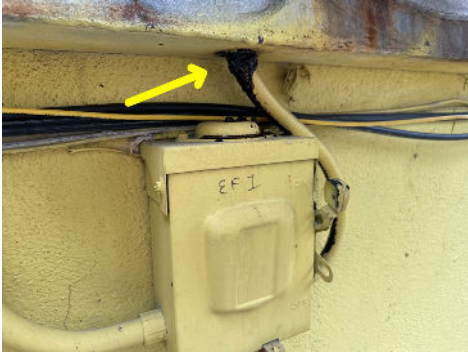
Exposed wiring was not properly protected at air condensing unit.

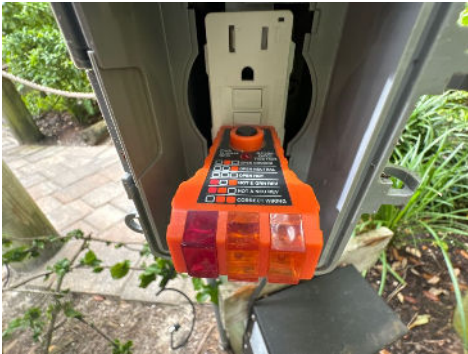
Outlet(s) were not operational at exterior.

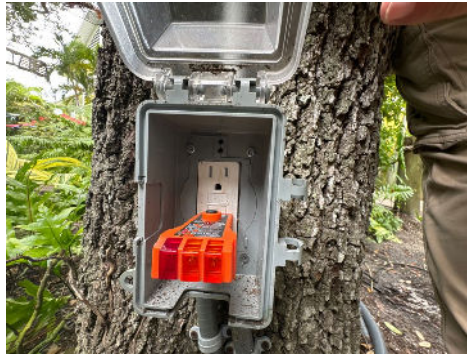
Outlet(s) were not operational at exterior.

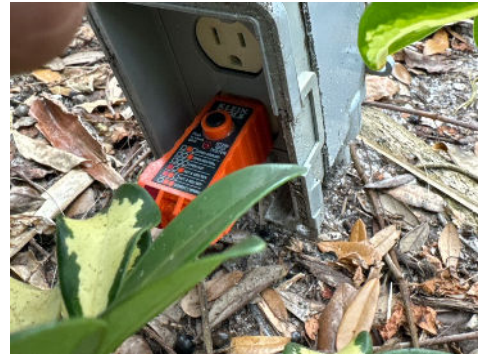
Outlet(s) were not operational at exterior.

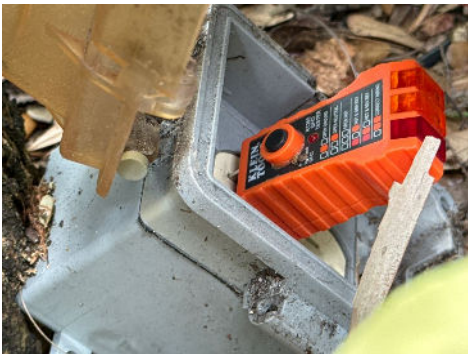
Outlet(s) were not operational at exterior.

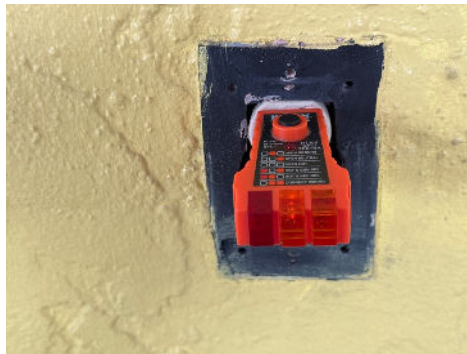
Outlet(s) tested not grounded at exterior.

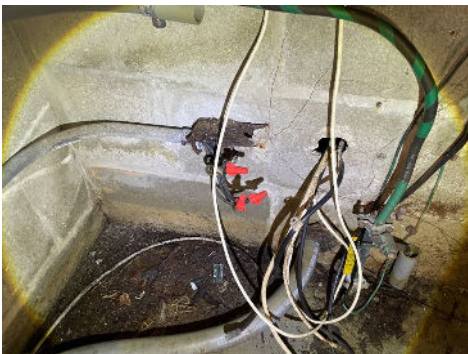
Exposed wiring was not properly protected at the electrical room

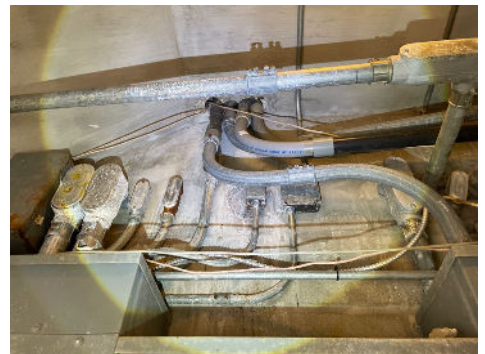
The buildings electrical room appears to have water intrusion through the stairway above.

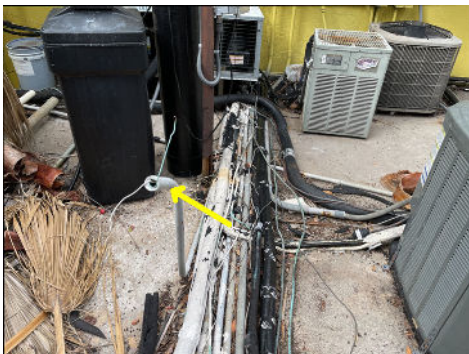
Exposed wiring was not properly protected at multiple locations.  
Rear

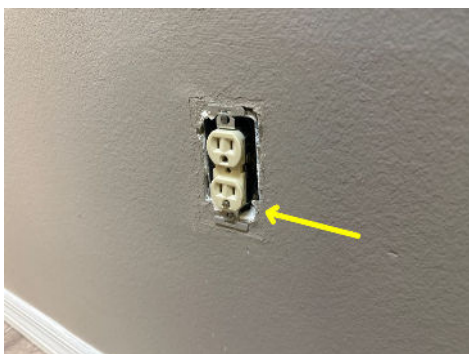
Outlet(s) were damaged (Unit 204).

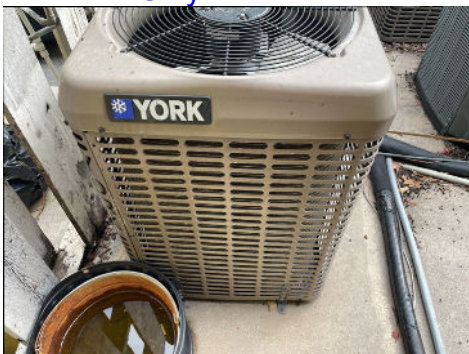
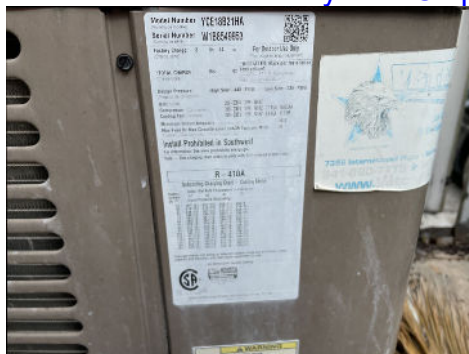
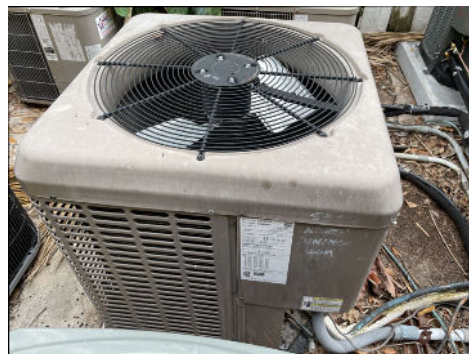
- Not all units were available for testing due to no access available.
- All HVAC systems should be evaluated and serviced by HVAC specialist.

Location: Rear, Manufacturer: York, Age: 2018, Size of Tonnage: 1.5 Ton

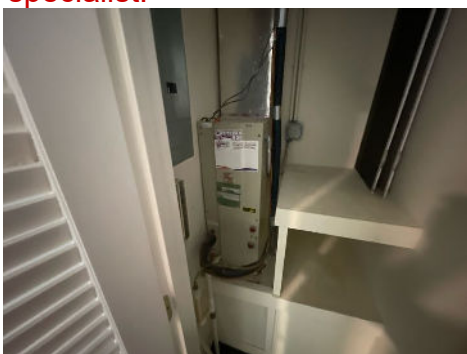
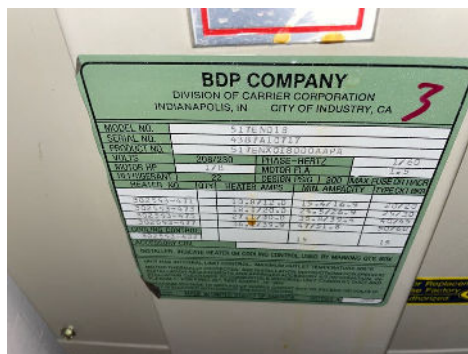
- Observations:
- Not all units were available for testing due to no access available.
  - Heating system made an unusual noise.
  - Based on the condition of the heating system(s), it should be evaluated by a licensed HVAC specialist.

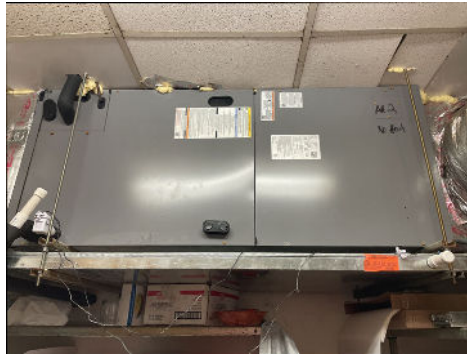
Location: Interior Closet,  
Manufacturer: International  
Comfort Products, Age: 2023,  
Size of Tonnage: 5 Ton

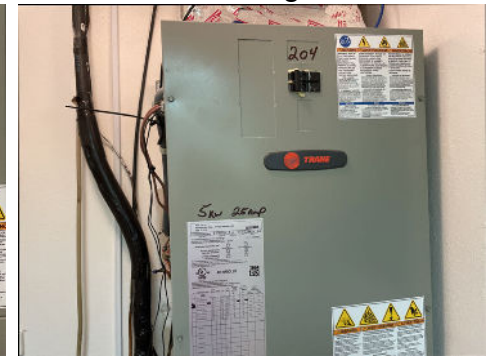
Heating system made an  
unusual noise (Suite 204).

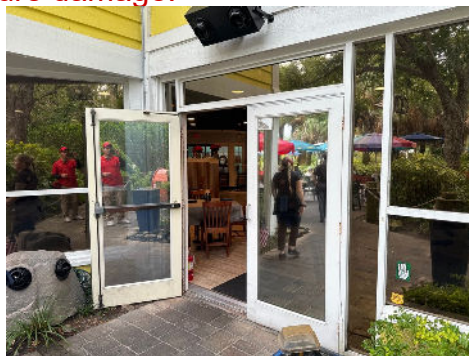
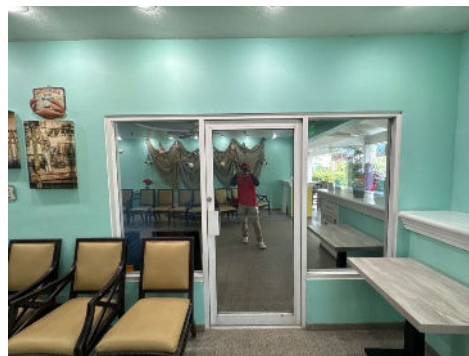
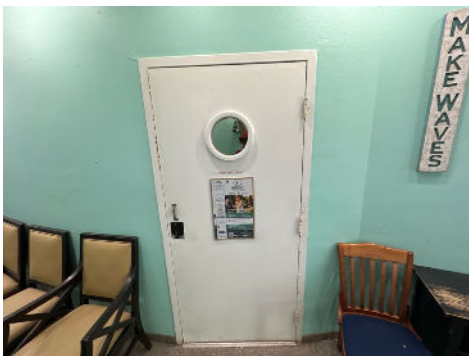
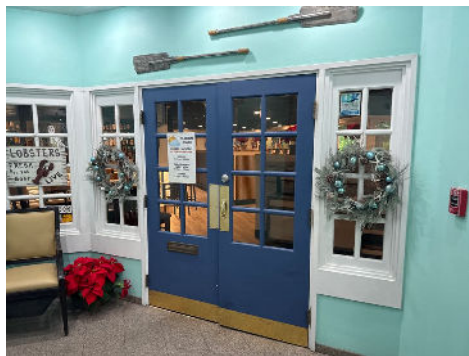
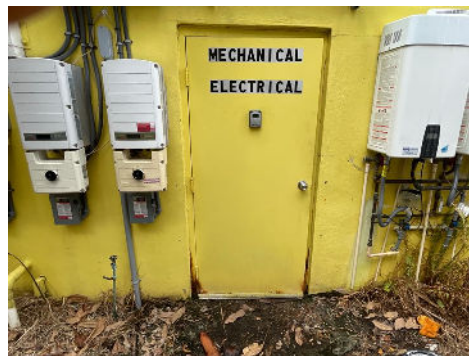
- The front door frame was damaged.
- The front door had visible moisture damage.

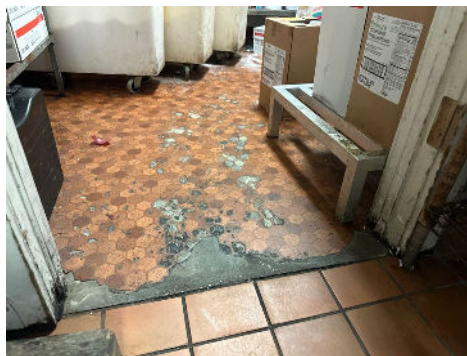
- Flooring was damaged at kitchen.

Flooring was damaged at kitchen.

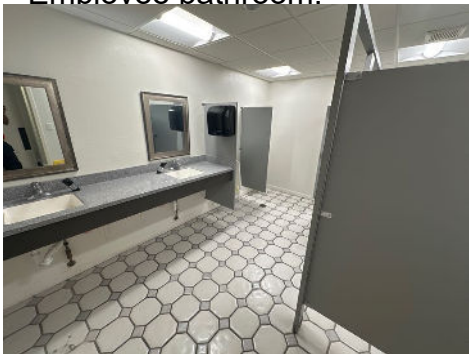
Men's bathroom.

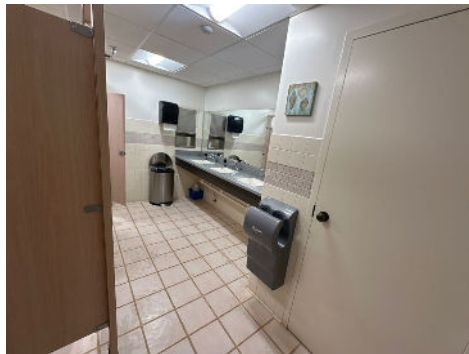
Women's bathroom.

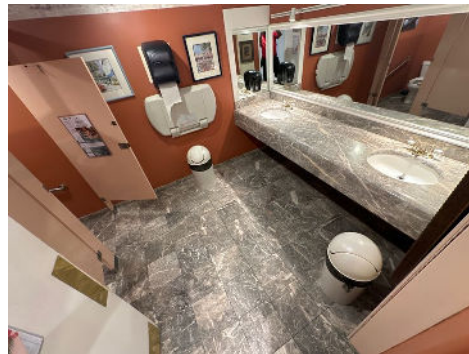
Women's bathroom.

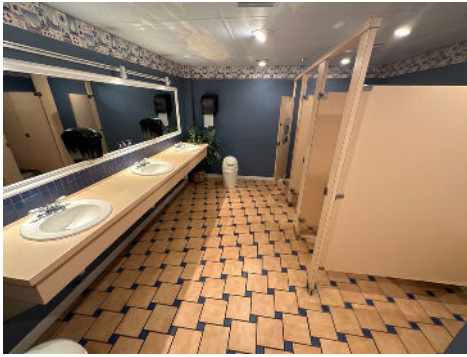
Men's bathroom.

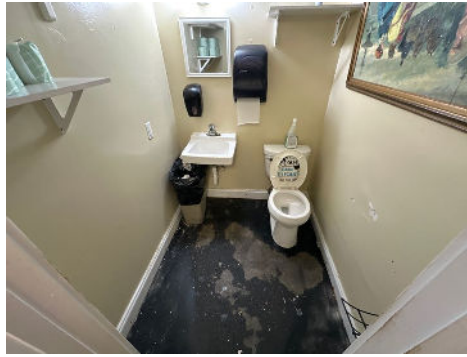
Employee bathroom.

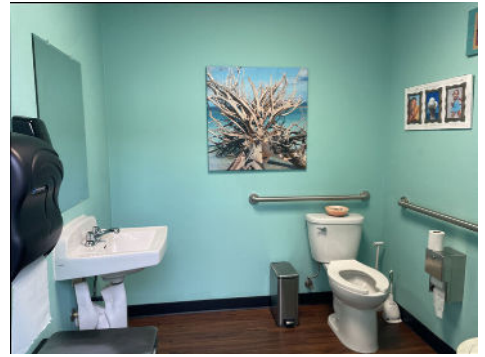
Employee bathroom.

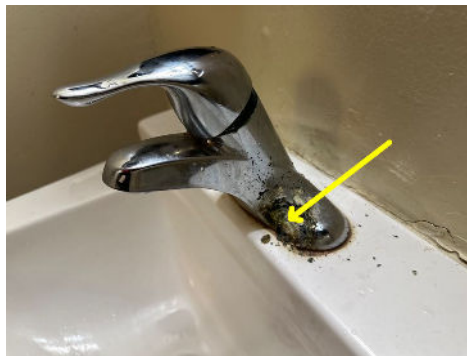
- Faucet was damaged at employee bathroom.

Faucet was damaged at employee bathroom.

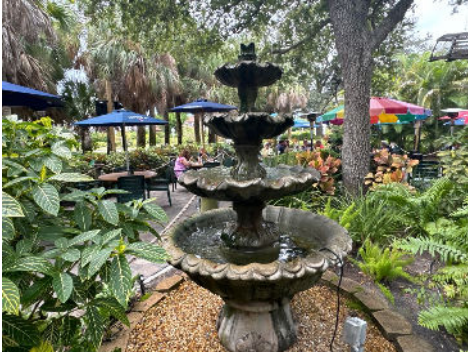
Water fountain system was present.

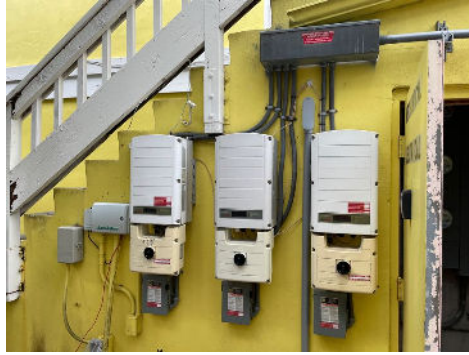
Solar panel system was present.

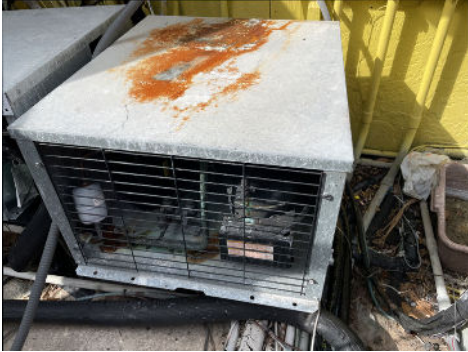
Restaurant cooler/freezer systems.

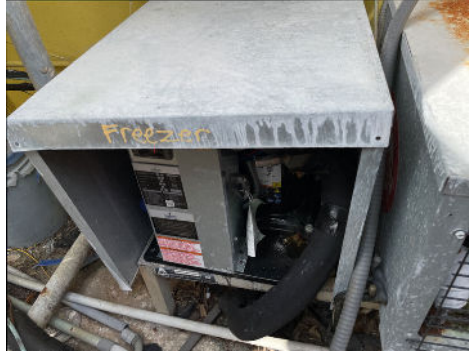
Restaurant cooler/freezer systems.

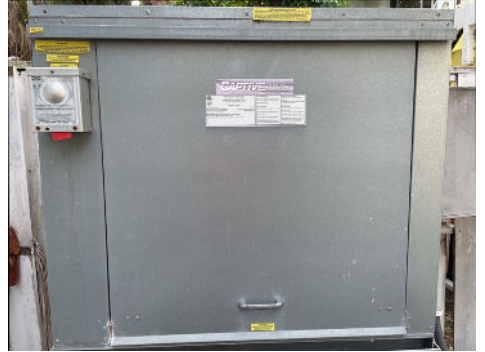
Restaurant ventilation systems.

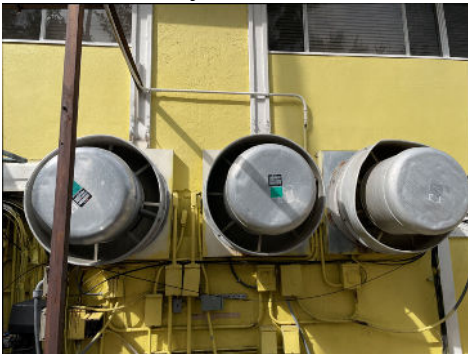
Restaurant ventilation systems.

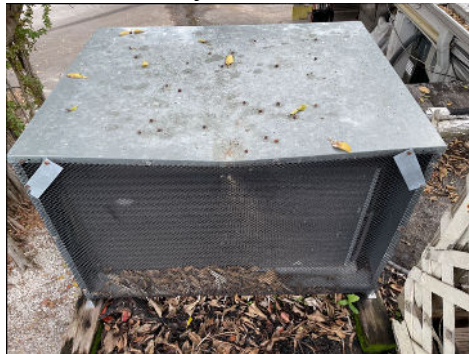
Restaurant cooler/freezer systems.

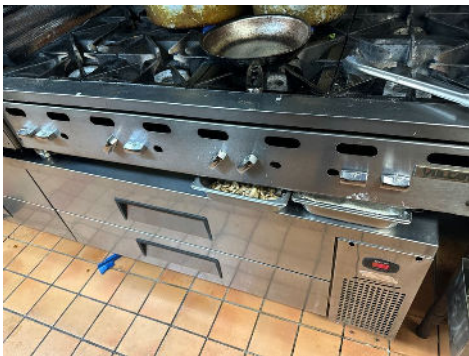
Mini-refrigerator was present.

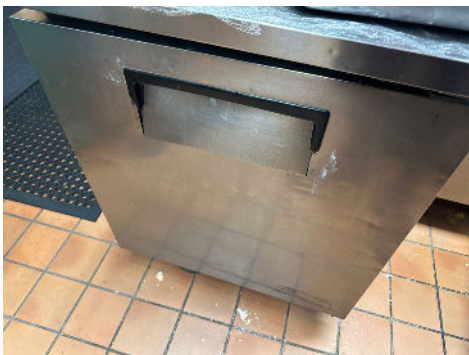
Mini-refrigerator was present.

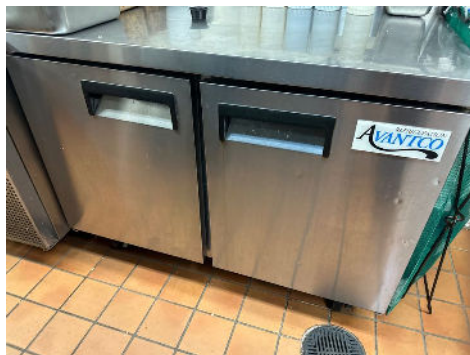
Mini-refrigerator was present.

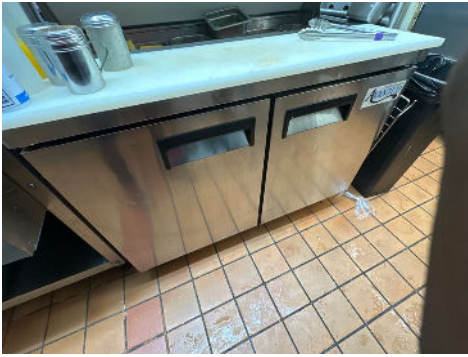
Mini-refrigerator was present.

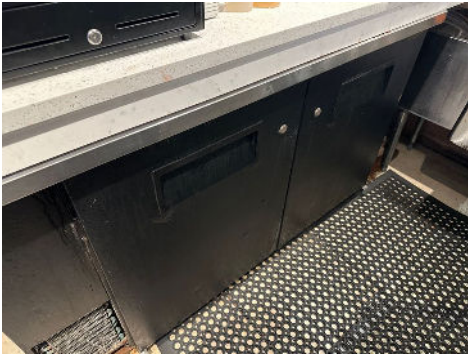
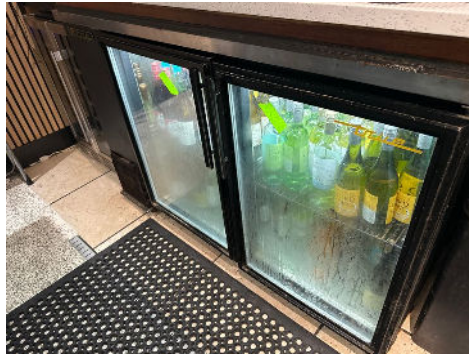
Mini-refrigerator was present.
