Property Inspection, LLC

INSPECTION REPORT

SAMPLE- 9876 Commercial Blvd Suite 600 Tampa, FL 32824

Inspection Date: 2/23/2024

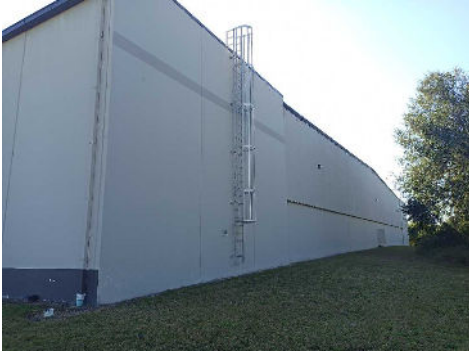
Side view Roof access was locked.

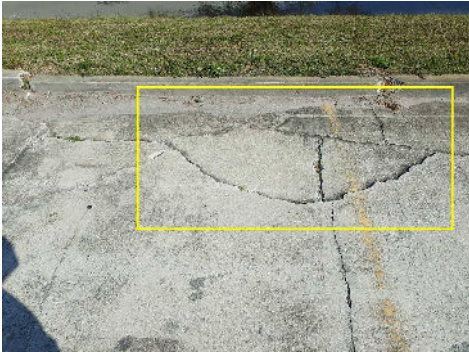
Parking lot had large and displaced crack(s) visible.

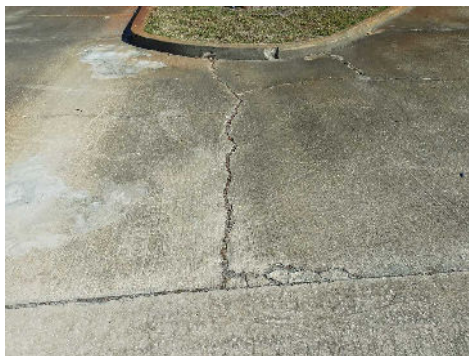
Parking lot had large crack(s) visible.

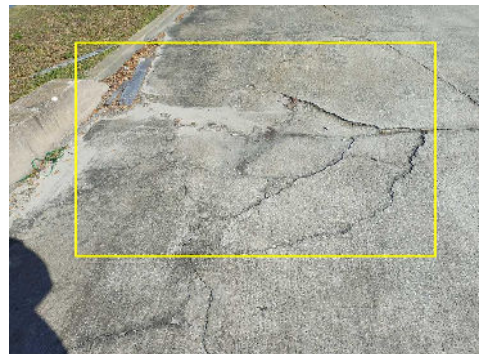
Parking lot had large and displaced crack(s) visible.

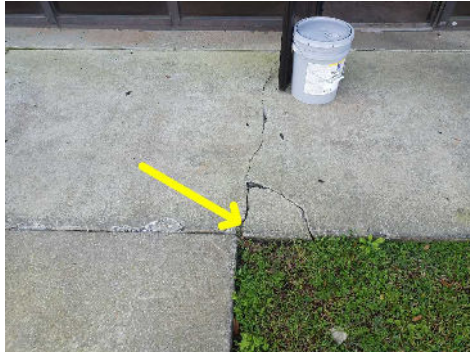
Walkway had large and displaced crack(s) visible.

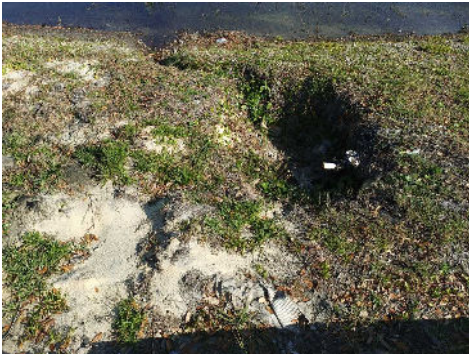
Visible signs of erosion were present.

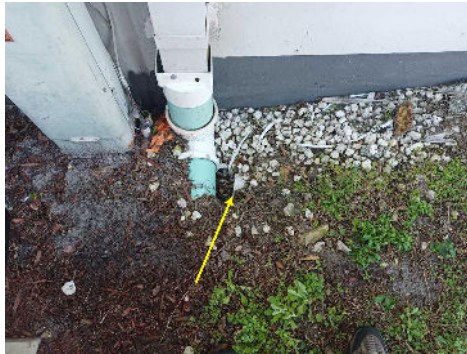
Visible signs of erosion were present.

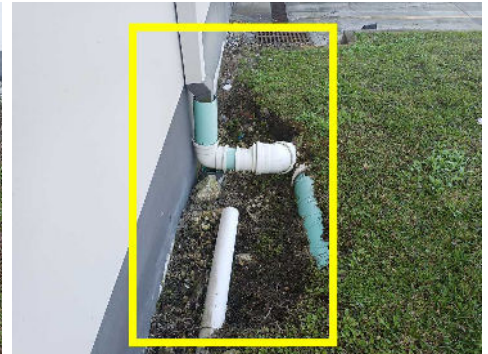
Visible signs of erosion were present.

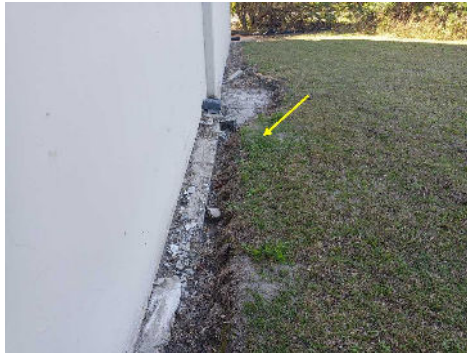
Visible signs of erosion were present.

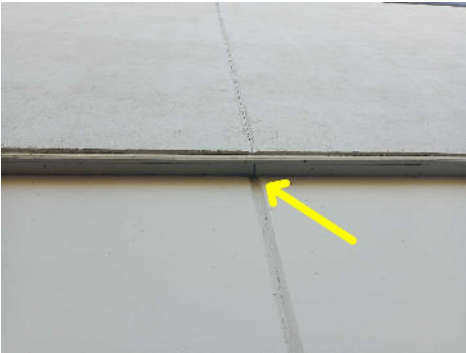
Settlement up to 1/8" cracks were visible at .

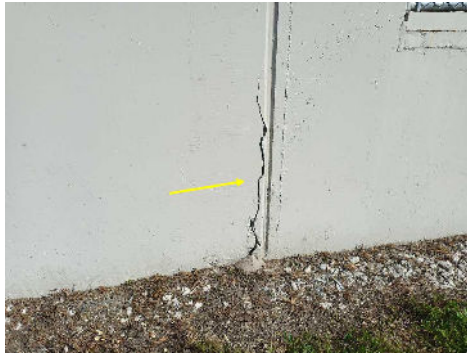
Large and/or displaced cracks were visible at rear.

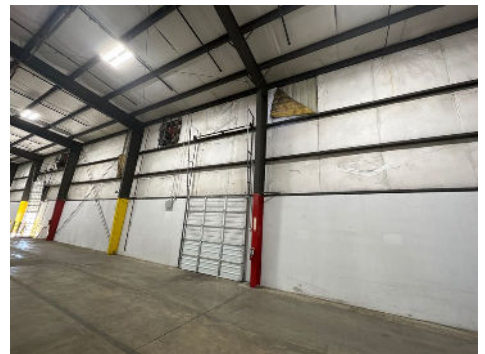
Insulation has been disturbed.

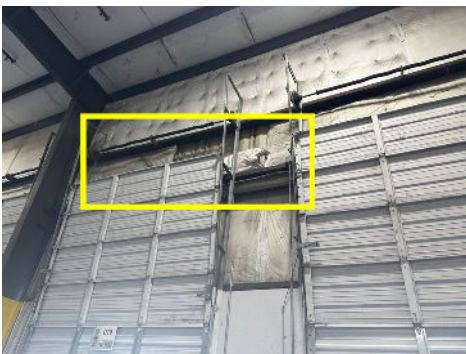
Insulation has been disturbed.

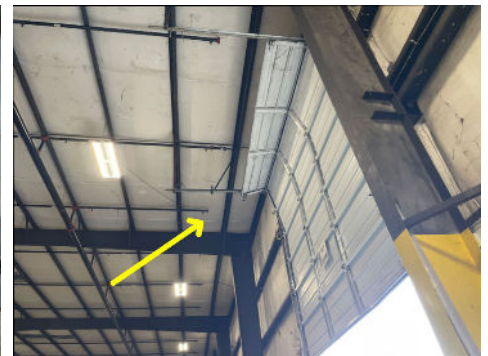
Door is off track number 27

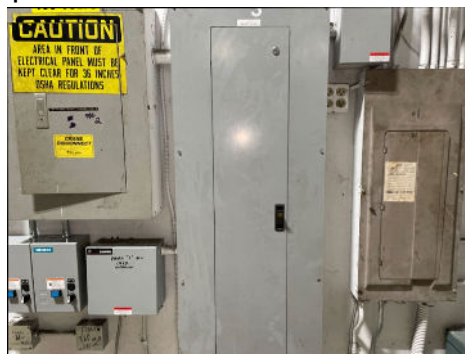
- Panel was not accessible for inspection. .

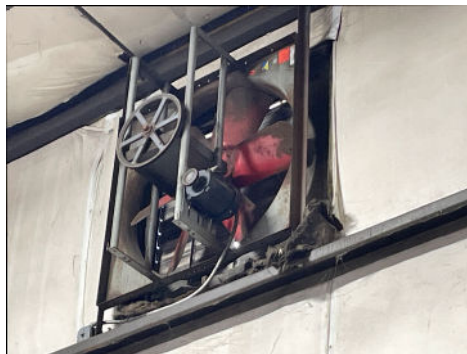
Exhaust fans were not operational.

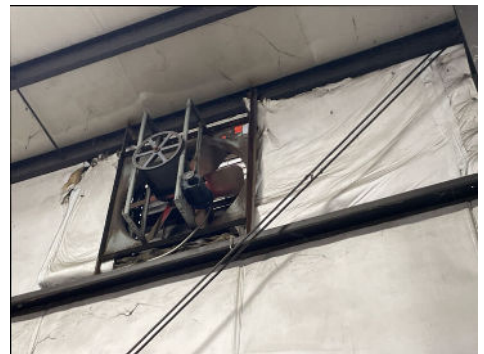
Exhaust fans were not operational.

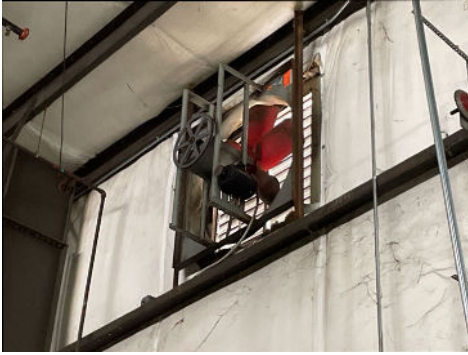
Exhaust fans were not operational.

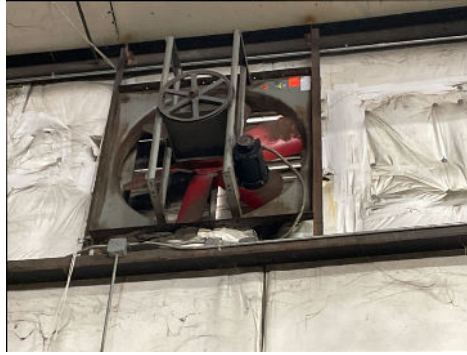
Exhaust fans were not operational.

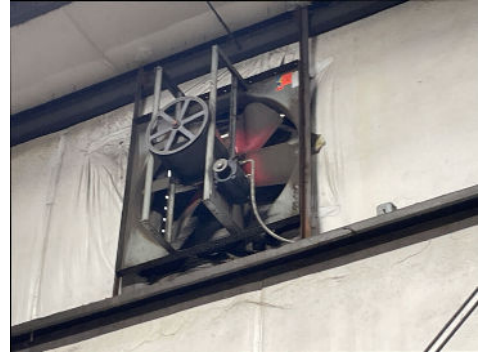
Exhaust fans were not operational.

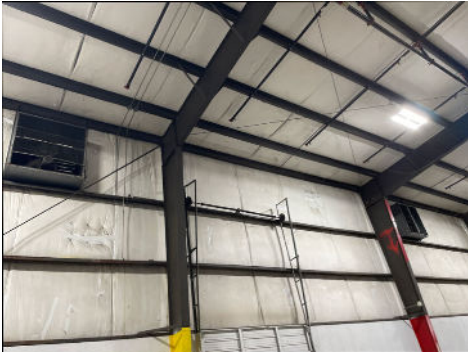
Exhaust fans were not operational.

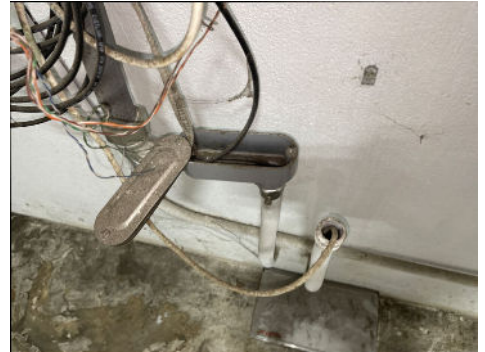
Junction box cover has been removed.

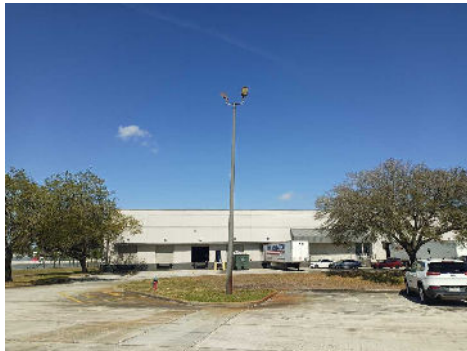
Parking lot lighting could not be tested. Controlled by dusk to dawn sensors.

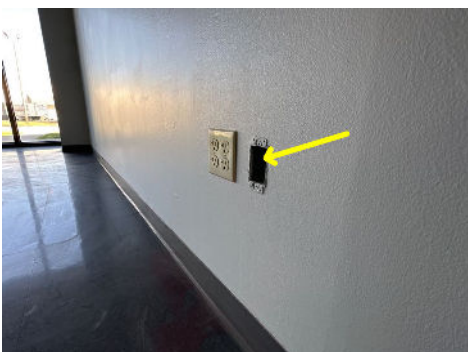
Cover plate(s) were not installed.

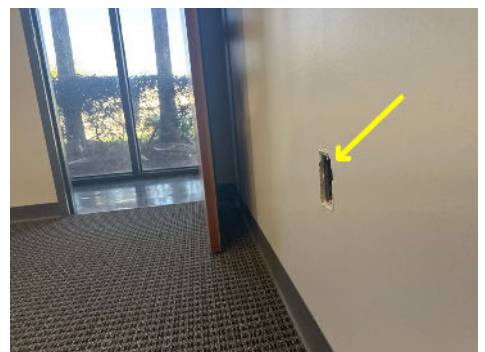
Cover plate(s) were not installed.

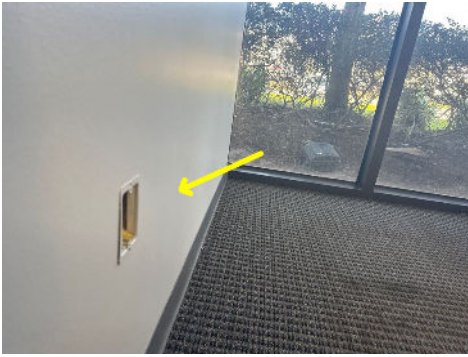
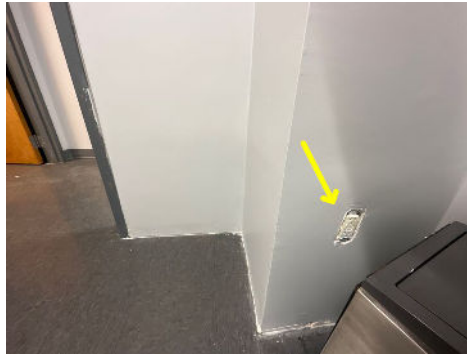
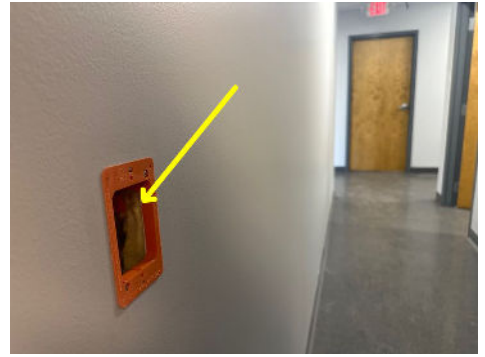
Cover plate(s) were not installed. Cover plate(s) were not installed. Cover plate(s) were not installed.

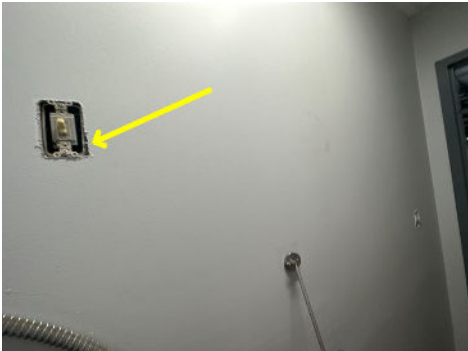
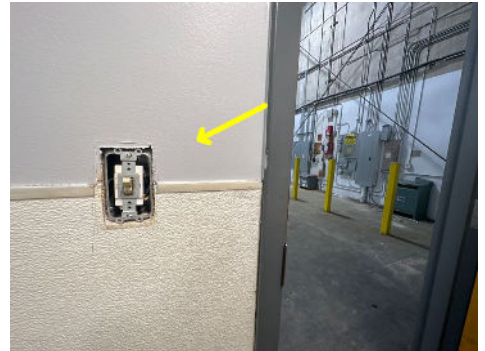
Cover plate(s) were not installed. Cover plate(s) were not installed. Cover plate(s) were not installed.

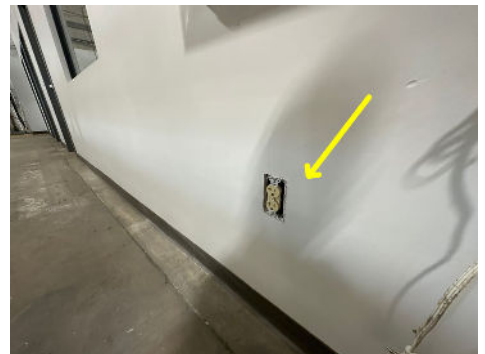
Cover plate(s) were not installed. Cover plate(s) were not installed. Cover plate(s) were not installed.

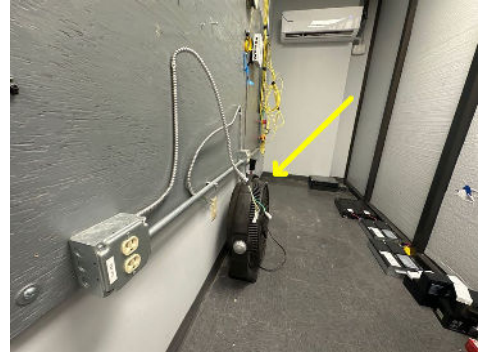
Exposed wiring was not properly protected at interior.

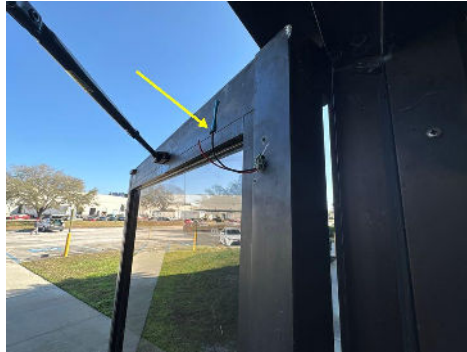
Exposed wiring was not properly protected at interior.

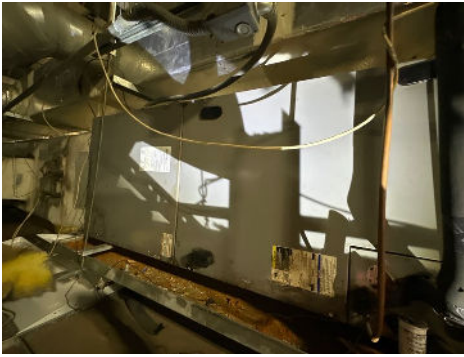
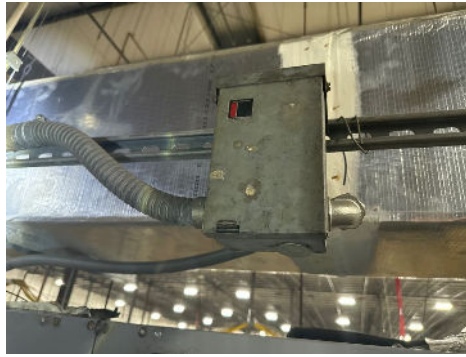
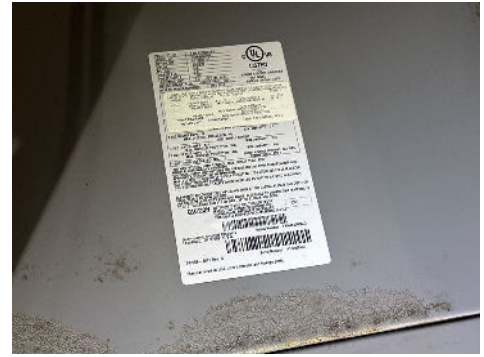
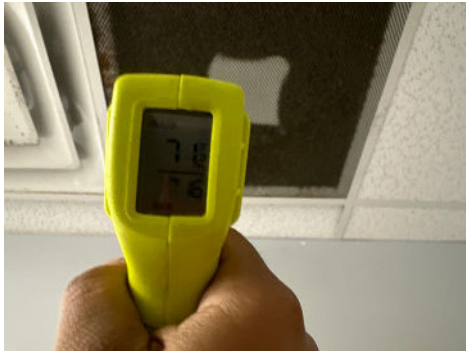
• Heating system did not operate properly. Air temperature differential was below manufacturer range of 25 - 30 degrees.

• Based on the condition of the heating system(s), it should be evaluated by a licensed HVAC specialist.

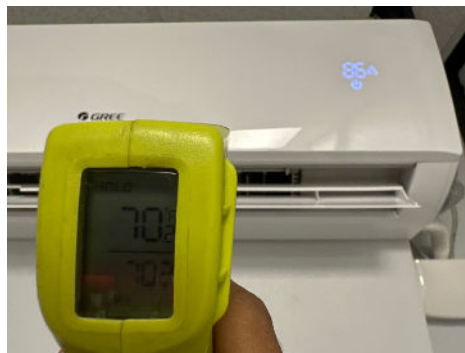
Heating system did not operate properly.

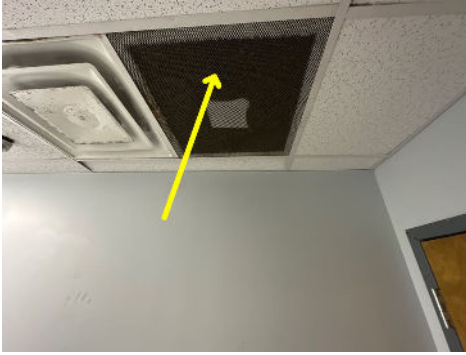
Registers were dirty with lint and dust.

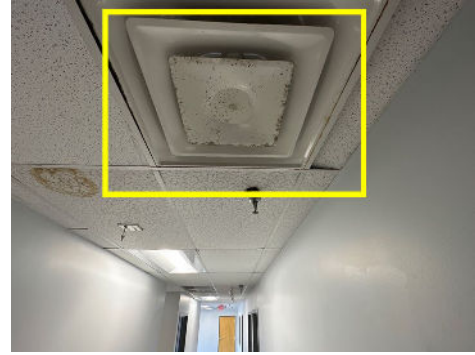
Microbial-like growth was visible at hallway

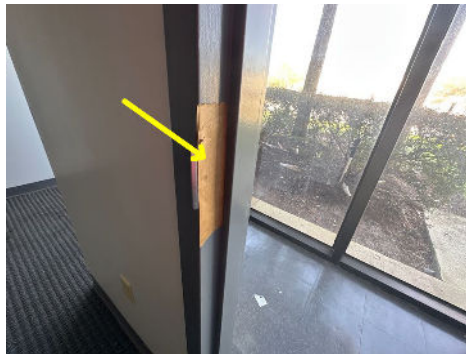
Door did not latch at multiple locations.

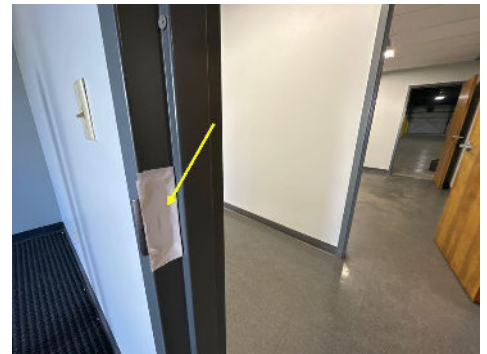
Door did not latch at multiple locations.

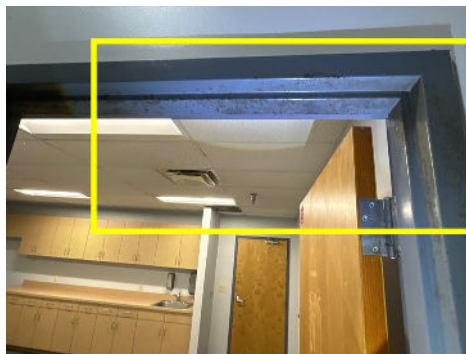
Microbial-like growth was visible at kitchen.

Page 24 Item: 1	Interior Doors Condition	<ul style="list-style-type: none"> • Microbial-like growth was visible at kitchen.
-----------------	--------------------------	---

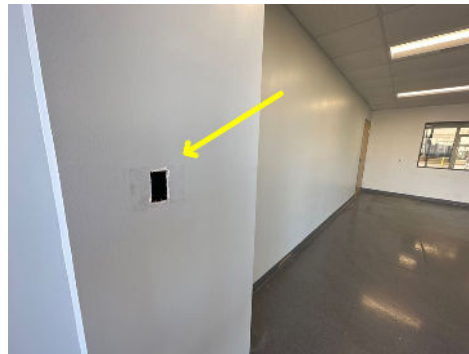
Touch-up paint/repairs needed at several areas.

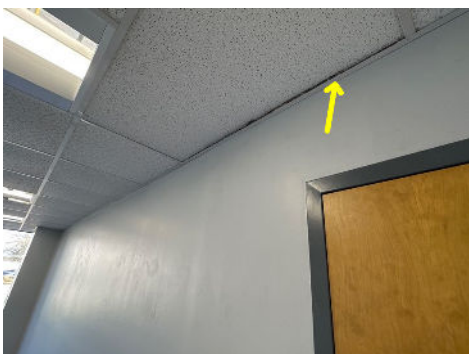
Ceiling tiles were cracked at multiple locations.

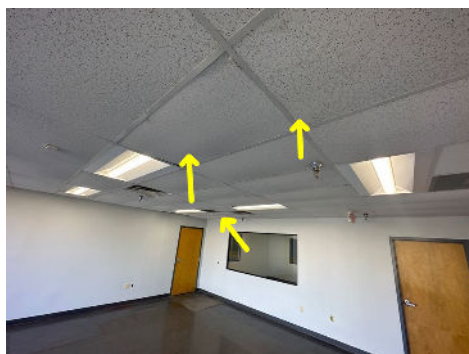
Ceiling tiles were cracked at multiple locations.

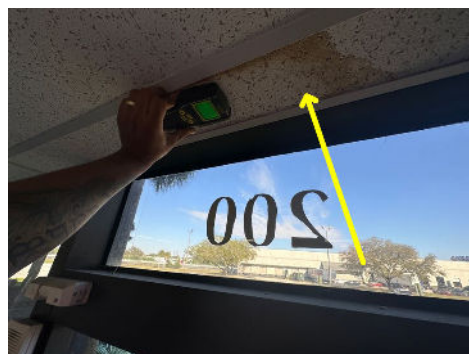
Although dry at the time of the inspection, the visible stain(s) indicated active leaks may be present at multiple locations.

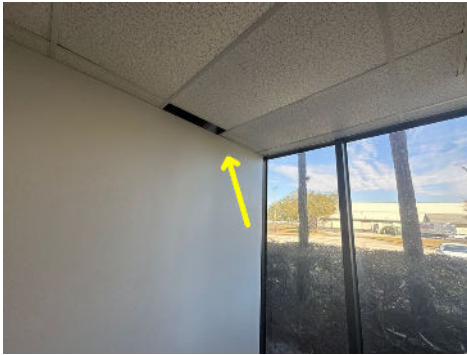
Ceiling tiles were cracked at multiple locations.

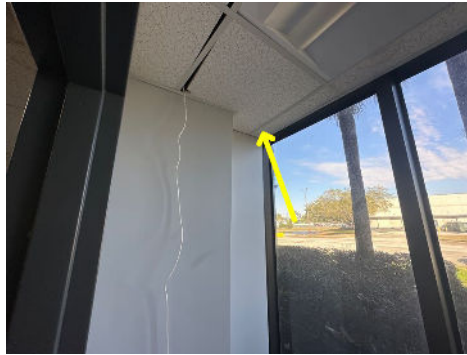
Ceiling tiles were cracked at multiple locations.

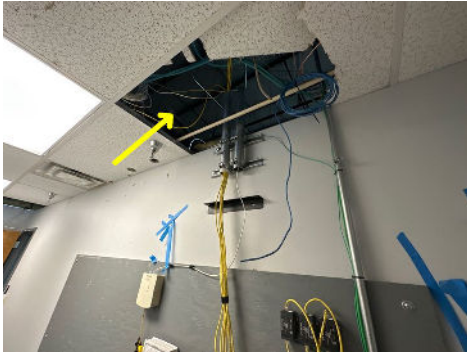
Ceiling tiles were cracked at multiple locations.

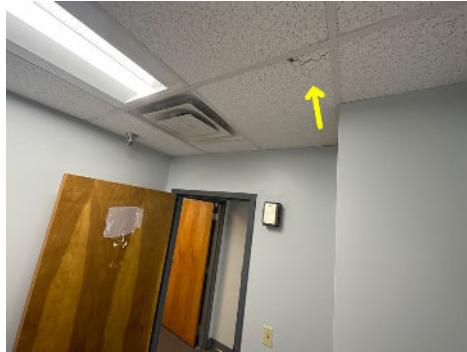
Ceiling tiles were cracked at multiple locations.

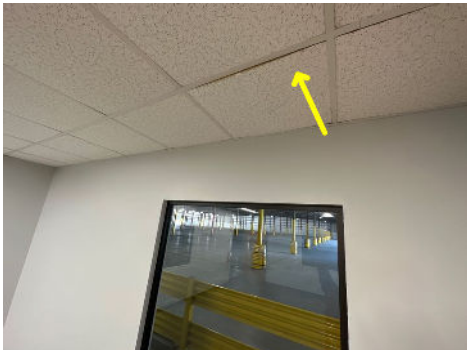
Ceiling tiles were cracked at multiple locations.

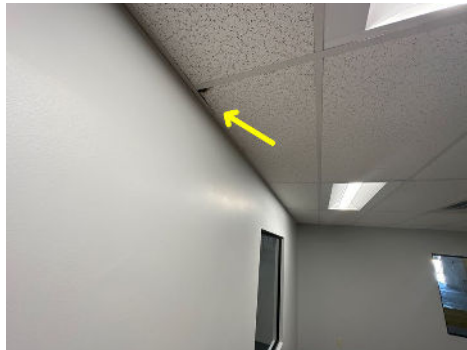
Ceiling tiles were cracked at multiple locations.

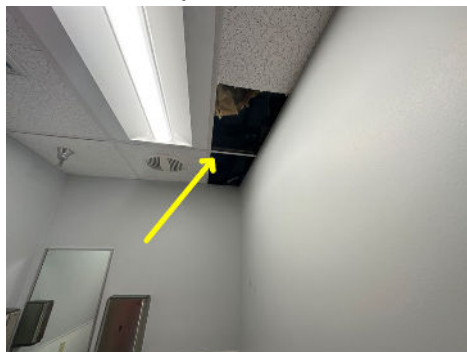
Ceiling tiles were cracked at multiple locations.

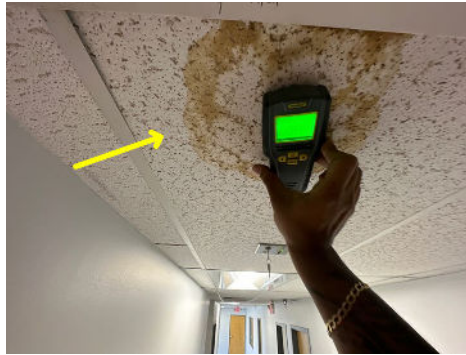
Although dry at the time of the inspection, the visible stain(s) indicated active leaks may be present at multiple locations.

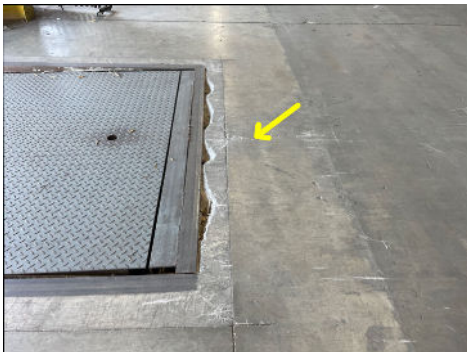
Concrete slab had physical damage dock door 20

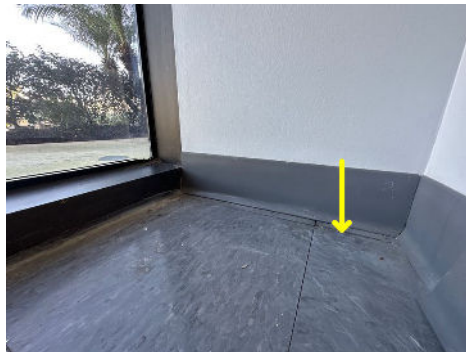
Cracked tiles were visible.

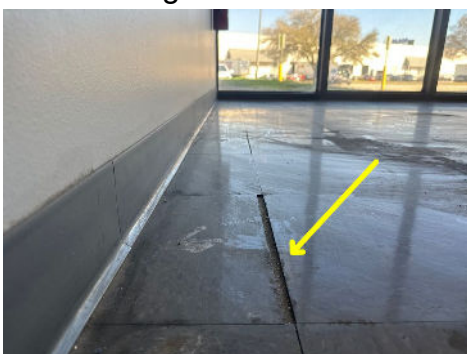
Cracked tiles were visible.

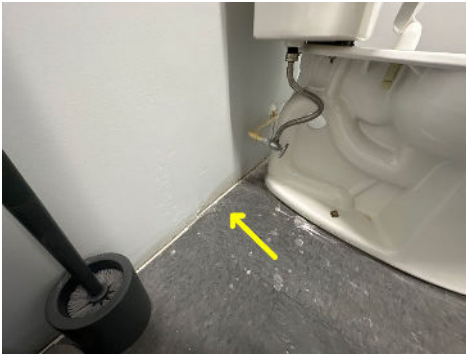
Tile grout was missing.

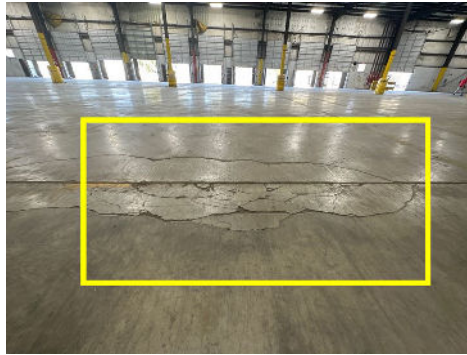
Flooring was damaged at multiple locations.

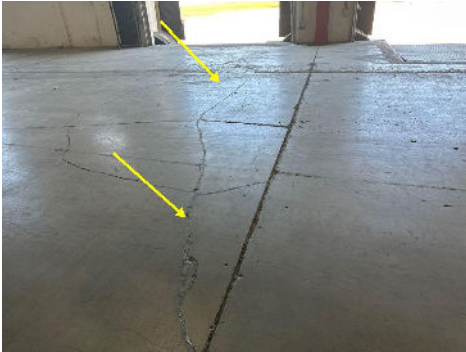
Settlement cracks were visible.

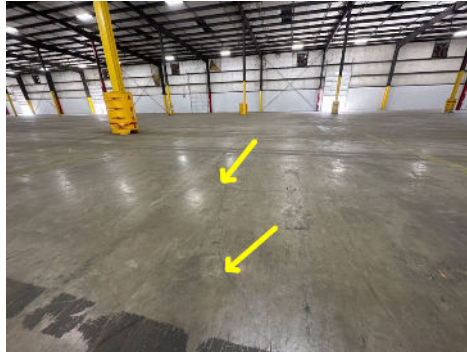
Settlement cracks were visible.

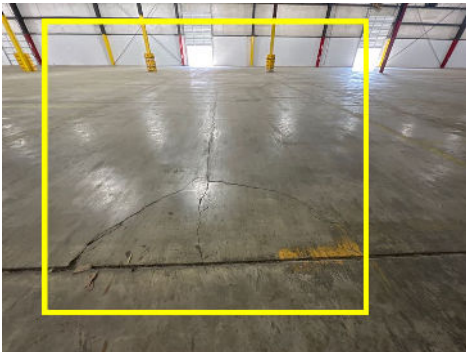
Settlement cracks were visible.

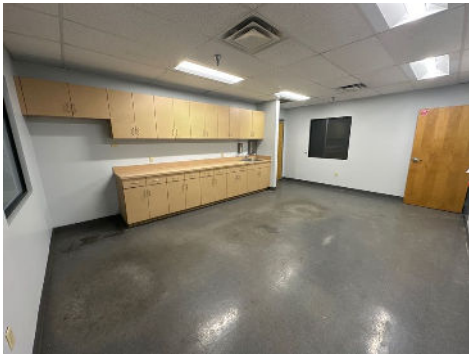
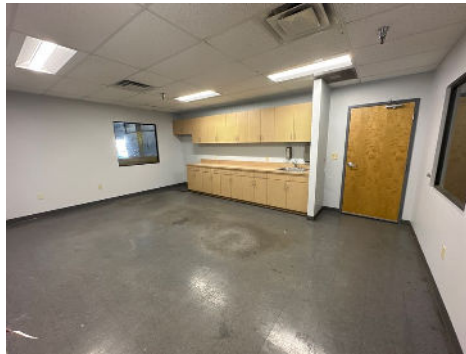
- Cabinets were worn.
