WAYPOINT

INSPECTION REPORT

1234 Easy Street Tampa, FL 33619

Inspection Date: 1/20/2024

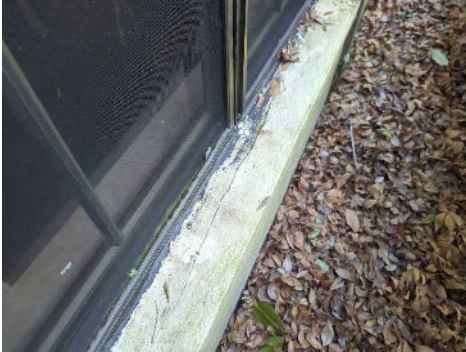
Settlement up to 1/8" cracks were visible at front.

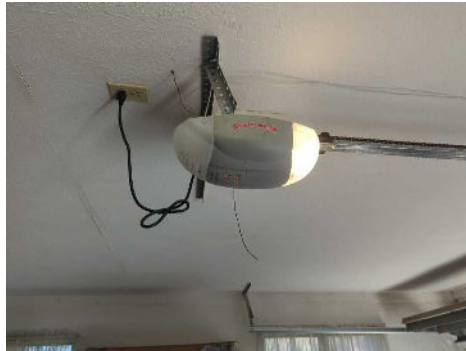
- Automatic PRESSURE REVERSE and/or ELECTRONIC EYE(S) safety feature did not operate when tested.

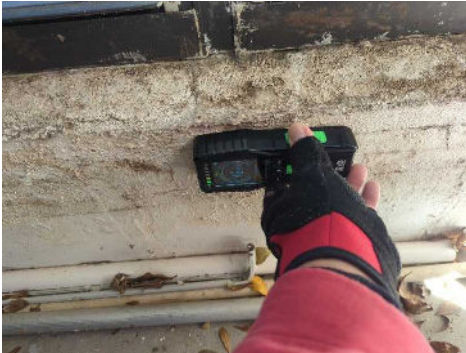
Visible moisture stain(s) indicated active leak(s) were present.

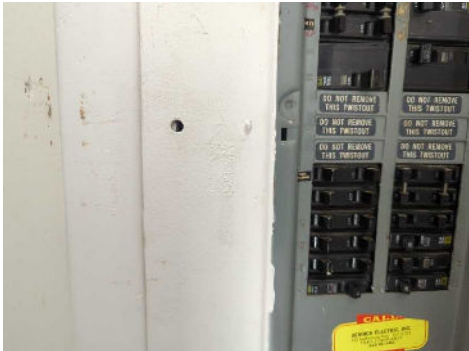
Fasteners were missing.

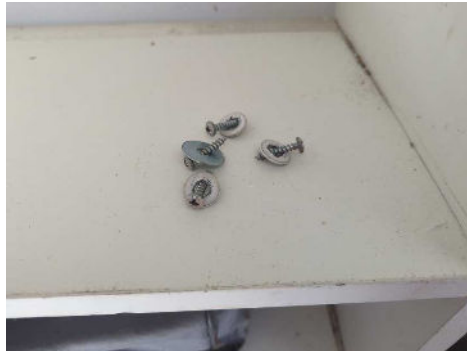
Fasteners were missing and improper.

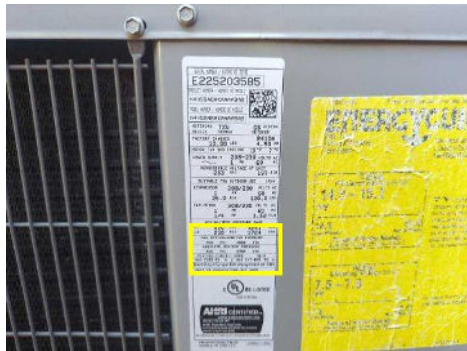
Breaker size at panel exceed the max rating (over fused) at the AC Condenser Unit

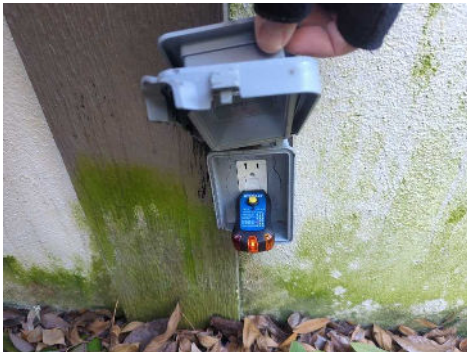
GFCI (Ground Fault Circuit Interrupter) outlet(s) tested as not grounded at exterior outlets.

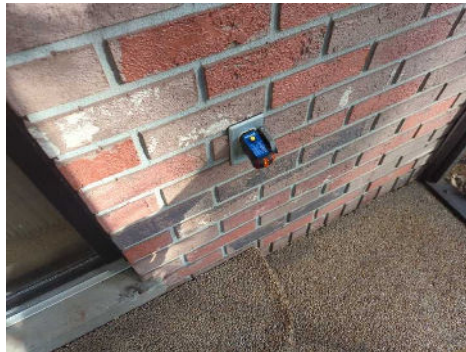
GFCI (Ground Fault Circuit Interrupter) outlet(s) should be installed at all wet areas.

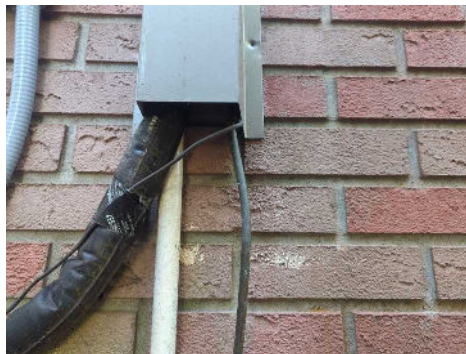
Steel wool/expanding foam should be installed at the base of the refrigerant chase to prevent pest intrusion into the house/attic.

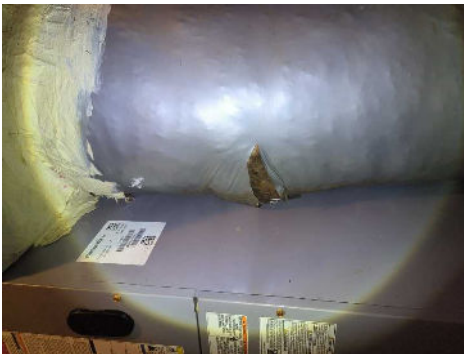
Visible ducts were damaged.

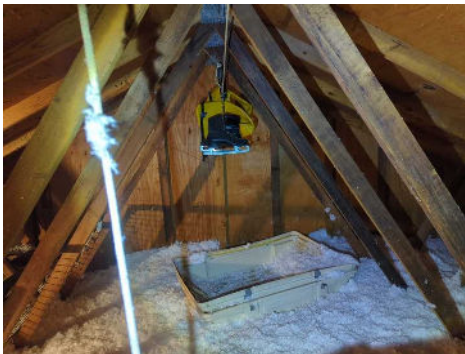
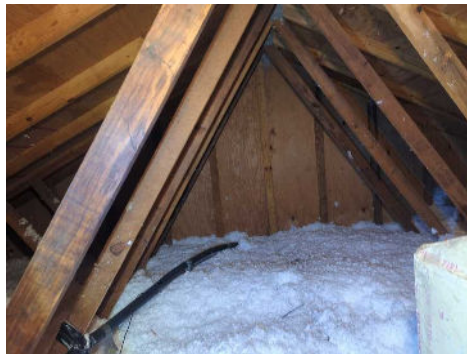
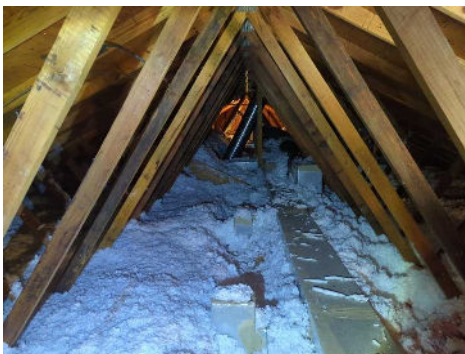
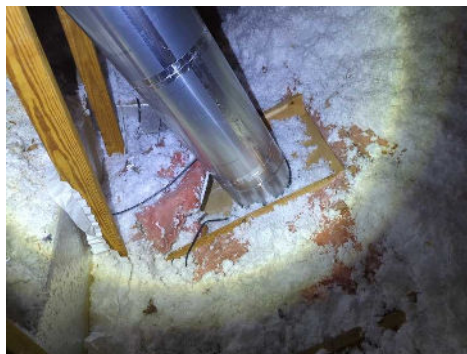
- Attic was not fully visible due to insulation, ductwork and height of structure.
- Toe nails were present at the roof-to-wall connections.
- 8d (2.5") nails secured the sheathing to the attic trusses.
- Closet scuttle was not **accessible** due to shelving.
- Although dry at the time of the inspection, visible stain(s) indicated active leaks may be present. Unable to determine the underlying condition.
- Insulation had been moved/disturbed, leaving low coverage areas.
- Prior repairs were visible.
- Moisture stain(s) were visible at the accessible areas of the attic. Stains tested wet at the time of inspection.

Insulation had been moved/disturbed, leaving low coverage areas.

Although dry at the time of the inspection, visible stain(s) indicated active leaks may be present. Unable to determine the underlying condition.

Moisture stain(s) were visible at the accessible areas of the attic. Stains tested wet at the time of inspection.

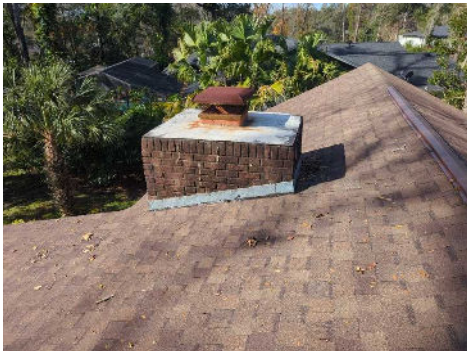
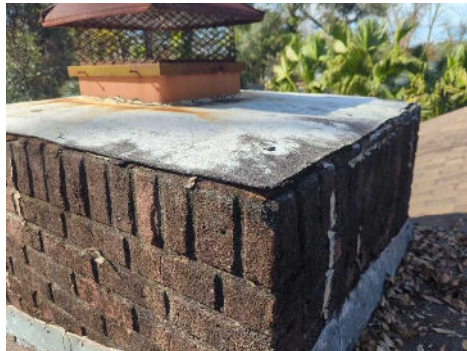
- Brick/mortar at chimney was damaged.
- Rain cap was damaged.
- Spark screen was damaged/deteriorated.
- Flashing around chimney was damaged.

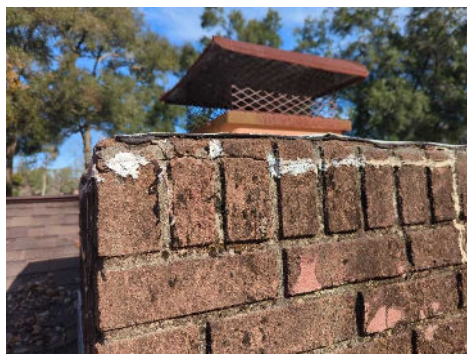
Flashing around chimney was damaged.

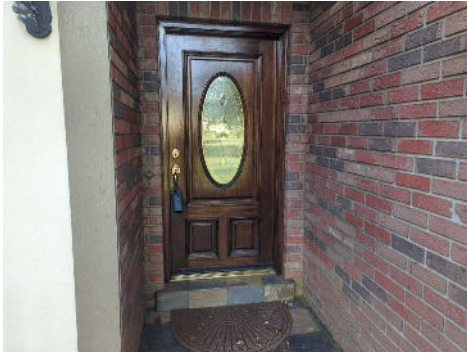
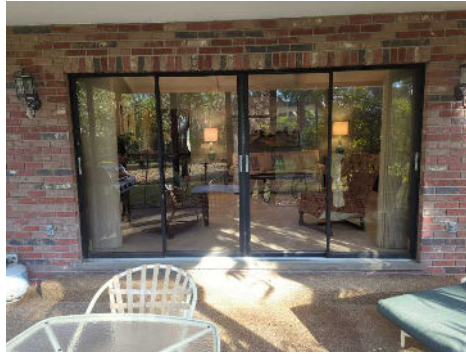
- The secondary door(s) hardware was hard to operate.
- The secondary door(s) had visible moisture damage.

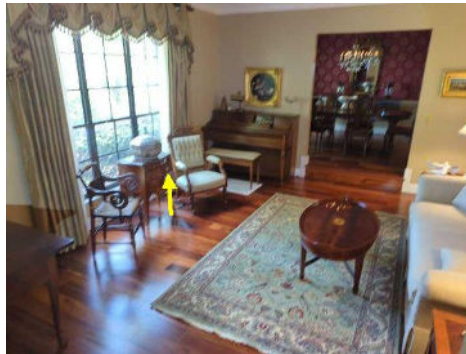
Visible stain(s) tested wet, using a moisture meter. Unable to determine underlying condition at living room.

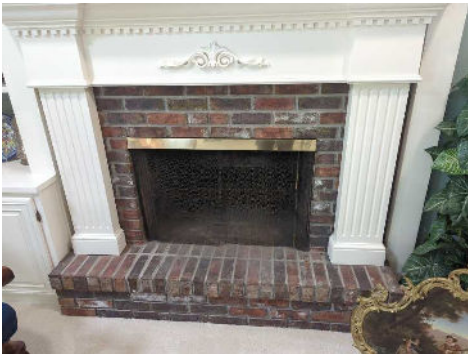
Glass cover was not installed.

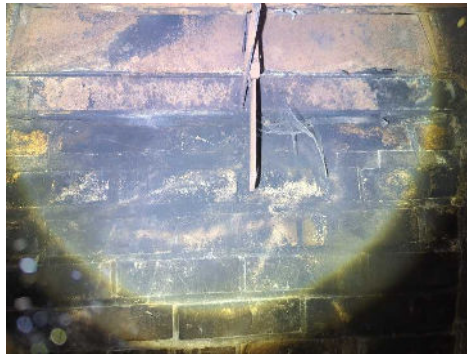
The fireplace vent flue and chimney should be professionally cleaned prior to the first use.

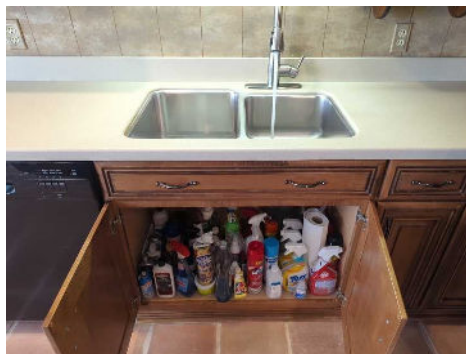
- Sink to counter transition should be sealed on a regular basis.
- Chemicals were present and blocked full access to sink. It was not fully visible for inspection.

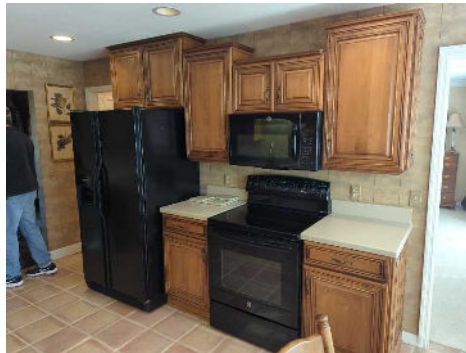
- Manufacturer: GE
- Refrigerator was near or exceeded the end of its useful life and may need replacement in the near future.
