# WAYPOINT

## INSPECTIONREPORT

1234 Seller Street Tampa, FL 33619

Inspection Date: 1/20/2024

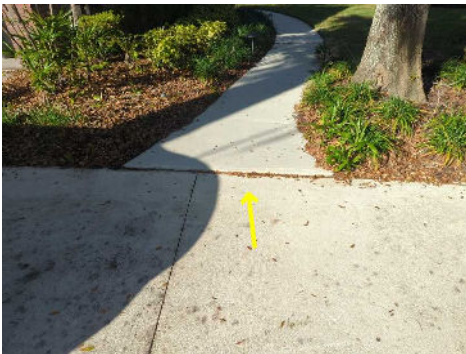
Walkway surface was uneven.

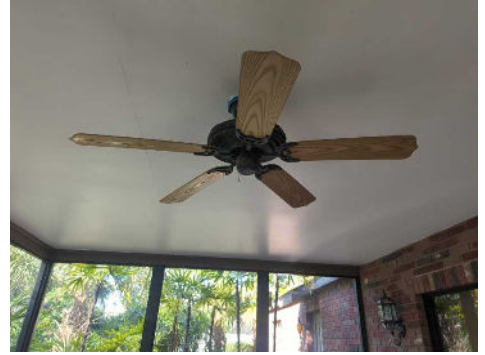
Ceiling fan was at the end of life.

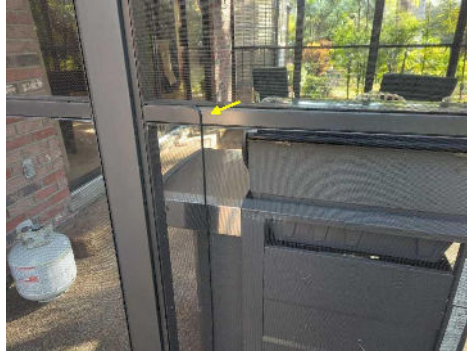
Patio screening was loose/not secured.

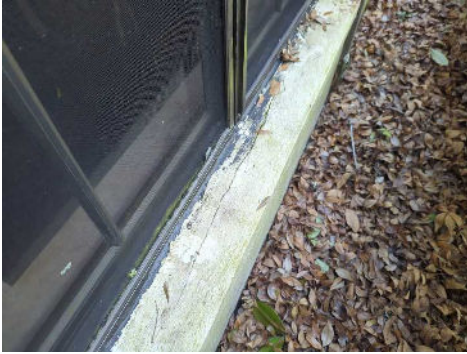
Settlement up to 1/8" cracks were visible at front.

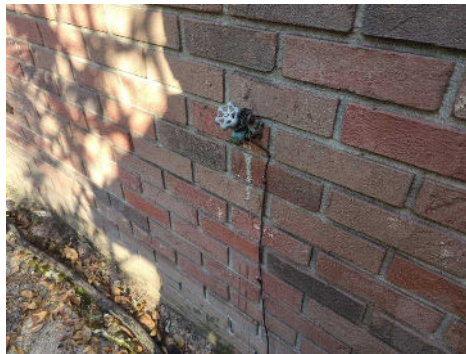
Back-flow device was not installed at the exterior faucets.

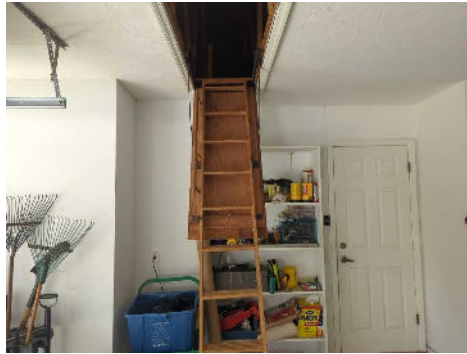
Attic pull down ladder was not fire-rated.  
(See NACHI Standard of Practice article - <https://www.nachi.org/inspecting-residential-attached-garages.htm>).

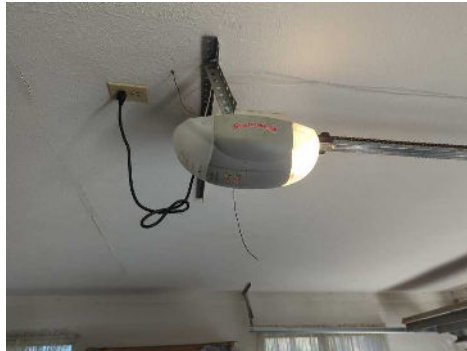
- **Automatic PRESSURE REVERSE** and/or **ELECTRONIC EYE(S)** safety feature did not operate when tested.

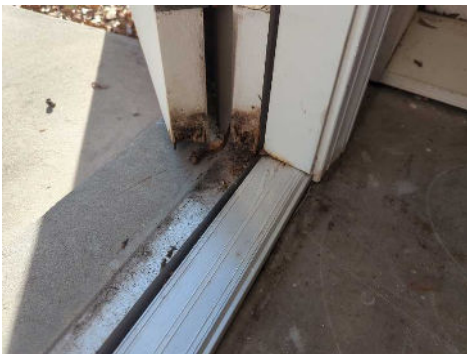
Moisture damage was visible at the door and/or door jamb.

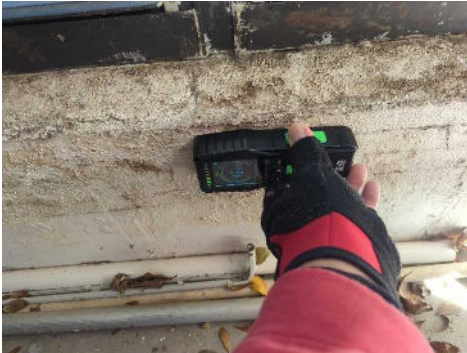
Visible moisture stain(s) indicated active leak(s) were present.

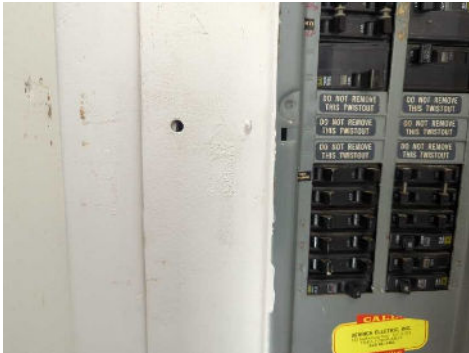
Fasteners were missing.

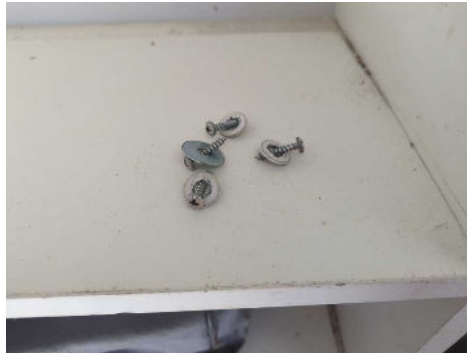
Fasteners were missing and improper.

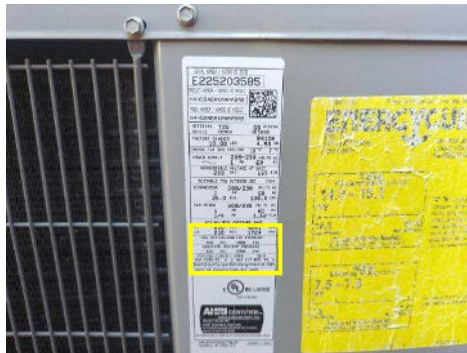
Breaker size at panel exceed the max rating (over fused) at the AC Condenser Unit

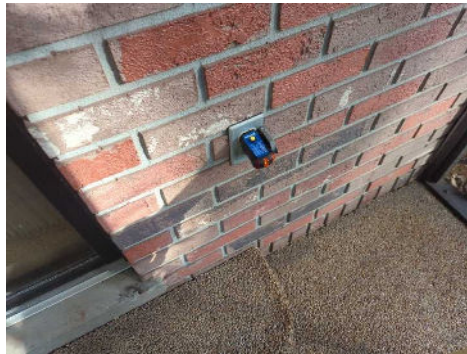
GFCI (Ground Fault Circuit Interrupter) outlet(s) should be installed at all wet areas.

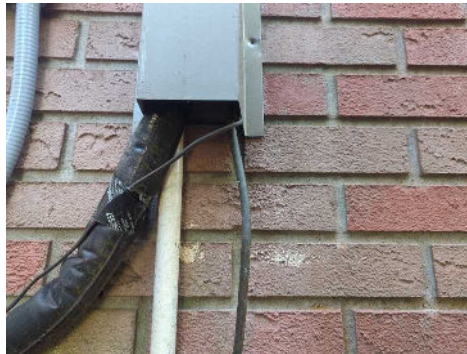
Steel wool/expanding foam should be installed at the base of the refrigerant chase to prevent pest intrusion into the house/attic.

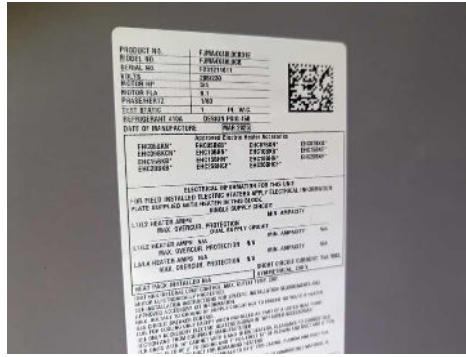
- Heating system operated: Yes
- Insulation should be installed on the condensate line.

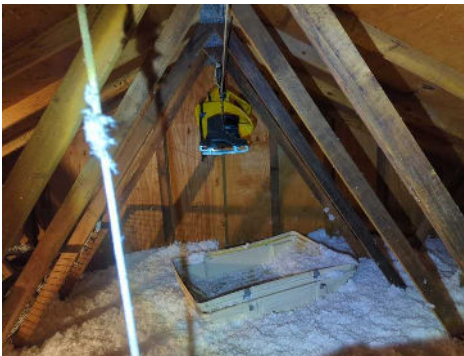
Insulation had been moved/disturbed, leaving low coverage areas.

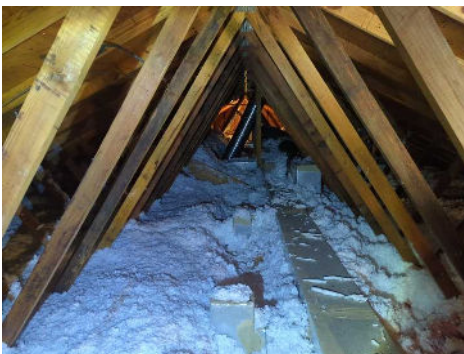
Although dry at the time of the inspection, visible stain(s) indicated active leaks may be present. Unable to determine the underlying condition.

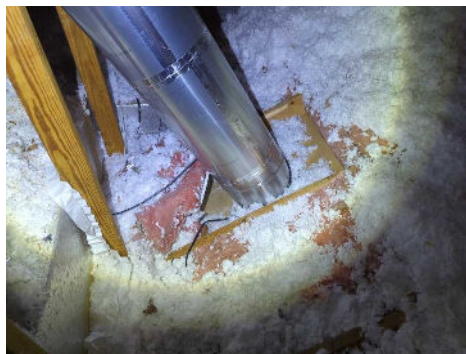
Although dry at the time of the inspection, visible stain(s) indicated active leaks may be present. Unable to determine the underlying condition.

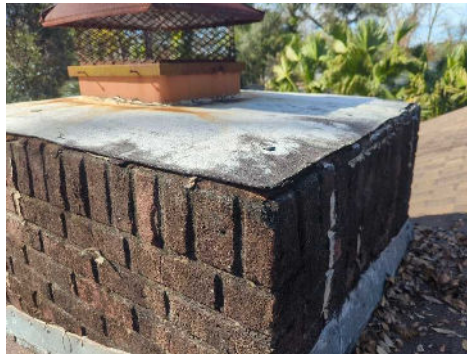
Rain cap was damaged.

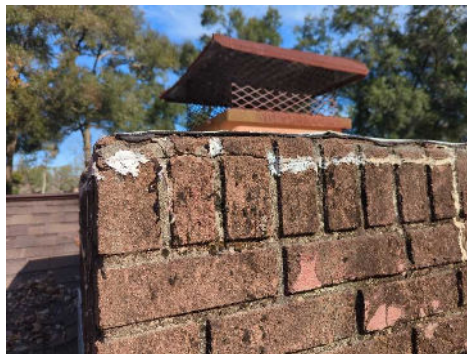
Brick/mortar at chimney was damaged.

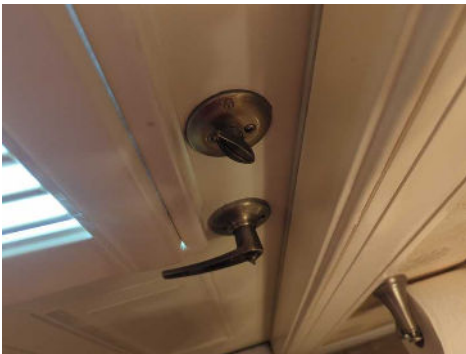
The secondary door(s) hardware was hard to operate.

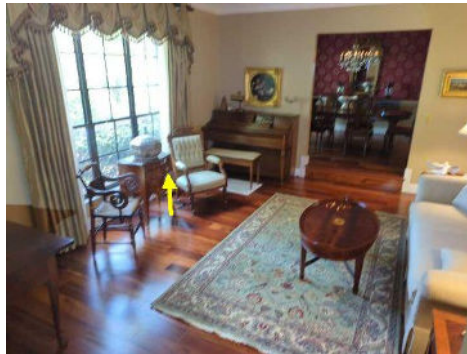
Visible stain(s) tested wet, using a moisture meter. Unable to determine underlying condition at living room.

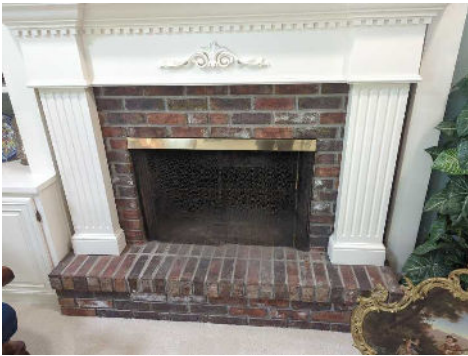
Glass cover was not installed.

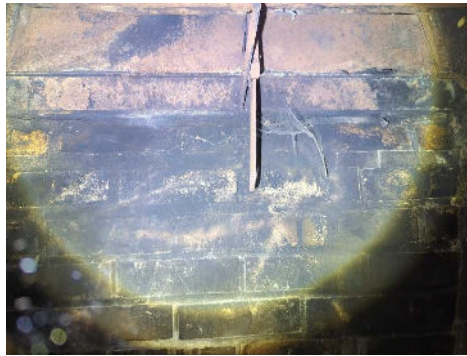
The fireplace vent flue and chimney should be professionally cleaned prior to the first use.

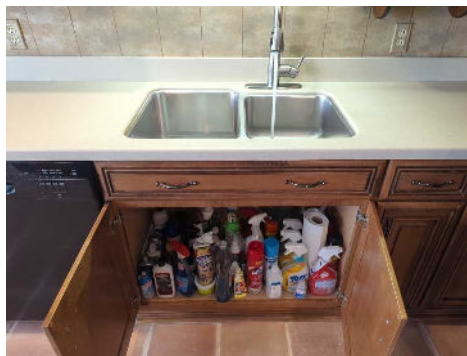
- Sink to counter transition should be sealed on a regular basis.
- Chemicals were present and blocked full access to sink. It was not fully visible for inspection.

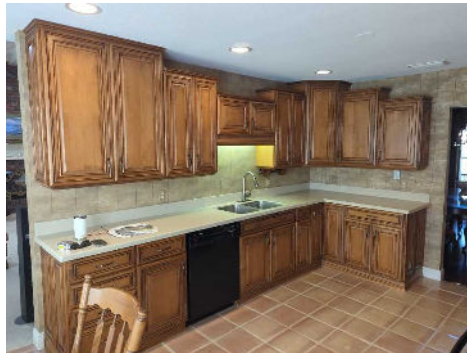
- Manufacturer: GE
- Dishwasher was near or exceeded the end of its useful life and may need replacement in the near future.

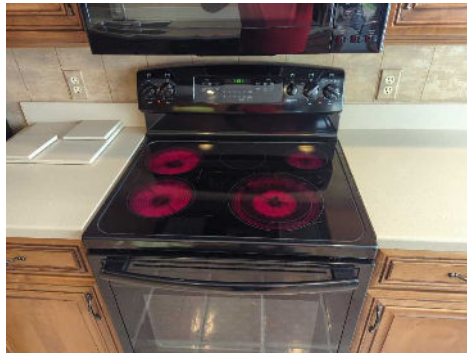
- Manufacturer: GE
- Oven - Stove Top was near or exceeded the end of its useful life and may need replacement in the near future.

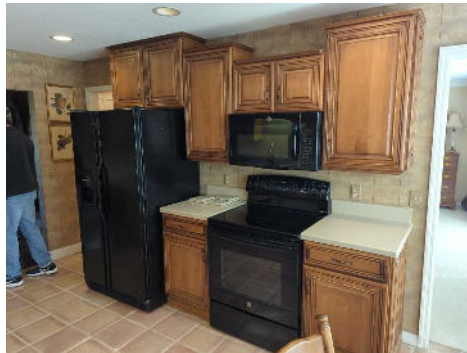
- Manufacturer: GE
- Refrigerator was near or exceeded the end of its useful life and may need replacement in the near future.
